ACCESSIBILITY ASSESSMENT

ADA TITLE II ASSESSMENT

Abernethy Hall
131 South Columbia Street
Chapel Hill, North Carolina 27514

July 22, 2024

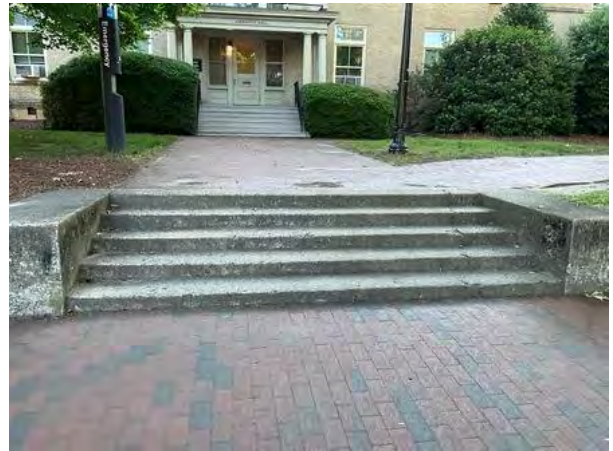
Photos for Barrier ID: AX455995

Assembly	Exterior Access Route	
Type	Stairs	
ADA Standard	2009 ANSI A117.1-504.5	
Barrier Detail		
NORTH CAROLINA: The stair tread, at the leading 2" at the stair nosing, does not have a visual contrast of dark-on-light or light-on-dark distinguished from the remainder of the tread.		
Location Description	Columbia Street	
Observed	May 20, 2024 by Brian.rogers@bureauveritas.com	
Site Conditions	The stair treads do not have visual contrast.	
Resolution		
Install a visual contrast on each stair tread at the nosing. At stair nosings, the leading 2" of tread shall have visual contrast of dark-on-light or light-on-dark from the remainder of the tread.		
Quantity	Unit Cost	Total Cost
5 Riser	125.00	\$ 625
Priority	1

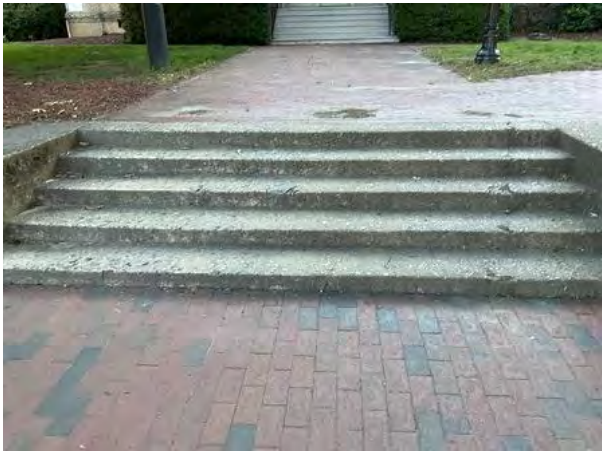
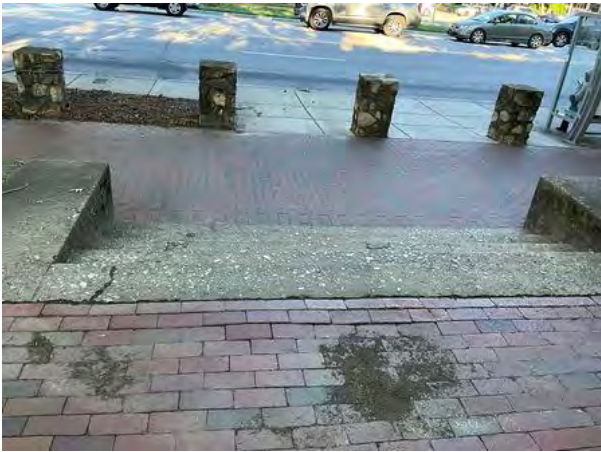
Photos for Barrier ID: AX455998

Assembly	Exterior Access Route
Type	Stairs
ADA Standard	505
Barrier Detail	Handrails are not compliant or are not provided.
Location Description	Columbia Street Main Entrance
Observed	May 20, 2024 by Brian.rogers@bureauveritas.com

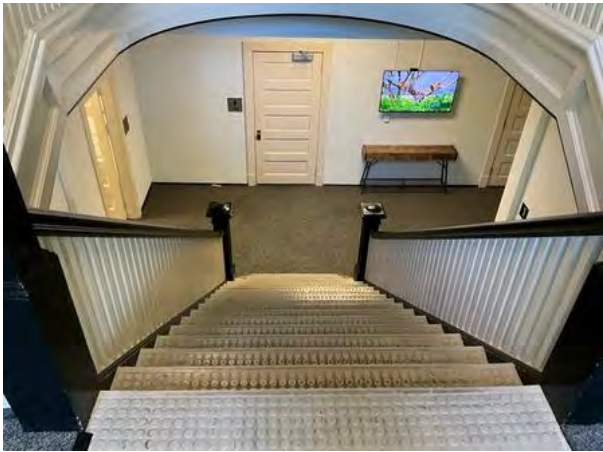
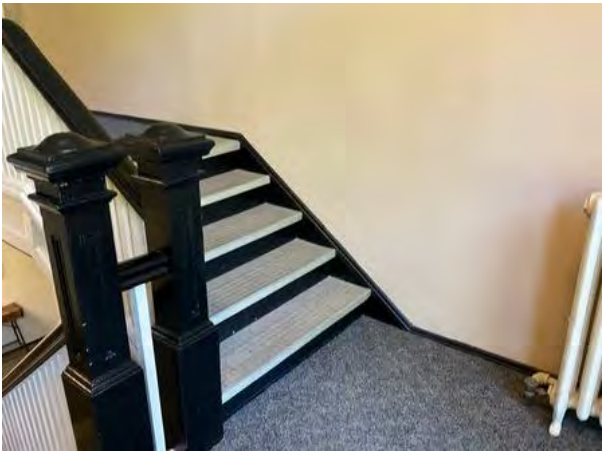
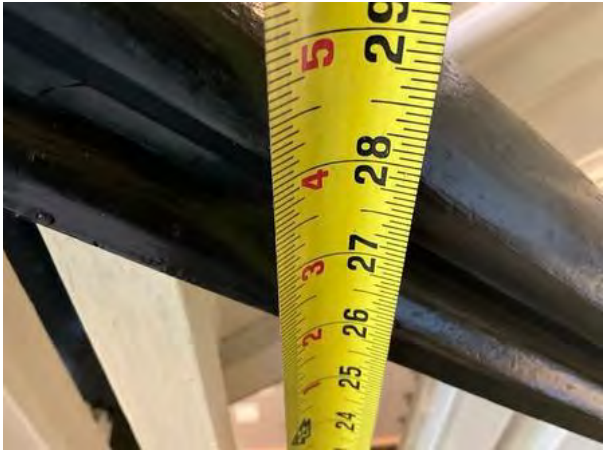
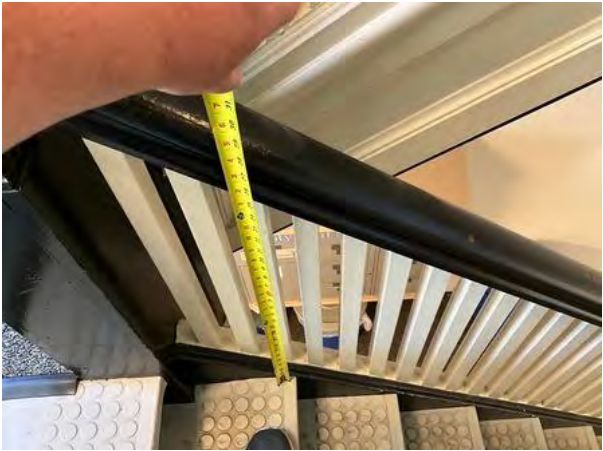
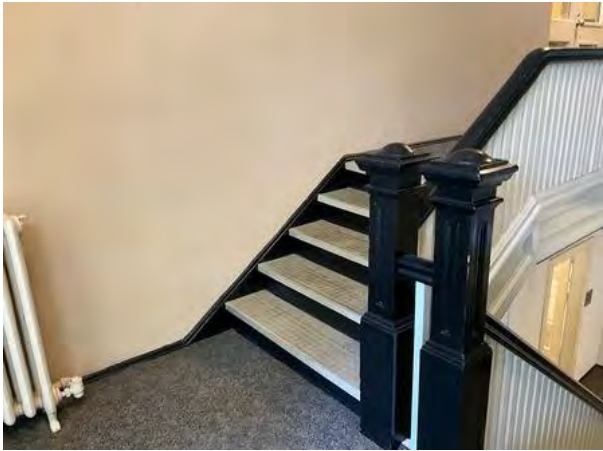
Assembly	Interior Access Route
Type	Stairs
ADA Standard	505
Barrier Detail	Handrails are not compliant.
Location Description	Main Staircase
Observed	May 20, 2024 by Brian.rogers@bureauveritas.com

Handrails are missing on the wall side on the top five steps on each side of the grand staircase. Existing handrail is 28 inches above the nose of the steps.

Install compliant handrails on both sides of the stairway. Inside handrails on switchback or dogleg stairs shall be continuous between runs. Top of gripping surfaces of handrails shall be 34" minimum and 38" maximum vertically above stair nosings. Handrails shall be at a consistent height above ramp surfaces. Clearance between handrail gripping surfaces and adjacent surfaces shall be 1-1/2" minimum. Handrail gripping surfaces shall be continuous along their length and shall not be obstructed along their tops or sides. The bottoms of handrail gripping surfaces shall not be obstructed for more than 20% of their length. Where provided, horizontal projections shall occur 1-1/2" minimum below the bottom of the handrail gripping surface. [EXCEPTION: The distance between horizontal projections and the bottom of the gripping surface shall be permitted to be reduced by 1/8" for each 1/2" of additional handrail perimeter dimension that exceeds 4".] Handrail gripping surfaces with a circular cross section shall have an outside diameter of 1-1/4" minimum and 2" maximum. Handrail gripping surfaces with a non-circular cross section shall have a perimeter dimension of 4" minimum and 6-1/4" maximum, and a cross-section dimension of 2-1/4" maximum. Handrail gripping surfaces and any surfaces adjacent to them shall be free of sharp or abrasive elements and shall have rounded edges. Handrails shall not rotate within their fittings. Handrail gripping surfaces shall extend beyond and in the same direction of stair flights. [EXCEPTIONS: 1. Extensions shall not be required for continuous handrails at the inside turn of switchback or dogleg ramps AND 3. In alterations, full extensions of handrails shall not be required where such extensions would be hazardous due to plan configuration.] At the top of a stair flight, handrails shall extend horizontally above the landing for 12" minimum beginning directly above the first riser nosing. At the bottom of a stair flight, handrails shall extend at the slope of the stair flight for a horizontal distance at least equal to one tread depth beyond the last riser nosing. Extensions shall return to a wall, guard, or the landing surface, or shall be continuous to the handrail of an adjacent stair flight. Removal of this barrier is required if the stairs are part of the required accessible means of egress from the accessible space, per emergency egress plans approved by the administrating local authority.

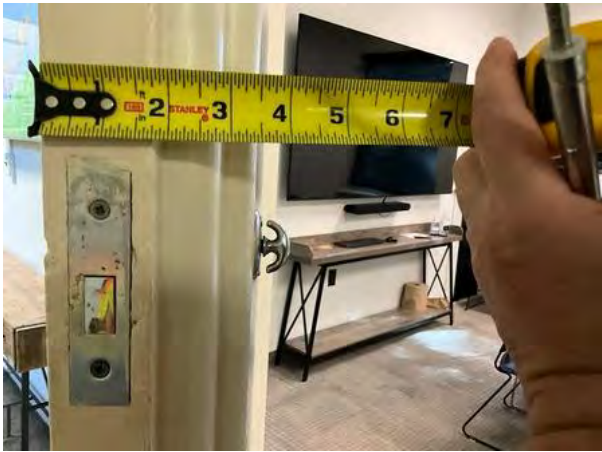
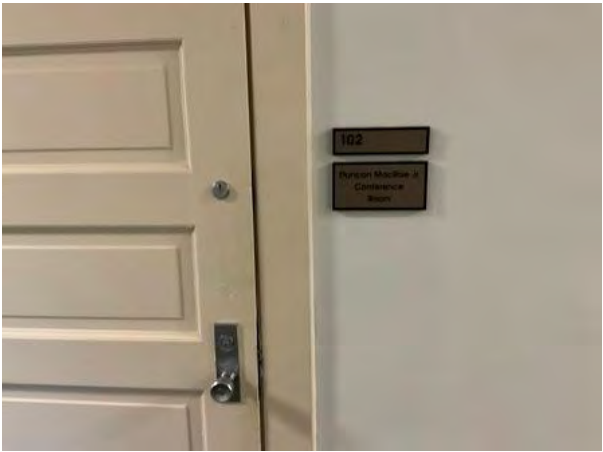
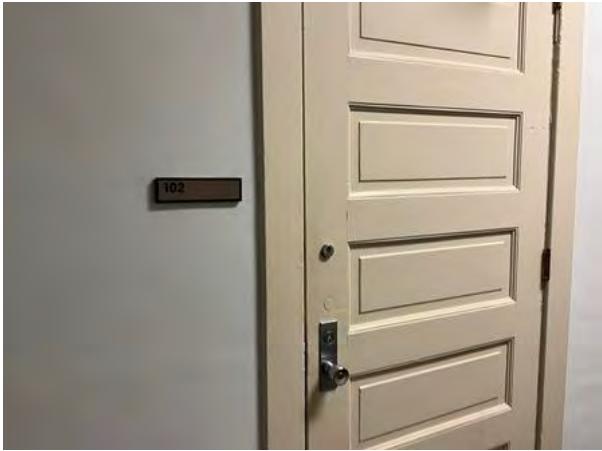
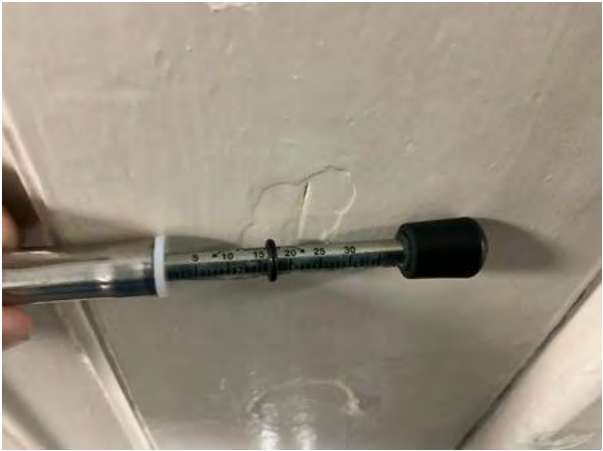
Assembly	Interior Access Route	
Type	Door	
ADA Standard	404.2.9	
Barrier Detail		
The opening force required to open the accessible, hinged, non-fire door is more than 5 pounds.		
Location Description	Room 102	
Observed	May 20, 2024 by Brian.rogers@bureauveritas.com	
Site Conditions	The two 3 1/2" thick sound proof doors take 16 pounds of pressure to open.	
Resolution		
Adjust the closer or replace with a door that requires no more than 5 pounds of force for pushing or pulling the door open. The force at the latch, the force to set the door in motion, and the force to fully open the door shall be maximum 5 pounds. These forces do not apply to the force required to retract latch bolts or disengage other devices that hold the door or gate in a closed position.		
Quantity	Unit Cost	Total Cost
2 EA	458.00	\$ 916
Priority	1

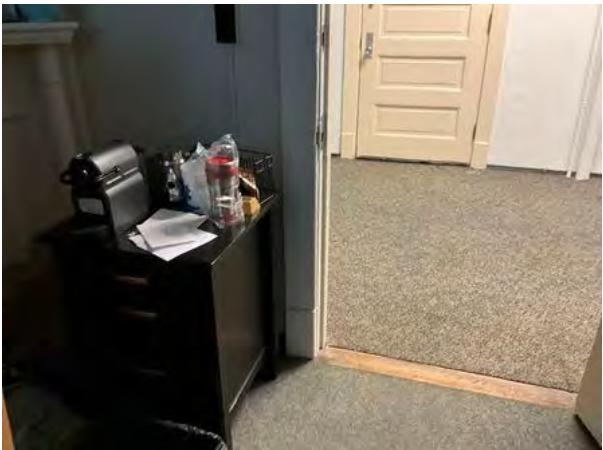
Photos for Barrier ID: AX456014

Assembly	Interior Access Route	
Type	Door	
ADA Standard	404.2.4; Table 404.2.4.1	
Barrier Detail		
The pull side of the accessible door does not have the required maneuvering clearances.		
Location Description	Room 105	
Observed	May 20, 2024 by Brian.rogers@bureauveritas.com	
Site Conditions		
For a front approach on the pull side of the door the latch side clearance is 5 1/2" to a 7" deep column.		
Dimensions	5 1/2"	
Resolution		
Redesign to provide the required maneuvering clearance at the pull side of the door. The required depth of the maneuvering clearance is 60" minimum. The required side clearance is 18" minimum on the latch side of the door. Maneuvering clearance shall extend the full width of the doorway and the required latch side clearance. Floor or ground space within the required maneuvering clearance shall be maximum 1:48 (2.08%) slope. Changes in level are not permitted.		
Quantity	Unit Cost	Total Cost

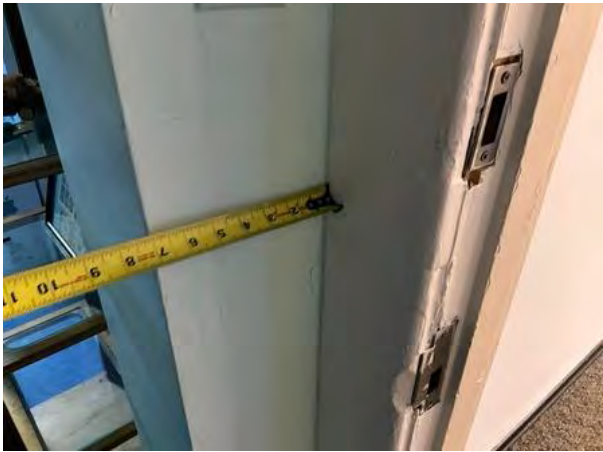
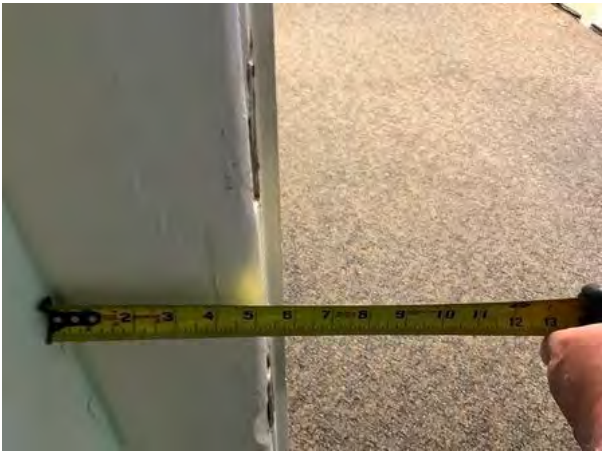
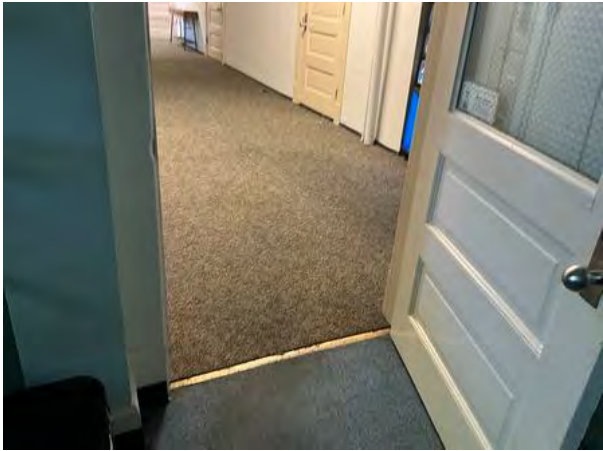
Assembly	Interior Access Route
Type	Door
ADA Standard	307.4, 404.2.3
Barrier Detail	The door has less than 32" clear width.
Location Description	Room 105 interior door
Observed	May 20, 2024 by Brian.rogers@bureauveritas.com
Site Conditions	The interior office door is 29 1/2" wide.
Width	29 1/2"

Remove and replace with a door that has a minimum clear opening of 32". Door openings shall provide a clear width of 32" minimum. Clear openings of doorways with swinging doors shall be measured between the face of the door and the stop, with the door open 90 degrees. Openings more than 24" deep shall provide a clear opening of 36" minimum. There shall be no projections into the required clear opening width lower than 34" above the finish floor or ground. Projections into the clear opening width between 34" and 80" above the finish floor or ground shall not exceed 4". [EXCEPTIONS: 1. In alterations, a projection of 5/8" maximum into the required clear width shall be permitted for the latch side stop. 2. Door closers and door stops shall be permitted to be 78" minimum above the finish floor or ground.]

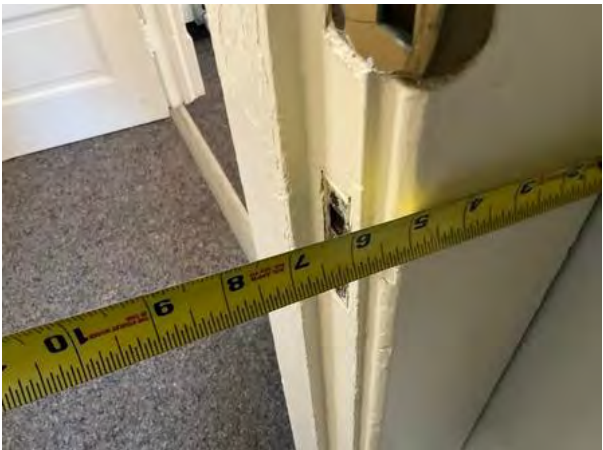
Photos for Barrier ID: AX456040

Assembly	Interior Access Route
Type	Door
ADA Standard	307.4, 404.2.3
Barrier Detail	The door has less than 32" clear width.
Location Description	Room 120
Observed	May 20, 2024 by Brian.rogers@bureauveritas.com

Remove and replace with a door that has a minimum clear opening of 32". Door openings shall provide a clear width of 32" minimum. Clear openings of doorways with swinging doors shall be measured between the face of the door and the stop, with the door open 90 degrees. Openings more than 24" deep shall provide a clear opening of 36" minimum. There shall be no projections into the required clear opening width lower than 34" above the finish floor or ground. Projections into the clear opening width between 34" and 80" above the finish floor or ground shall not exceed 4". [EXCEPTIONS: 1. In alterations, a projection of 5/8" maximum into the required clear width shall be permitted for the latch side stop. 2. Door closers and door stops shall be permitted to be 78" minimum above the finish floor or ground.]

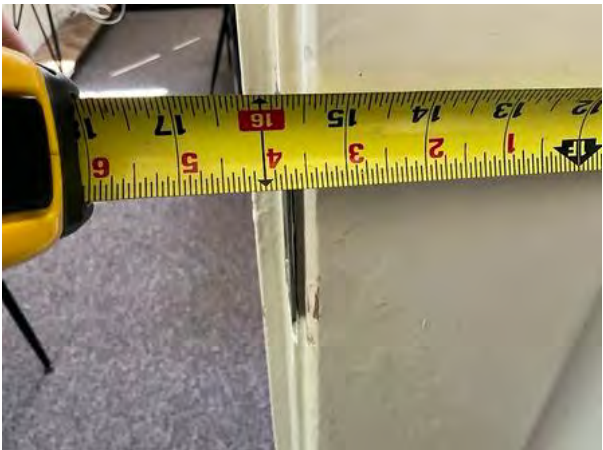
Photos for Barrier ID: AX456043

Assembly	Interior Access Route
Type	Door
ADA Standard	307.4, 404.2.3
Barrier Detail	The door has less than 32" clear width.
Location Description	Room 202A
Observed	May 20, 2024 by Brian.rogers@bureauveritas.com
Site Conditions	The door is 26 3/4 inches wide.
Width	26 3/4"

Remove and replace with a door that has a minimum clear opening of 32". Door openings shall provide a clear width of 32" minimum. Clear openings of doorways with swinging doors shall be measured between the face of the door and the stop, with the door open 90 degrees. Openings more than 24" deep shall provide a clear opening of 36" minimum. There shall be no projections into the required clear opening width lower than 34" above the finish floor or ground. Projections into the clear opening width between 34" and 80" above the finish floor or ground shall not exceed 4". [EXCEPTIONS: 1. In alterations, a projection of 5/8" maximum into the required clear width shall be permitted for the latch side stop. 2. Door closers and door stops shall be permitted to be 78" minimum above the finish floor or ground.]

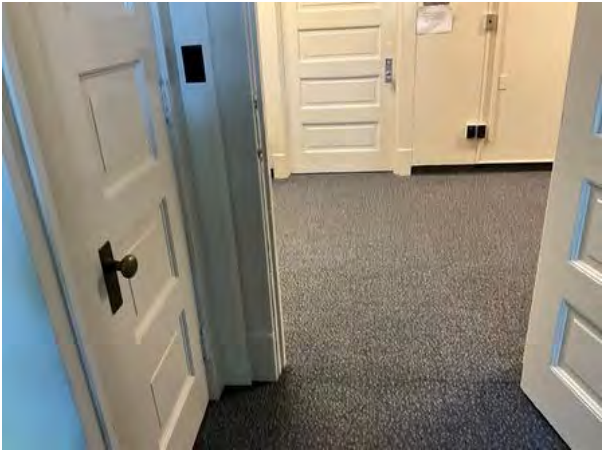
Photos for Barrier ID: AX456064

Assembly	Interior Access Route
Type	Door
ADA Standard	307.4, 404.2.3
Barrier Detail	The door has less than 32" clear width.
Location Description	Room 203A
Observed	May 20, 2024 by Brian.rogers@bureauveritas.com
Site Conditions	The door is 29 inches wide.
Width	29"

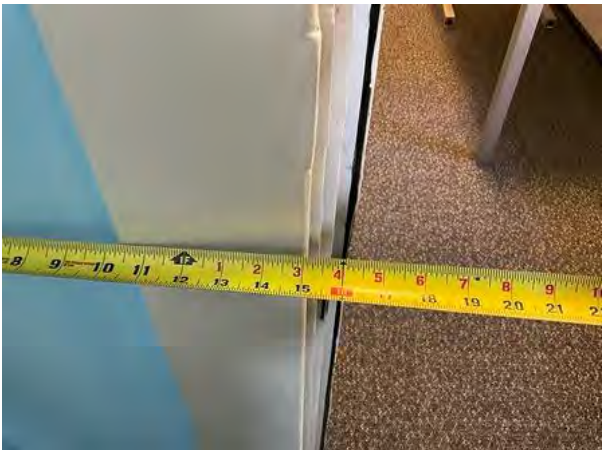
Photos for Barrier ID: AX456074

Assembly	Interior Access Route	
Type	Door	
ADA Standard	404.2.9	
Barrier Detail		
The opening force required to open the accessible, hinged, non-fire door is more than 5 pounds.		
Location Description	Room 218A	
Observed	May 20, 2024 by Brian.rogers@bureauveritas.com	
Site Conditions		
The door rubs on the threshold, creating an initial 23 pounds of pressure to open.		
Resolution		
Adjust the closer or replace with a door that requires no more than 5 pounds of force for pushing or pulling the door open. The force at the latch, the force to set the door in motion, and the force to fully open the door shall be maximum 5 pounds. These forces do not apply to the force required to retract latch bolts or disengage other devices that hold the door or gate in a closed position.		
Quantity	Unit Cost	Total Cost
1 EA	458.00	\$ 458
Priority	1

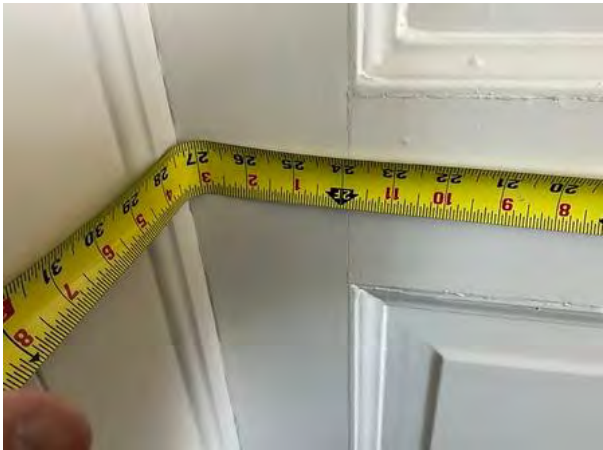
Assembly	Interior Access Route
Type	Door
ADA Standard	307.4, 404.2.3
Barrier Detail	The door has less than 32" clear width.
Location Description	Room 219B
Observed	May 20, 2024 by Brian.rogers@bureauveritas.com
Site Conditions	The door is 27 1/2 inches wide.
Width	27 1/2"

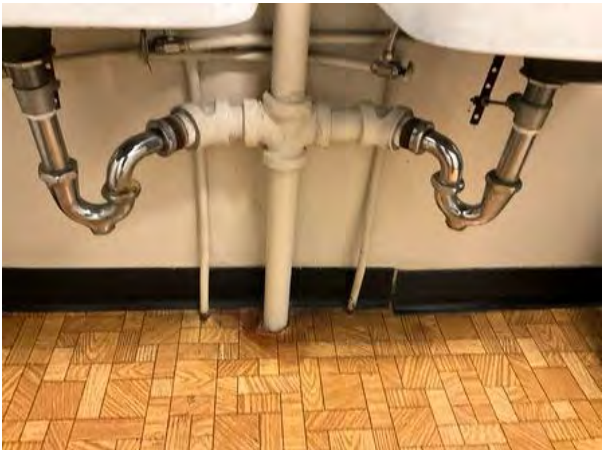
Photos for Barrier ID: AX456022

Assembly	Restroom
Type	Controls And Dispensers
ADA Standard	606.1; 309.3
Barrier Detail	The height of controls are not compliant.
Location Description	First Floor Women's Restroom
Observed	May 20, 2024 by Brian.rogers@bureauveritas.com

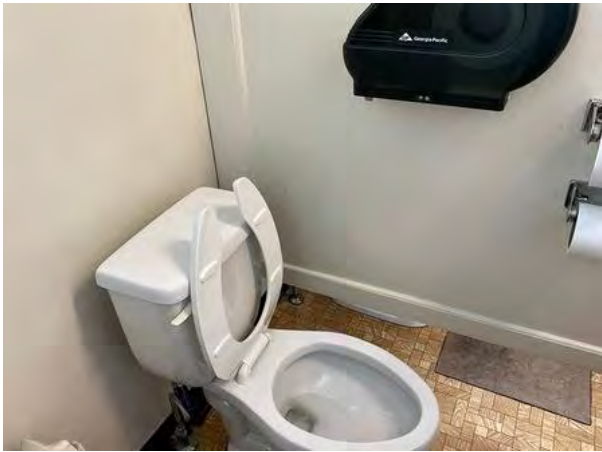
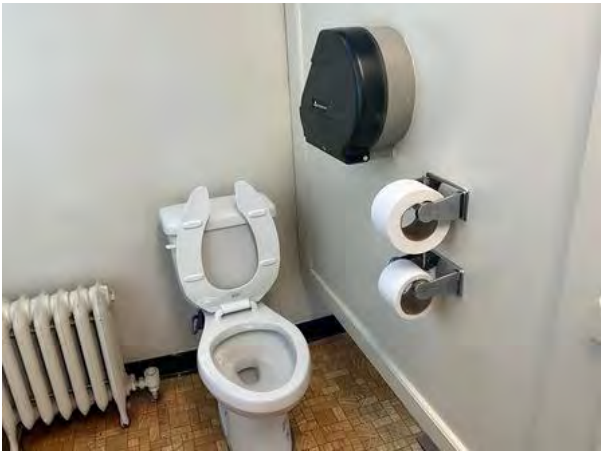
Photos for Barrier ID: AX456018

Assembly	Restroom	
Type	Restroom/Bathroom - Water Closet	
ADA Standard	604.2	
Barrier Detail		
The centerline of the toilet in the wheelchair stall is not 16" minimum to 18" maximum from the sidewall.		
Location Description	First Floor Women's Restroom	
Observed	May 20, 2024 by Brian.rogers@bureauveritas.com	
Site Conditions	The center line of the toilet is 14 1/2 inches from the side wall.	
Resolution		
Provide a water closet with centerline 16" minimum to 18" maximum from the side wall or partition. The water closet shall be positioned with a wall or partition to the rear and to one side. The centerline of the water closet shall be 16" minimum to 18" maximum from the side wall or partition in a wheelchair stall. Water closets shall be arranged for a left-hand or right-hand approach. Clearance around a water closet shall be 60" minimum measured perpendicular from the side wall and 56" minimum measured perpendicular from the rear wall. The required clearance around the water closet shall be permitted to overlap the water closet, associated grab bars, dispensers, personal product disposal units, coat hooks, shelves, accessible routes, clear floor space and clearances required at other fixtures, and the turning space. No other fixtures or obstructions shall be located within the required water closet clearance. [ADVISORY: It is advisable, but not required, to use the specifications for children where children are the primary users of the restroom. Guidance in applying the specifications for children according to the age group served reflects the differences in the size, stature, and reach ranges of children ages 3 to 12. The specifications chosen should correspond to the age of the primary user group. The specifications of one age group should be applied consistently in the installation of a water closet and related elements. Water Closet Centerline: Ages 3 and 4- 12"; Ages 5 through 8- 12" to 15"; Ages 9 through 12- 15" to 18". Toilet Seat Height: Ages 3 and 4- 11" to 12"; Ages 5 through 8- 12" to 15"; Ages 9 through 12- 15" to 17". Grab Bar Height: Ages 3 and 4- 18" to 20"; Ages 5 through 8- 20" to 25"; Ages 9 through 12- 25" to 27"; Dispenser Height: Ages 3 and 4- 14"; Ages 5 through 8- 14" to 17"; Ages 9 through 12- 17" to 19"].

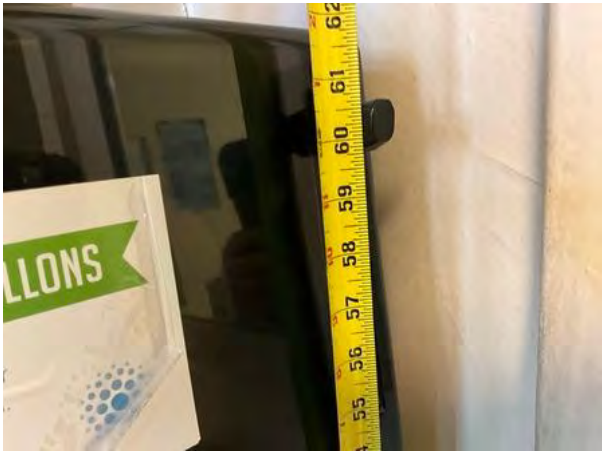
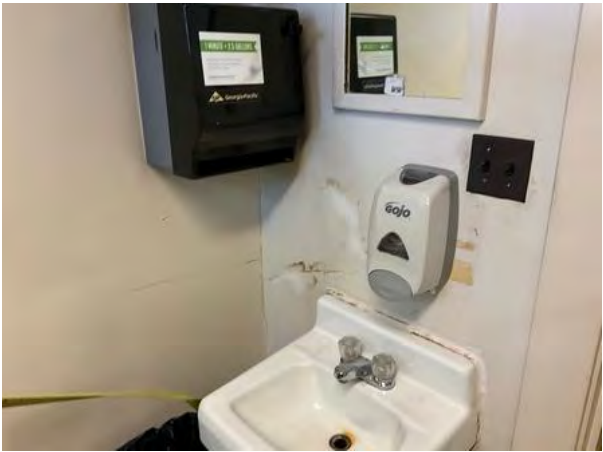
Assembly	Restroom
Type	Restroom/Bathroom - Door
ADA Standard	404.2.3
Barrier Detail	The door has less than 32" clear width.
Location Description	Second Floor Men's Restroom
Observed	May 20, 2024 by Brian.rogers@bureauveritas.com
Site Conditions	Interior door of the men's restroom is 26 inches wide.

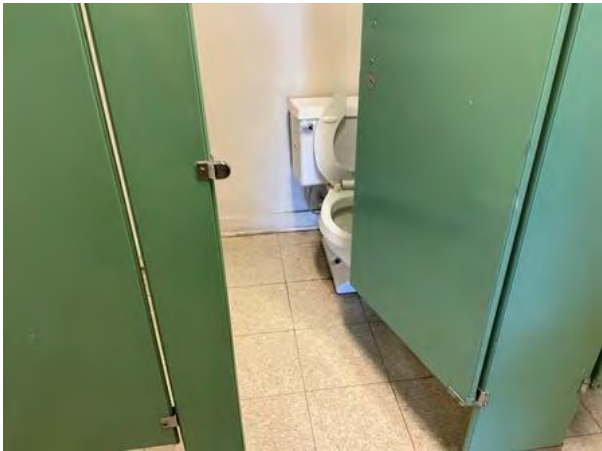
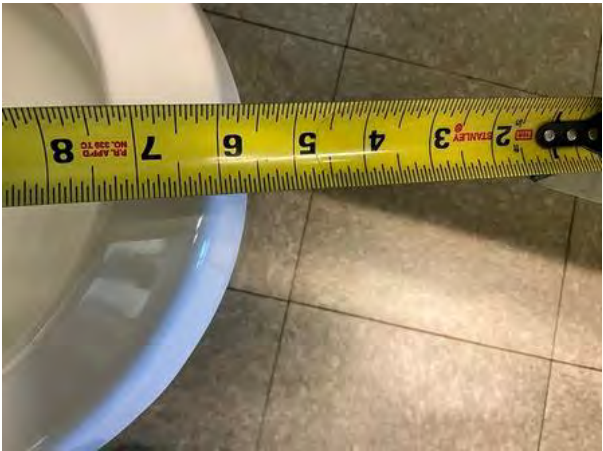
Photos for Barrier ID: AX456048

Assembly	Restroom
Type	Restroom/Bathroom - Door
ADA Standard	404.2.3
Barrier Detail	The door has less than 32" clear width.
Location Description	Second Floor Men's Restroom
Observed	May 20, 2024 by Brian.rogers@bureauveritas.com
Site Conditions	The stall door is 22 1/2 inches wide.

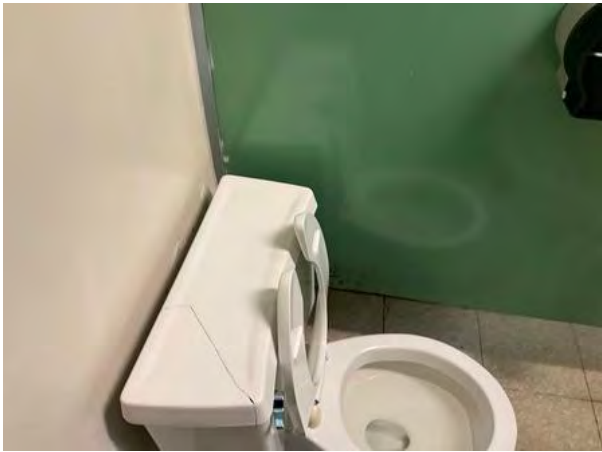
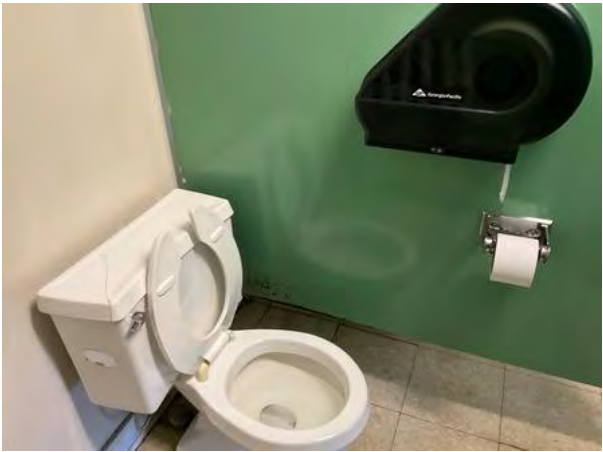
Photos for Barrier ID: AX456050

Assembly	Restroom	
Type	Restroom/Bathroom - Water Closet	
ADA Standard	604.2	
Barrier Detail		
The centerline of the toilet in the wheelchair stall is not 16" minimum to 18" maximum from the sidewall.		
Location Description	Second Floor Men's Restroom	
Observed	May 20, 2024 by Brian.rogers@bureauveritas.com	
Site Conditions	The center line of the toilet is 13 inches from the side wall.	
Resolution		
Provide a water closet with centerline 16" minimum to 18" maximum from the side wall or partition. The water closet shall be positioned with a wall or partition to the rear and to one side. The centerline of the water closet shall be 16" minimum to 18" maximum from the side wall or partition in a wheelchair stall. Water closets shall be arranged for a left-hand or right-hand approach. Clearance around a water closet shall be 60" minimum measured perpendicular from the side wall and 56" minimum measured perpendicular from the rear wall. The required clearance around the water closet shall be permitted to overlap the water closet, associated grab bars, dispensers, personal product disposal units, coat hooks, shelves, accessible routes, clear floor space and clearances required at other fixtures, and the turning space. No other fixtures or obstructions shall be located within the required water closet clearance. [ADVISORY: It is advisable, but not required, to use the specifications for children where children are the primary users of the restroom. Guidance in applying the specifications for children according to the age group served reflects the differences in the size, stature, and reach ranges of children ages 3 to 12. The specifications chosen should correspond to the age of the primary user group. The specifications of one age group should be applied consistently in the installation of a water closet and related elements. Water Closet Centerline: Ages 3 and 4- 12"; Ages 5 through 8- 12" to 15"; Ages 9 through 12- 15" to 18". Toilet Seat Height: Ages 3 and 4- 11" to 12"; Ages 5 through 8- 12" to 15"; Ages 9 through 12- 15" to 17". Grab Bar Height: Ages 3 and 4- 18" to 20"; Ages 5 through 8- 20" to 25"; Ages 9 through 12- 25" to 27"; Dispenser Height: Ages 3 and 4- 14"; Ages 5 through 8- 14" to 17"; Ages 9 through 12- 17" to 19"].
