ACCESSIBILITY ASSESSMENT

June 21, 2024

ADA TITLE II ASSESSMENT

Abernethy Annex

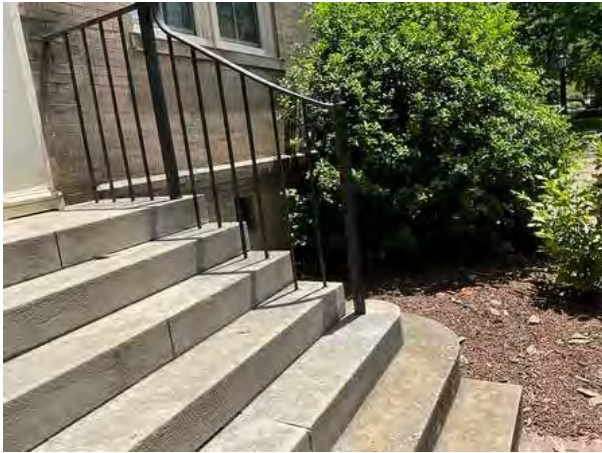
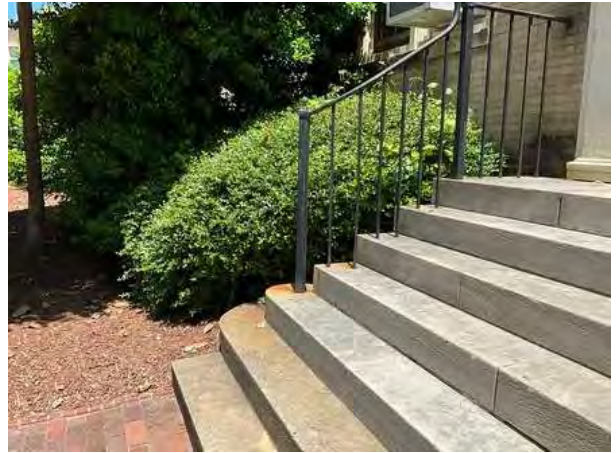
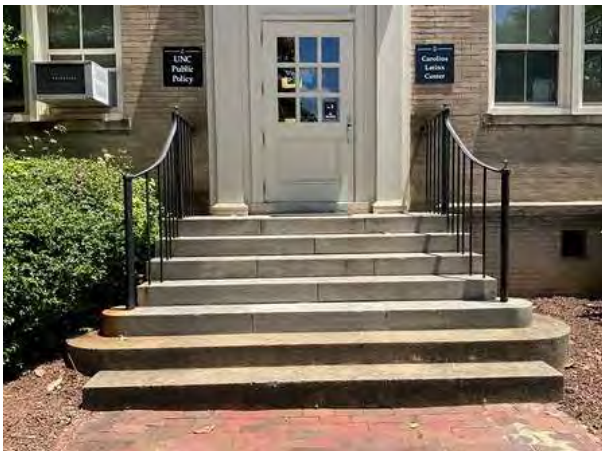
Photos for Barrier ID: AX455970

Assembly	Exterior Access Route	
Type	Stairs	
ADA Standard	2009 ANSI A117.1-504.5	
Barrier Detail		
NORTH CAROLINA: The stair tread, at the leading 2" at the stair nosing, does not have a visual contrast of dark-on-light or light-on-dark distinguished from the remainder of the tread.		
Location Description	Front entry	
Observed	May 22, 2024 by Brian.rogers@bureauveritas.com	
Site Conditions	The stairs do not have contrast on the top nose	
Resolution		
Install a visual contrast on each stair tread at the nosing. At stair nosings, the leading 2" of tread shall have visual contrast of dark-on-light or light-on-dark from the remainder of the tread.		
Quantity	Unit Cost	Total Cost
7 Riser	250.00	\$ 1,750
Priority	1

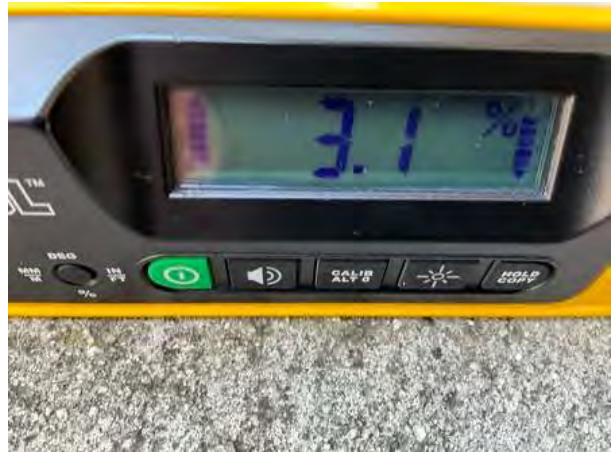
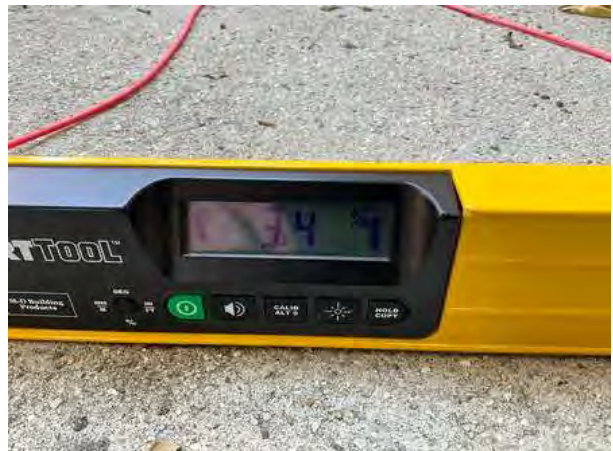
Photos for Barrier ID: AX455991

Site Conditions	The bottom portion of the ramp has a running slope of 9.8% for 6 feet.
-----------------	--

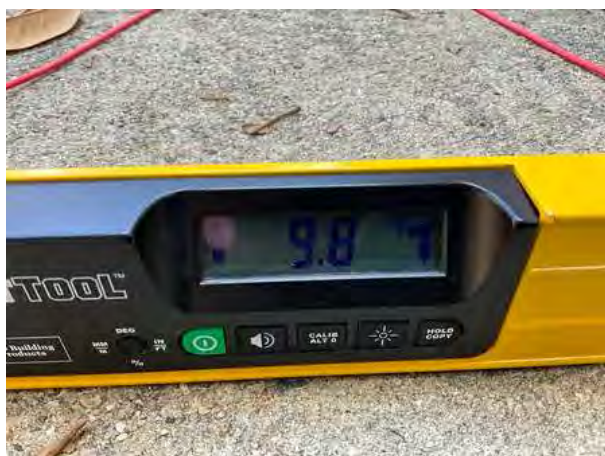
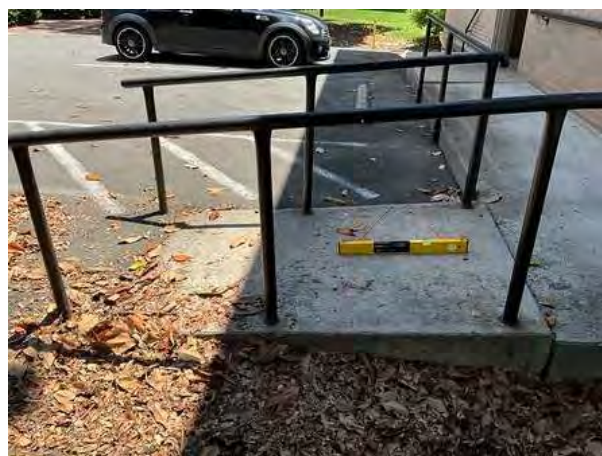
Photos for Barrier ID: AX455992

Assembly	Exterior Access Route
Type	Ramp
ADA Standard	North Carolina Building Code 2012-1104.1
Barrier Detail	NORTH CAROLINA: The exterior ramp is less than 48" wide.
Location Description	Rear Entrance
Observed	May 22, 2024 by Brian.rogers@bureauveritas.com
Site Conditions	The clear width between handrails is 45 1/2 inches.
Width	45 1/2"

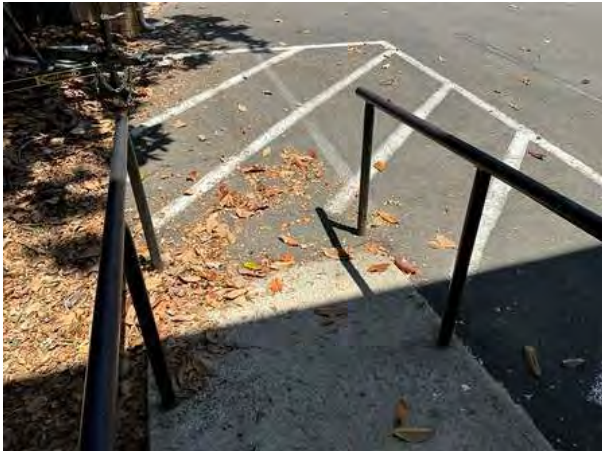
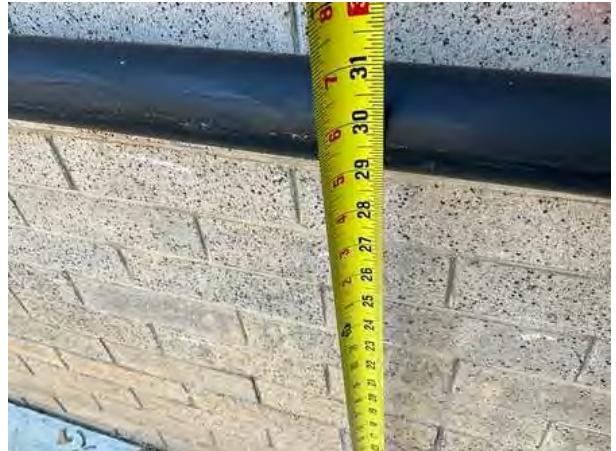
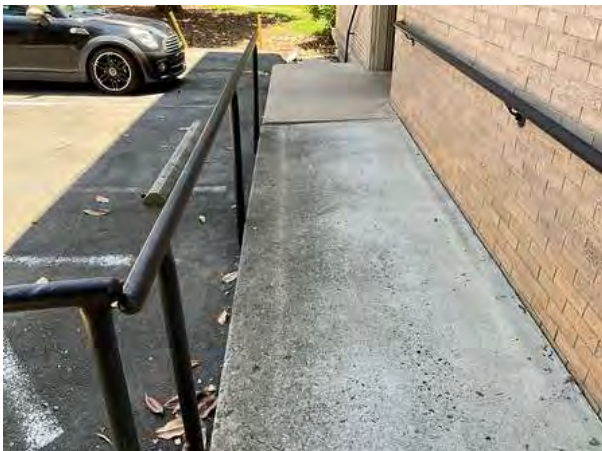
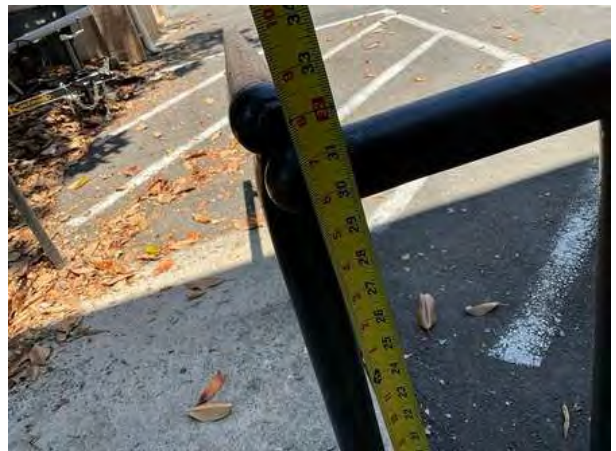
Photos for Barrier ID: AX455994

Assembly	Exterior Access Route
Type	Stairs
ADA Standard	505
Barrier Detail	Handrails are not compliant or are not provided.
Location Description	Rear Entrance
Observed	May 22, 2024 by Brian.rogers@bureauveritas.com
Site Conditions	A handrail is missing on the outside of the steps.

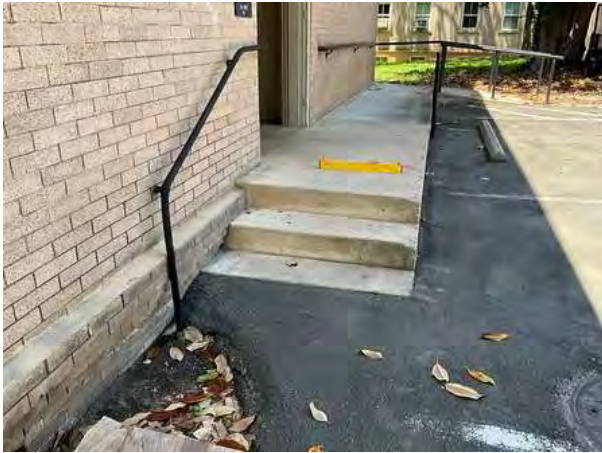
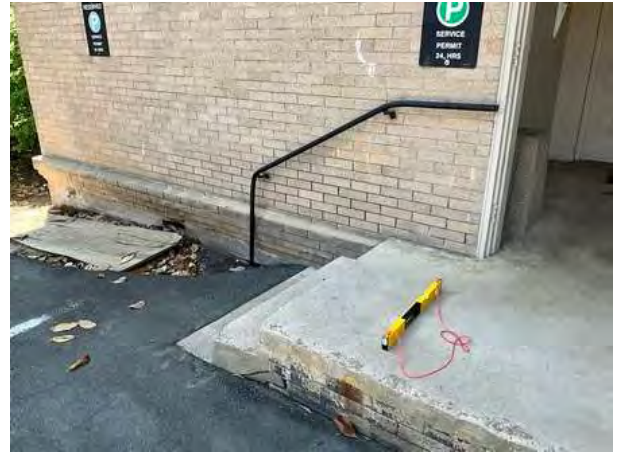
Photos for Barrier ID: AX455989

Assembly	Exterior Access Route	
Type	Stairs	
ADA Standard	403.5.1; 403.5.3	
Barrier Detail		
Sidewalk does not meet the 36" minimum clear width requirement (60" minimum where passing areas are present).		
Location Description	Rear Entrance	
Observed	May 22, 2024 by Brian.rogers@bureauveritas.com	
Site Conditions		
The landing has been cut out at the bottom of the steps is only 18 inches wide.		
Width	18"	
Resolution		
The sidewalk should be removed and replaced with a compliant sidewalk. The clear width of walking surfaces shall be 36" minimum. [EXCEPTION: The clear width shall be permitted to be reduced to 32" minimum for a length of 24" maximum provided that reduced width segments are separated by segments that are 48" long minimum and 36" wide minimum.] An accessible route has maximum 1:20 (5%) running slope and maximum 1:50 (2%) cross slope. [EXCEPTION: Cross slopes not greater than 1:48 (2.08%) are permitted.]

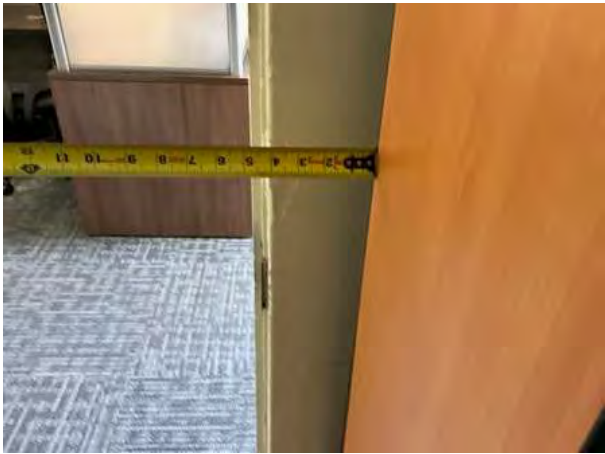
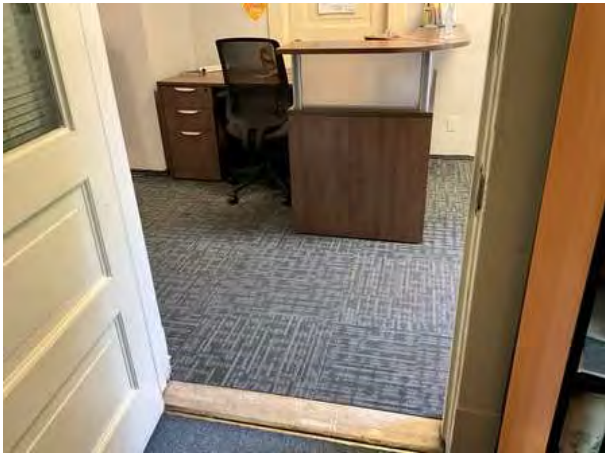
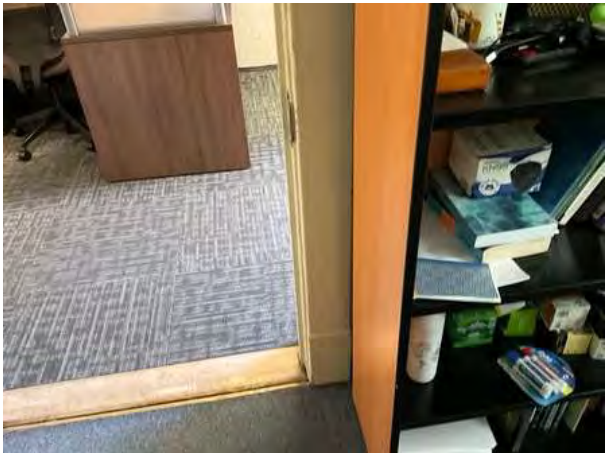
Assembly	Interior Access Route
Type	Door
ADA Standard	307.4, 404.2.3
Barrier Detail	The door has less than 32" clear width.
Location Description	Room 111
Observed	May 22, 2024 by Brian.rogers@bureauveritas.com
Site Conditions	The door is 31 inches wide.
Width	31"

Remove and replace with a door that has a minimum clear opening of 32". Door openings shall provide a clear width of 32" minimum. Clear openings of doorways with swinging doors shall be measured between the face of the door and the stop, with the door open 90 degrees. Openings more than 24" deep shall provide a clear opening of 36" minimum. There shall be no projections into the required clear opening width lower than 34" above the finish floor or ground. Projections into the clear opening width between 34" and 80" above the finish floor or ground shall not exceed 4". [EXCEPTIONS: 1. In alterations, a projection of 5/8" maximum into the required clear width shall be permitted for the latch side stop. 2. Door closers and door stops shall be permitted to be 78" minimum above the finish floor or ground.]

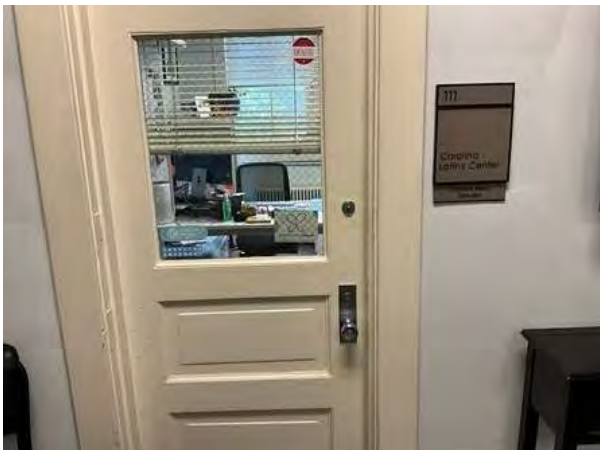
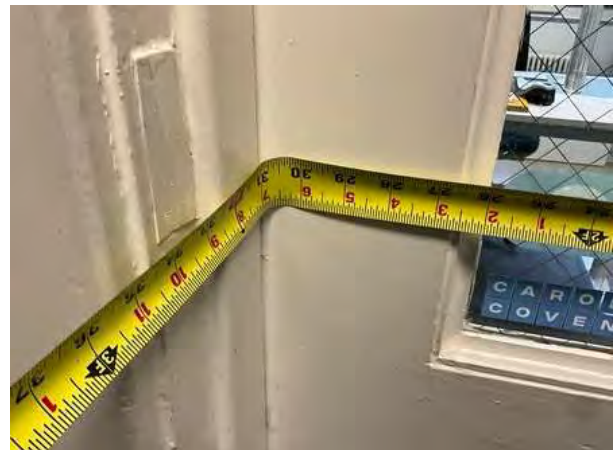
Photos for Barrier ID: AX455988

Assembly	Interior Access Route
Type	Door
ADA Standard	307.4, 404.2.3
Barrier Detail	The door has less than 32" clear width.
Location Description	Room 111A
Observed	May 22, 2024 by Brian.rogers@bureauveritas.com
Site Conditions	The door is 31 inches wide.
Width	31"

Remove and replace with a door that has a minimum clear opening of 32". Door openings shall provide a clear width of 32" minimum. Clear openings of doorways with swinging doors shall be measured between the face of the door and the stop, with the door open 90 degrees. Openings more than 24" deep shall provide a clear opening of 36" minimum. There shall be no projections into the required clear opening width lower than 34" above the finish floor or ground. Projections into the clear opening width between 34" and 80" above the finish floor or ground shall not exceed 4". [EXCEPTIONS: 1. In alterations, a projection of 5/8" maximum into the required clear width shall be permitted for the latch side stop. 2. Door closers and door stops shall be permitted to be 78" minimum above the finish floor or ground.]

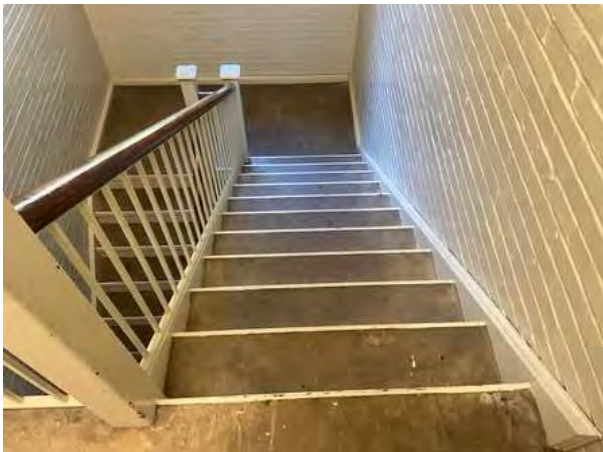
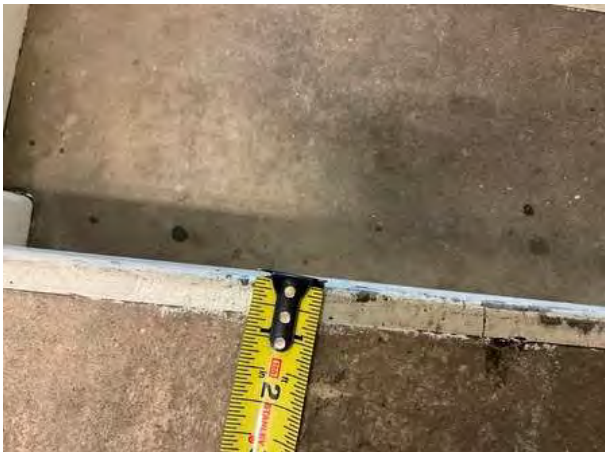
Photos for Barrier ID: AX455982

Assembly	Interior Access Route
Type	Stairs
ADA Standard	505
Barrier Detail	Handrails are not compliant.
Location Description	Stair
Observed	May 22, 2024 by Brian.rogers@bureauveritas.com

Handrails are missing on the wall side of the steps. The interior handrail is 32 inches above the nose of the steps..

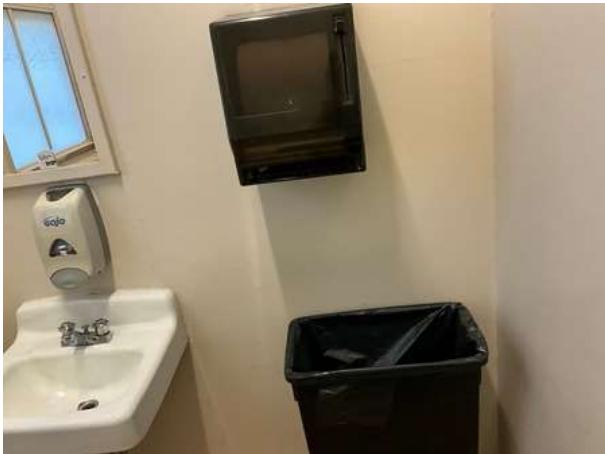
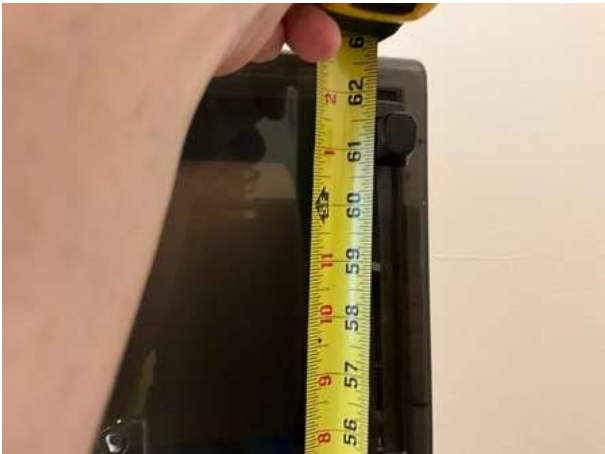
Assembly	Restroom
Type	Restroom/Bathroom
ADA Standard	603, 604, 606
Barrier Detail	The entire restroom is not compliant due to limited room dimensions.
Location Description	Restroom 108
Observed	May 22, 2024 by Brian.rogers@bureauveritas.com

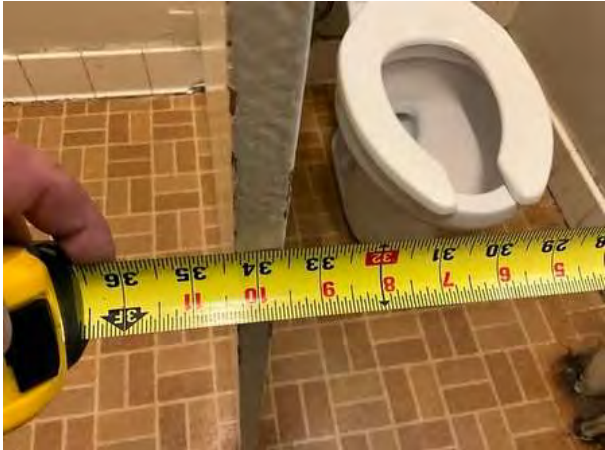
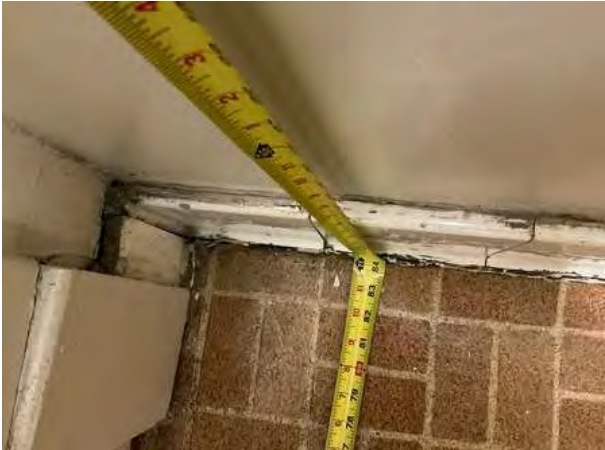
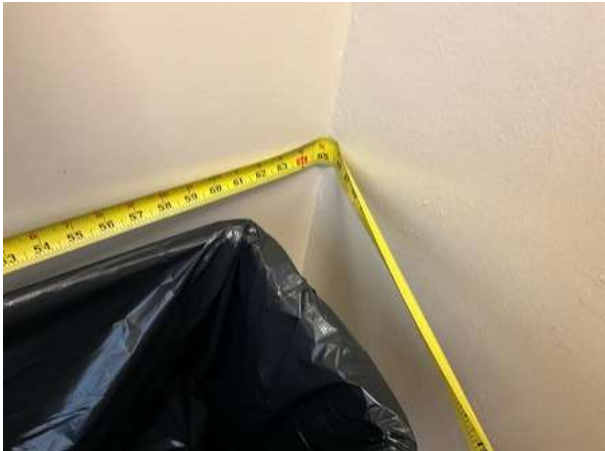
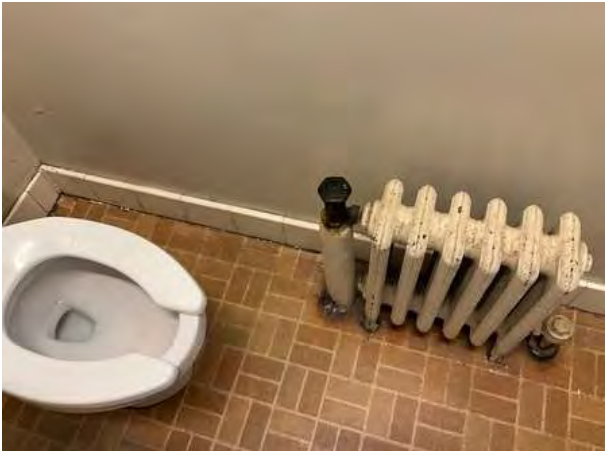
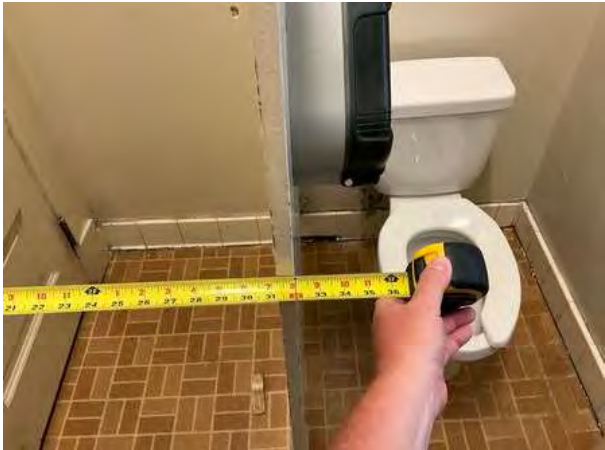
Photos for Barrier ID: AX456004

Assembly	Restroom
Type	Restroom/Bathroom - Door
ADA Standard	404.2.3
Barrier Detail	The door has less than 32" clear width.
Location Description	Restroom 108
Observed	May 22, 2024 by Brian.rogers@bureauveritas.com
Site Conditions	The door is 27" wide.

Remove and replace with a door that has a minimum clear opening of 32"; measured with the door open at 90°, measured from the face of the door to the stop. Door openings shall provide a clear width of 32" minimum. Clear openings of doorways with swinging doors shall be measured between the face of the door and the stop, with the door open 90°. Openings more than 24" deep shall provide a clear opening of 36" minimum. There shall be no projections into the required clear opening width lower than 34" above the finish floor or ground. Projections into the clear opening width between 34" and 80" above the finish floor or ground shall not exceed 4".

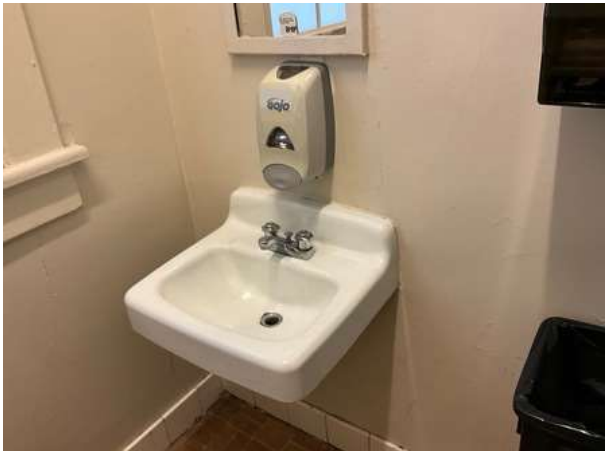
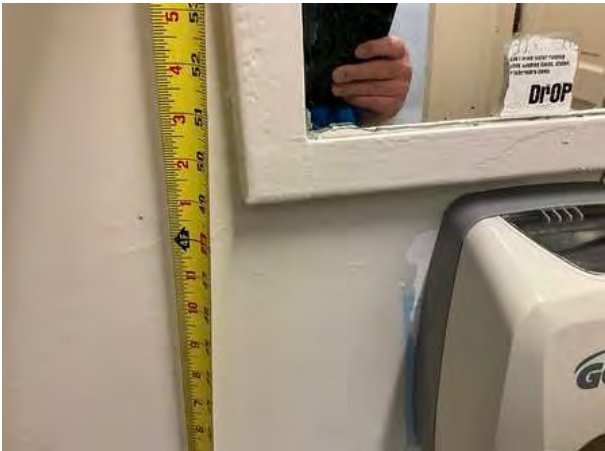
Photos for Barrier ID: AX456006

Assembly	Restroom
Type	Controls And Dispensers
ADA Standard	606.1; 309.3
Barrier Detail	The height of controls are not compliant.
Location Description	Room 205A women's restroom
Observed	May 22, 2024 by Brian.rogers@bureauveritas.com
Site Conditions	The height of the operable part is 65 3/4 inches above the finish floor.
Width	65 3/4"

Provide operable parts of all controls, dispenser, receptacle and other operable equipment within at least one of the reach ranges. Operable parts shall be placed within one or more of the reach ranges. Unobstructed Forward Reach: Where a forward reach is unobstructed, the high forward reach shall be 48" maximum and the low forward reach shall be 15" minimum above the finish floor or ground. Obstructed High Forward Reach: Where a high forward reach is over an obstruction, the clear floor space shall extend beneath the element for a distance not less than the required reach depth over the obstruction. The high forward reach shall be 48" maximum where the reach depth is 20" maximum. Where the reach depth exceeds 20", the high forward reach shall be 44" maximum and the reach depth shall be 25" maximum. Unobstructed Side Reach: Where a clear floor or ground space allows a parallel approach to an element and the side reach is unobstructed, the high side reach shall be 48" maximum and the low side reach shall be 15" minimum above the finish floor or ground. [EXCEPTION: An obstruction shall be permitted between the clear floor or ground space and the element where the depth of the obstruction is 10" maximum.] Obstructed High Side Reach: Where a clear floor or ground space allows a parallel approach to an element and the high side reach is over an obstruction, the height of the obstruction shall be 34" maximum and the depth of the obstruction shall be 24" maximum. The high side reach shall be 48" maximum for a reach depth of 10" maximum. Where the reach depth exceeds 10", the high side reach shall be 46" maximum for a reach depth of 24" maximum. [ADVISORY for Children's Forward or Side Reach Ranges: High reach (maximum): 36" for ages 3 to 4; 40" for ages 5 to 8; and 44" for ages 9 to 12. Low reach (minimum): 20" for ages 3 to 4; 18" for ages 5 to 8; and 16" for ages 9 to 12.]

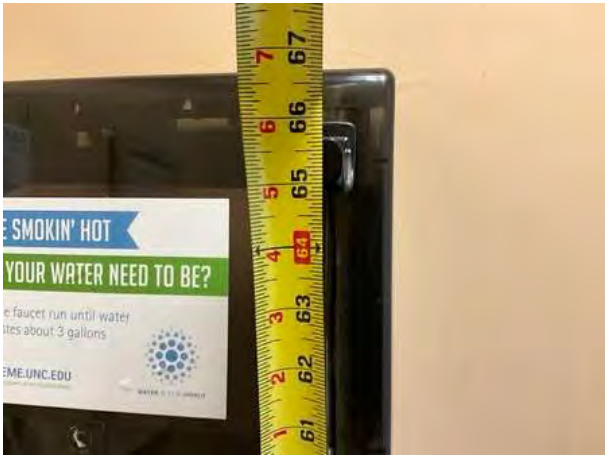
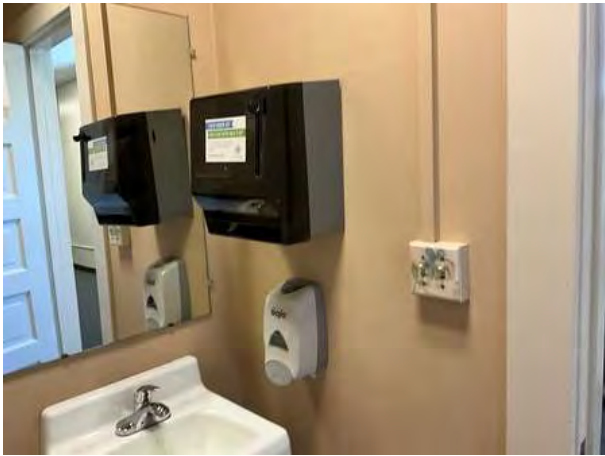
Assembly	Restroom
Type	Restroom/Bathroom
ADA Standard	603, 604, 606
Barrier Detail	The entire restroom is not compliant due to limited room dimensions.
Location Description	Room 205A women's restroom
Observed	May 22, 2024 by Brian.rogers@bureauveritas.com
Site Conditions	The restroom is 58 inches wide and 78 inches deep.
Length	78"
Width	58"

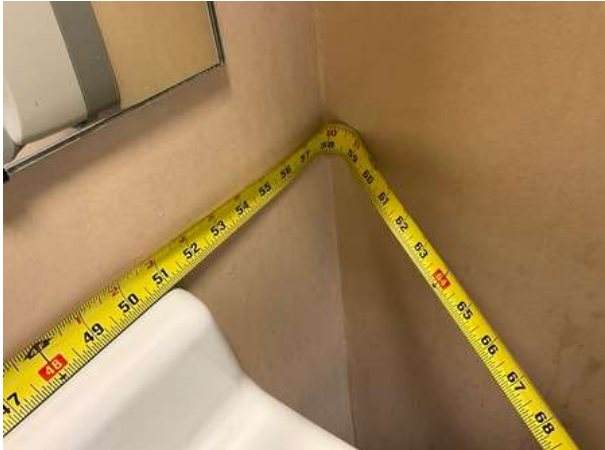
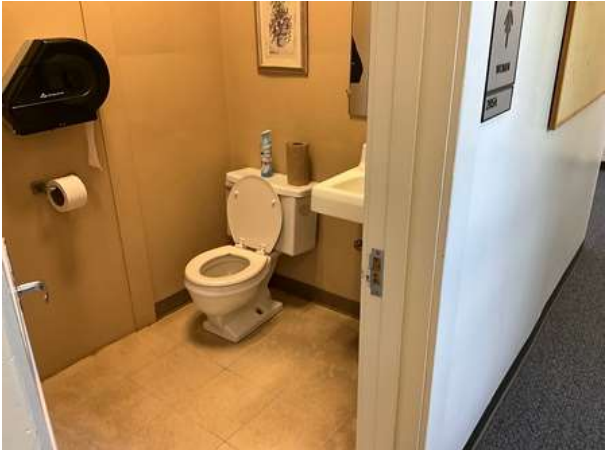
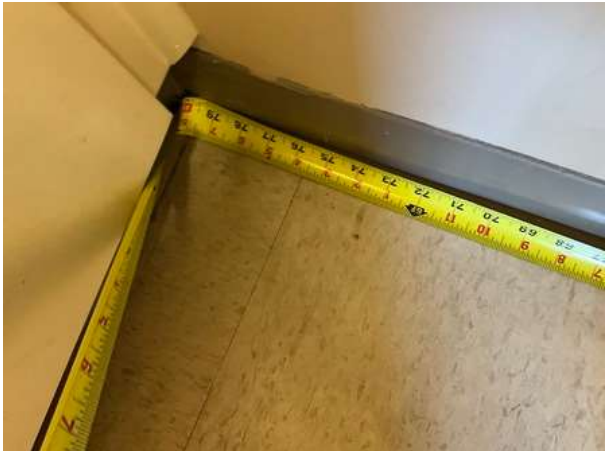
Photos for Barrier ID: AX455972

Assembly	Restroom
Type	Restroom/Bathroom - Lavatory
ADA Standard	213.3.4, 606.5
Barrier Detail	Pipes are not insulated.
Location Description	Room 205A women's restroom
Observed	May 22, 2024 by Brian.rogers@bureauveritas.com
Site Conditions	The lavatory pipes are not insulated.

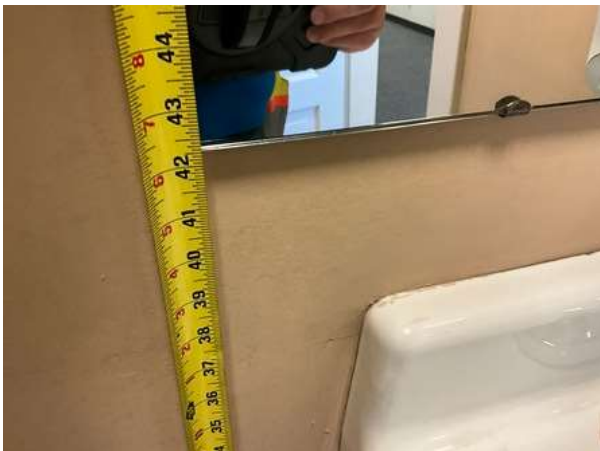
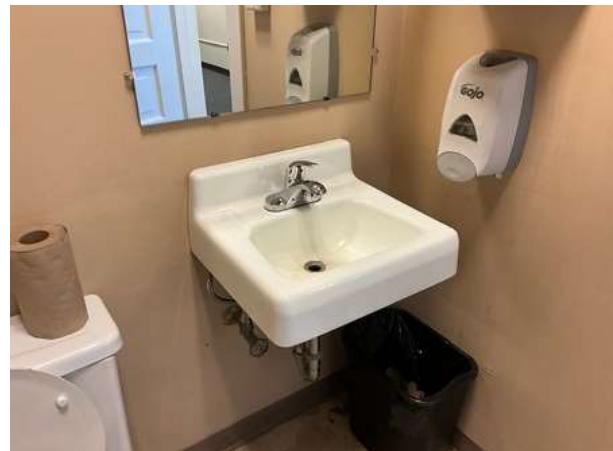
Photos for Barrier ID: AX455975

Assembly	Restroom
Type	Restroom/Bathroom - Water Closet
ADA Standard	604.5.2
Barrier Detail	The grab bars at the water closet are not compliant.
Location Description	Room 205A women's restroom
Observed	May 22, 2024 by Brian.rogers@bureauveritas.com
Site Conditions	No side and rear grab bars are present.
