# ACCESSIBILITY ASSESSMENT

July 1, 2024

## **ADA TITLE II ASSESSMENT**

Anderson Stadium  
910 Raleigh Road  
Chapel Hill, North Carolina 27514

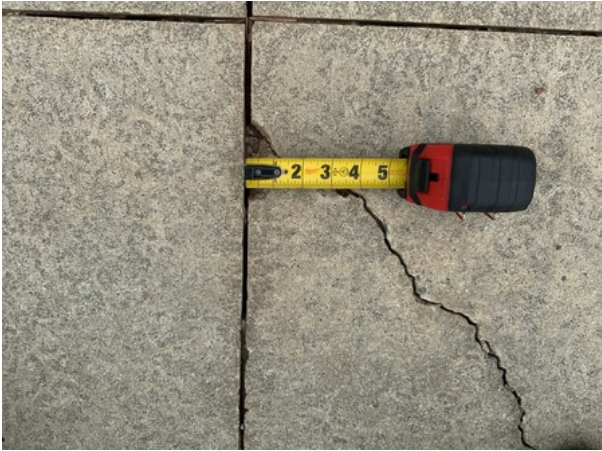
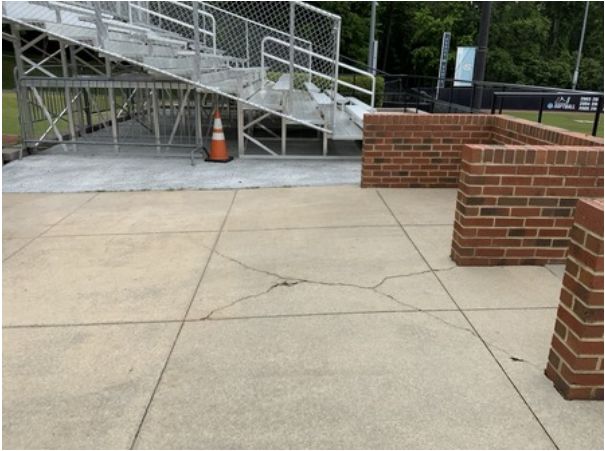
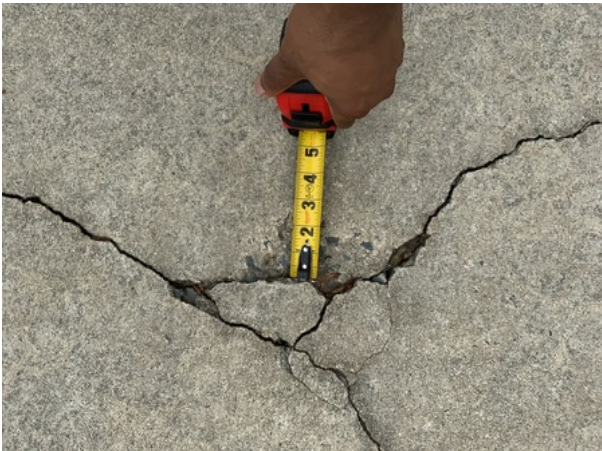
1 35.906744478020634,-79.03152249119407

Assembly	Exterior Access Route
Type	Exterior Accessible Route
ADA Standard	302.3
Barrier Detail	The accessible route has gaps in the surface greater than 1/2" wide.
Location Description	Accessible Route between Concession Stand & Bleachers
Observed	May 16, 2024 by javondrick.orange@bureauveritas.com
Site Conditions	The accessible route has 1/2" wide gaps in a 5' by 5' section of the concrete.

Repair the accessible route to eliminate openings in the surface greater than 1/2" wide. Openings in the ground surface of the accessible route shall not allow passage of a sphere more than 1/2" diameter. Elongated openings shall be placed so that the long dimension is perpendicular to the dominant direction of travel.

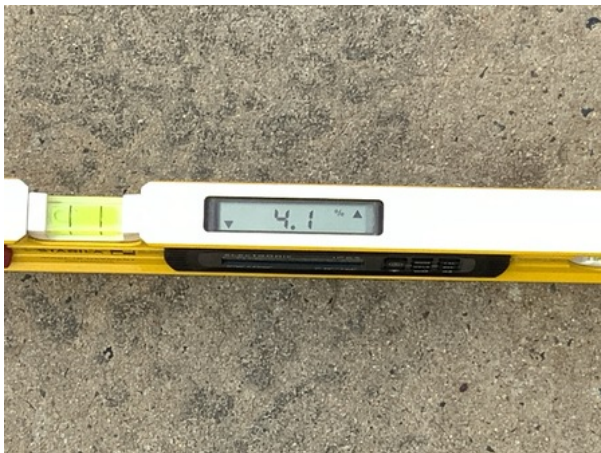
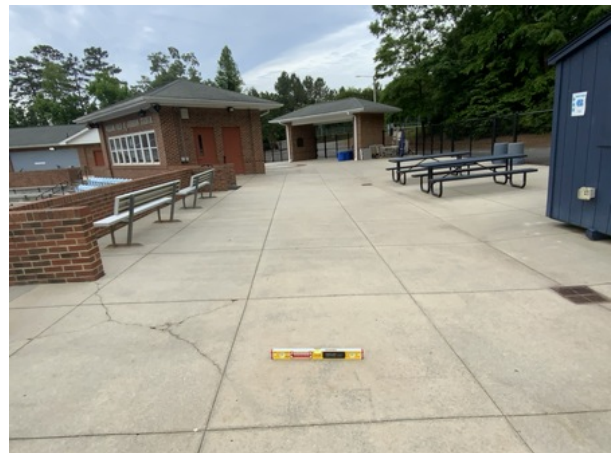
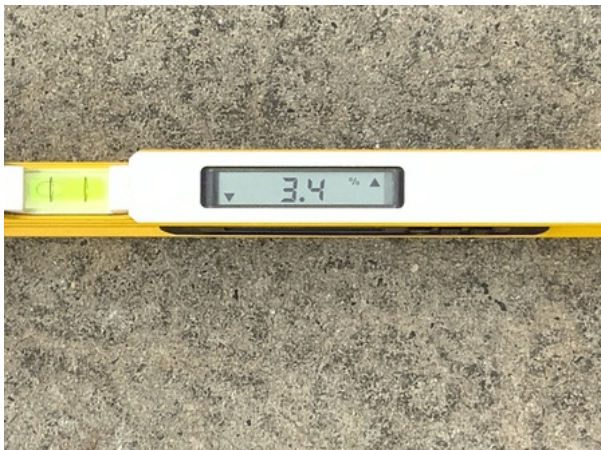
Photos for Barrier ID: AX468765

Assembly	Exterior Access Route
Type	Exterior Accessible Route
ADA Standard	403.3
Barrier Detail	The accessible route has cross slopes greater than 1:50 (2%).
Location Description	Accessible Route between Concession Stand & Bleachers
Observed	May 16, 2024 by javondrick.orange@bureauveritas.com

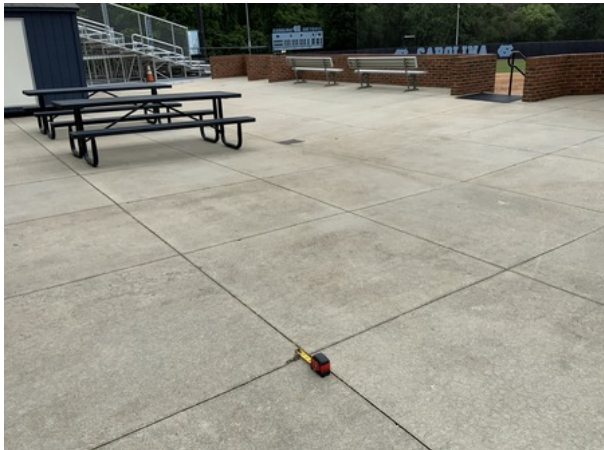
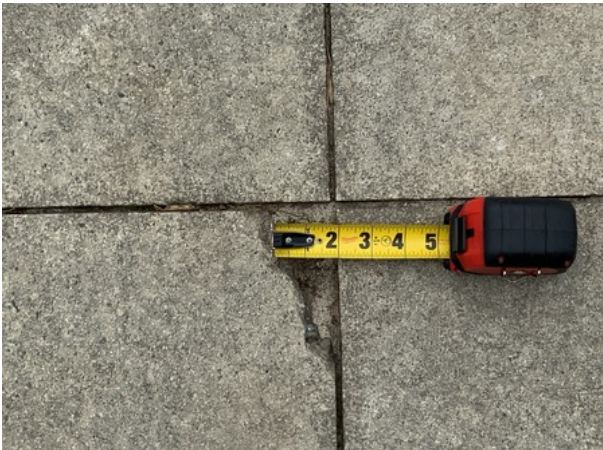
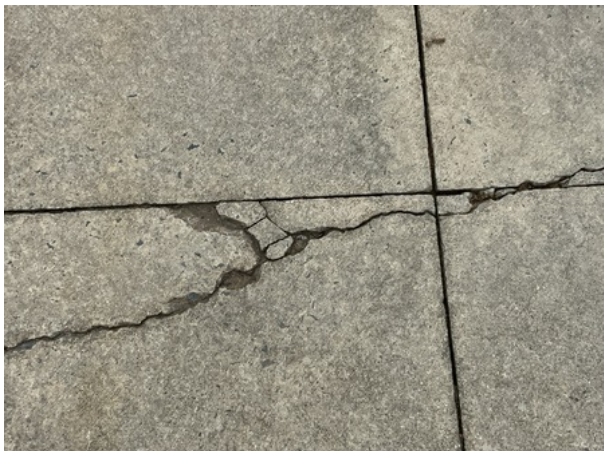
Photos for Barrier ID: AX468766

Assembly	Exterior Access Route
Type	Exterior Accessible Route
ADA Standard	302.3
Barrier Detail	The accessible route has gaps in the surface greater than 1/2" wide.
Location Description	Accessible Route between Concession Stand & Bleachers
Observed	May 16, 2024 by javondrick.orange@bureauveritas.com
Site Conditions	The accessible route has 1/2" wide gaps in a 5' by 5' section of the concrete.

Repair the accessible route to eliminate openings in the surface greater than 1/2" wide. Openings in the ground surface of the accessible route shall not allow passage of a sphere more than 1/2" diameter. Elongated openings shall be placed so that the long dimension is perpendicular to the dominant direction of travel.

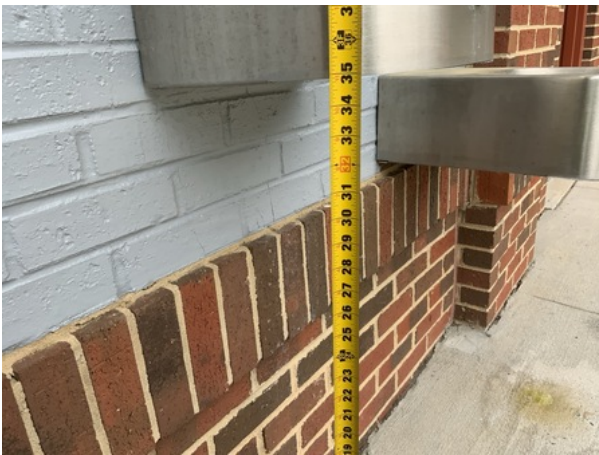
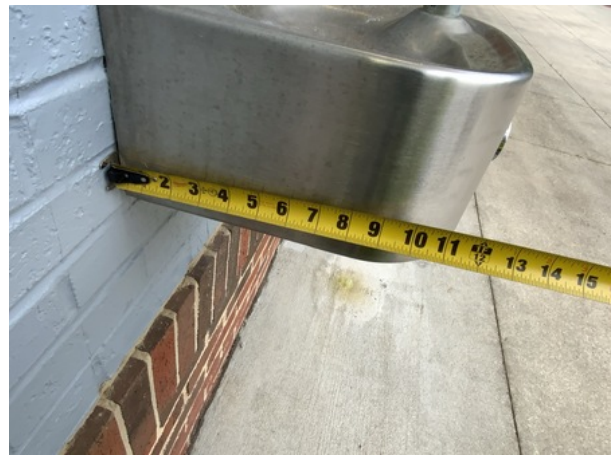
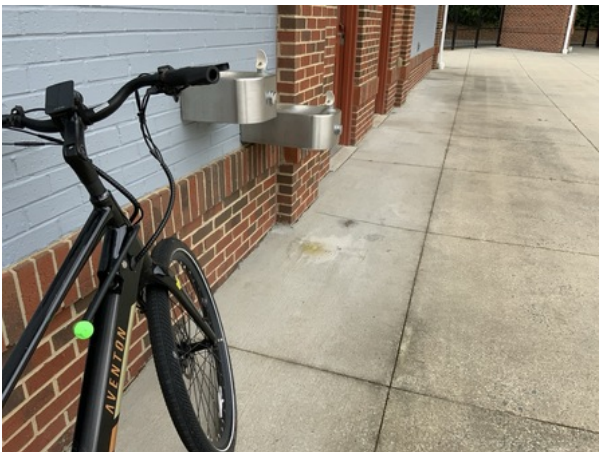
Photos for Barrier ID: AX468768

Location Description	Restroom Building
Observed	May 16, 2024 by javondrick.orange@bureauveritas.com

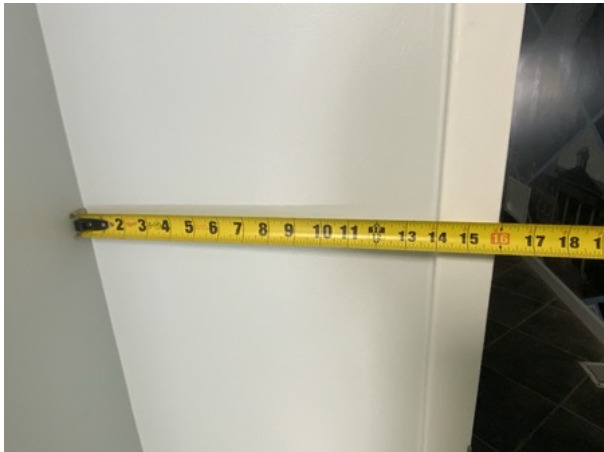
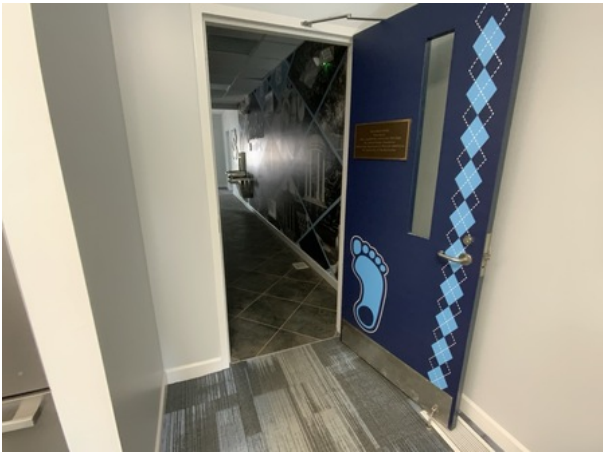
Photos for Barrier ID: AX468729

Assembly	Interior Access Route
Type	Door
ADA Standard	404.2.4; Table 404.2.4.1
<b>Barrier Detail</b>	
The pull side of the accessible door does not have the required maneuvering clearances.	
Location Description	Team Room
Observed	May 16, 2024 by javondrick.orange@bureauveritas.com
Site Conditions	For an approach from the front on the pull side the side clearance is 16".

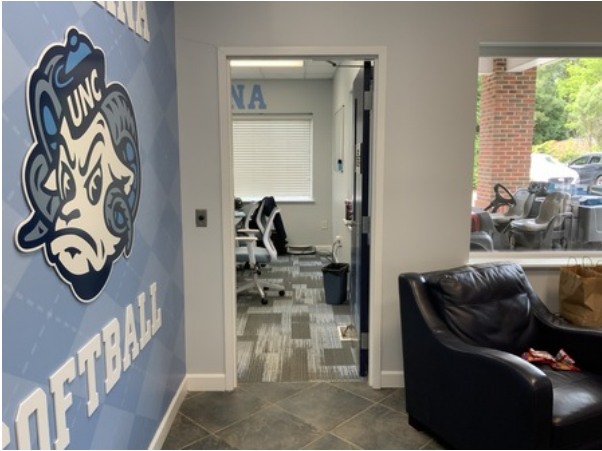
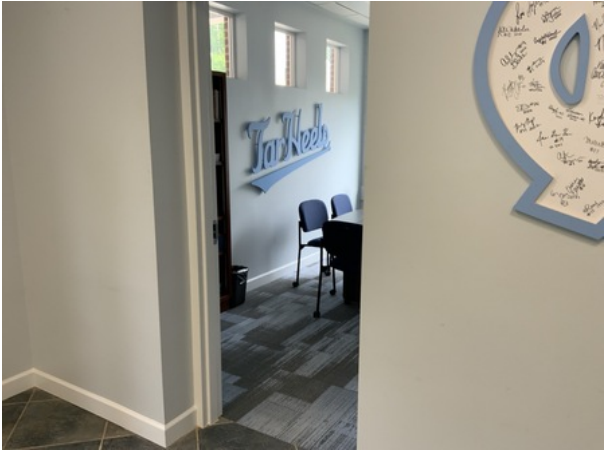
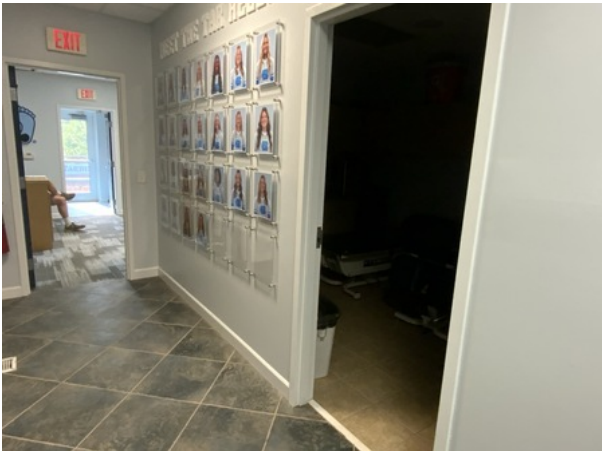
Location Description	Rooms Throughout Building
Observed	May 16, 2024 by javondrick.orange@bureauveritas.com
Site Conditions	Signage is not provided on the latch side of the doors.

Remove and replace signage with compliant signage. Raised characters shall be compliant and shall be duplicated in Braille. Raised characters shall be as follows: Depth: Raised characters shall be 1/32" minimum above their background. Case: Characters shall be uppercase. Style: Characters shall be sans serif. Characters shall not be italic, oblique, script, highly decorative, or of other unusual forms. Character Proportions: Characters shall be selected from fonts where the width of the uppercase letter "O" is 55 % minimum and 110 % maximum of the height of the uppercase letter "I". Character Height: Character height measured vertically from the baseline of the character shall be 5/8" minimum and 2" maximum based on the height of the uppercase letter "I". [EXCEPTION: Where separate raised and visual characters with the same information are provided, raised character height shall be permitted to be 1/2" minimum.] Tactile characters on signs shall be located 48" minimum above the finish floor or ground surface, measured from the baseline of the lowest tactile character and 60" maximum above the finish floor or ground surface, measured from the baseline of the highest tactile character. Where a tactile sign is provided at a door, the sign shall be located alongside the door at the latch side. Where a tactile sign is provided at double doors with one active leaf, the sign shall be located on the inactive leaf. Where a tactile sign is provided at double doors with two active leafs, the sign shall be located to the right of the right hand door. Where there is no wall space at the latch side of a single door or at the right side of double doors, signs shall be located on the nearest adjacent wall. Signs containing tactile characters shall be located so that a clear floor space of 18" minimum by 18" minimum, centered on the tactile characters, is provided beyond the arc of any door swing between the closed position and 45 degree open position. [EXCEPTION: Signs with tactile characters shall be permitted on the push side of doors with closers and without hold-open devices.]

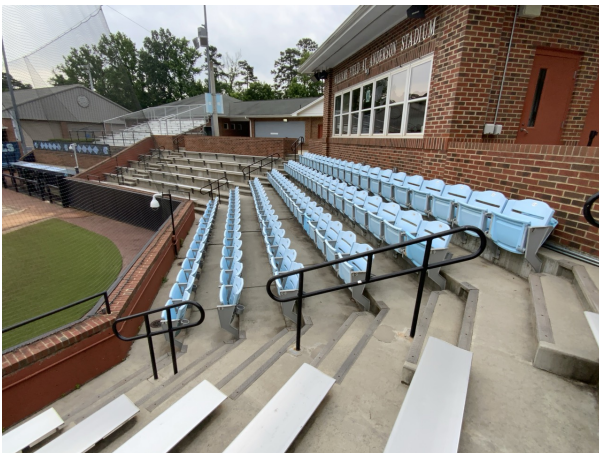
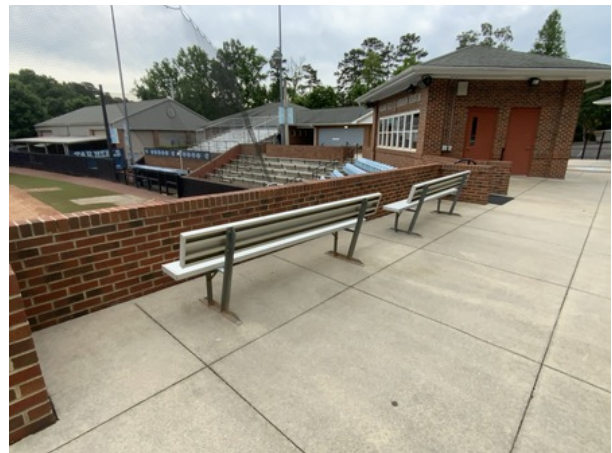
Photos for Barrier ID: AX468910

Assembly	Common Areas
Type	Assembly Area
ADA Standard	221.4; 802.4
Barrier Detail	Assembly areas do not provide compliant aisle seats.
Location Description	Spectator Seating
Observed	May 22, 2024 by javondrick.orange

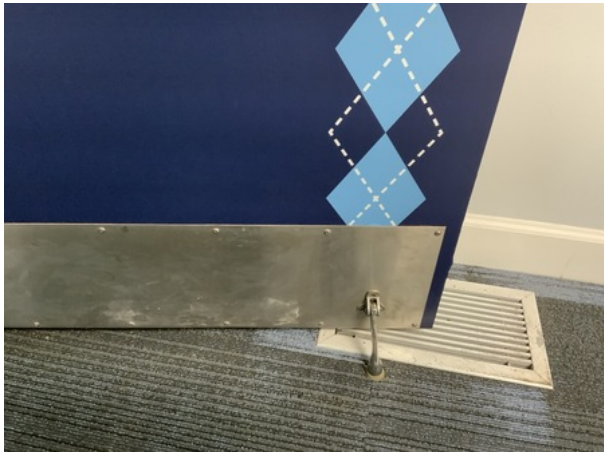
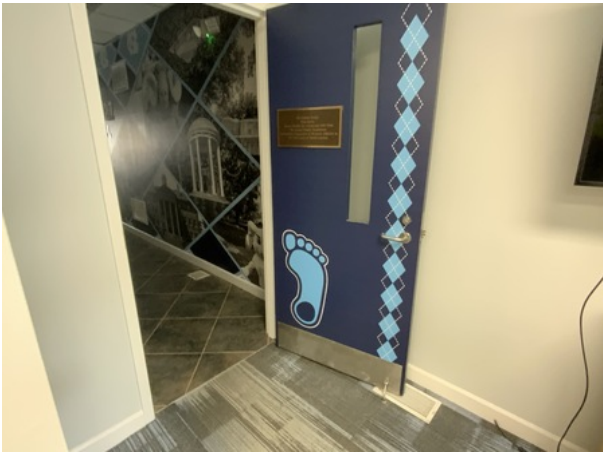
Photos for Barrier ID: AX468728

Assembly	Interior Access Route	
Type	Door	
ADA Standard	404.2.10	
Barrier Detail		
The surface of the swinging door within 10 inches of the finish floor or ground for the full width of the door on the push side is not smooth.		
Location Description	Team Room	
Observed	May 16, 2024 by javondrick.orange@bureauveritas.com	
Site Conditions	The doorstep is within the 10" smooth surface on the push side of the door.	
Resolution		
Modify or replace the door to provide a smooth surface on the door within 10 inches of the finish floor or ground for the full width of the door on the push side. Parts creating horizontal or vertical joints in these surfaces shall be within 1/16 inch of the same plane as the other and be free of sharp or abrasive edges. Cavities created by added kick plates shall be capped.Swinging door and gate surfaces within 10 inches of the finish floor or ground measured vertically shall have a smooth surface on the push side extending the full width of the door or gate. Parts creating horizontal or vertical joints in these surfaces shall be within 1/16 inch of the same plane as the other. Cavities created by added kick plates shall be capped. [EXCEPTIONS: 1. Sliding doors shall not be required to comply. 2. Tempered glass doors without stiles and having a bottom rail or shoe with the top leading edge tapered at 60 degrees minimum from the horizontal shall not be required to meet the 10 inch bottom smooth surface height requirement. 3. Doors and gates that do not extend to within 10 inches of the finish floor or ground shall not be required to comply. 4. Existing doors and gates without smooth surfaces within 10 inches of the finish floor or ground shall not be required to provide smooth surfaces provided that if added kick plates are installed, cavities created by such kick plates are capped.]

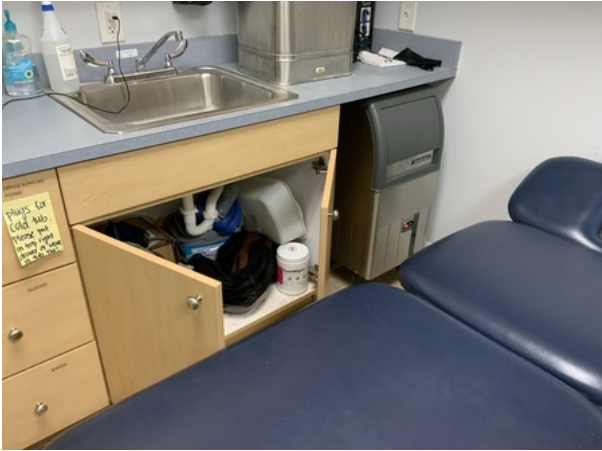
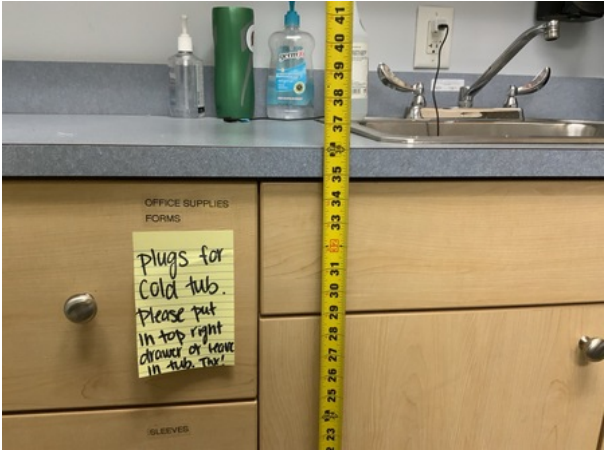
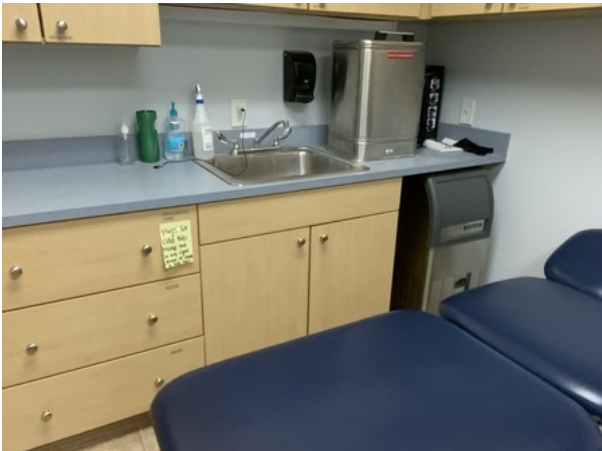
Photos for Barrier ID: AX468727

Assembly	Interior Access Route	
Type	Sink	
ADA Standard	306.2 and 606.3	
Barrier Detail		
The sink rim is higher than 34", and does not have knee and toe clearance (does not apply to mop basins, utility sinks, or bar sinks).		
Location Description	Training Room	
Observed	May 16, 2024 by javondrick.orange@bureauveritas.com	
Site Conditions		
The sink rim is 36 1/4" above the floor and knee and toe clearance not provided due to the location of the cabinet under the sink.		
Resolution		
Relocate sink to compliant height with knee and toe clearances. Lavatories and sinks shall be installed with the front of the higher of the rim or counter surface 34" maximum above the finish floor or ground. Knee Clearance: Space under an element between 9" and 27" above the finish floor or ground shall be considered knee clearance. Knee clearance shall extend 25" maximum under an element at 9" above the finish floor or ground. Where knee clearance is required under an element as part of a clear floor space, the knee clearance shall be 11" deep minimum at 9" above the finish floor or ground, and 8" deep minimum at 27" above the finish floor or ground. Between 9" and 27" above the finish floor or ground, the knee clearance shall be permitted to reduce at a rate of 1" in depth for each 6" in height. Knee clearance shall be 30" wide minimum. Toe Clearance: Space under an element between the finish floor or ground and 9" above the finish floor or ground shall be considered toe clearance. Toe clearance shall extend 25" maximum under an element. Where toe clearance is required at an element as part of a clear floor space, the toe clearance shall extend 17" minimum under the element. Space extending greater than 6" beyond the available knee clearance at 9" above the finish floor or ground shall not be considered toe clearance. Toe clearance shall be 30" wide minimum.

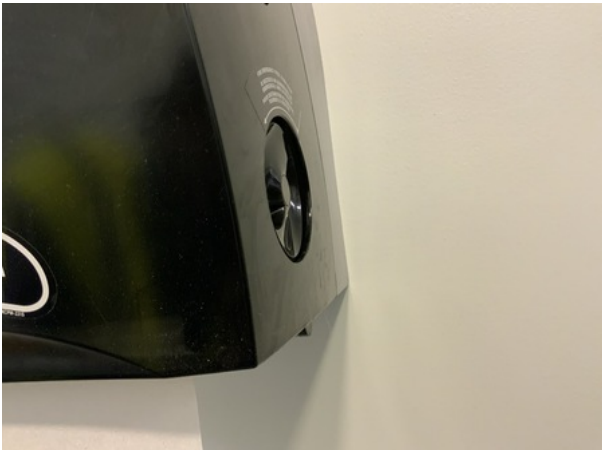
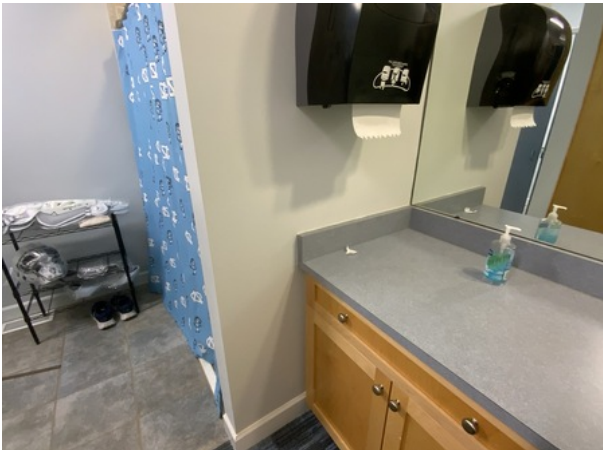
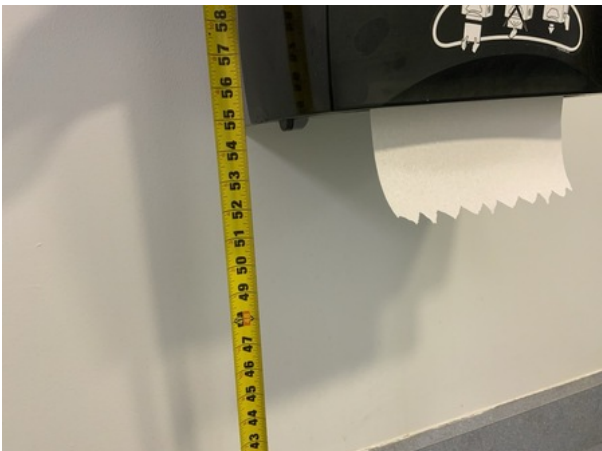
Photos for Barrier ID: AX468724

Assembly	Restroom
Type	Controls And Dispensers
ADA Standard	606.1; 309.3
Barrier Detail	The height of controls are not compliant.
Location Description	Head Coach Office - Restroom
Observed	May 16, 2024 by javondrick.orange@bureauveritas.com
Site Conditions	The highest operable part of the paper towel dispenser is 54" above the floor.

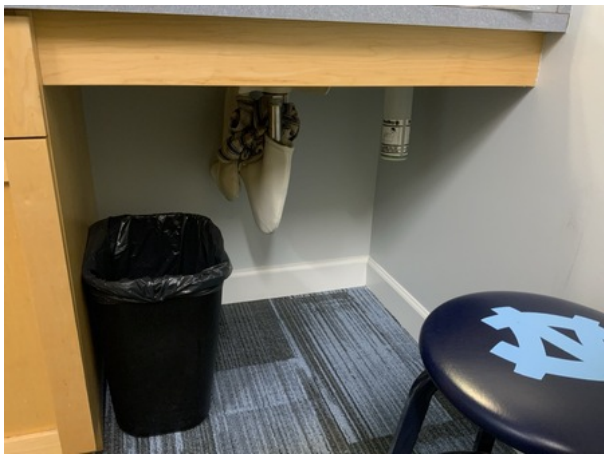
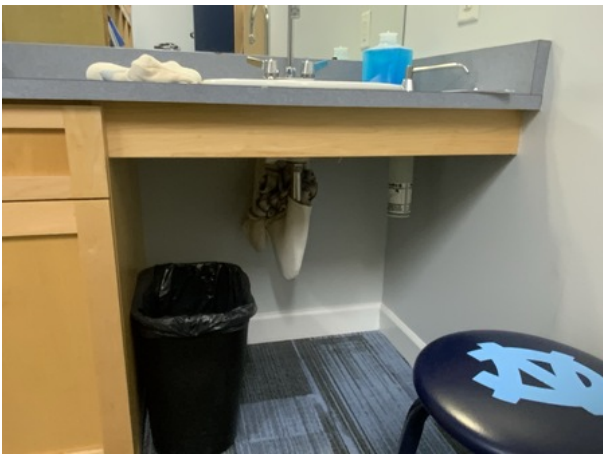
**Photos for Barrier ID: AX468722**

Assembly	Restroom
Type	Restroom/Bathroom - Lavatory
ADA Standard	213.3.4, 606.5
Barrier Detail	Pipes are not insulated.
Location Description	Head Coach Office - Restroom
Observed	May 16, 2024 by javondrick.orange@bureauveritas.com
Site Conditions	The lavatory drainpipe and water supply lines are not insulated.

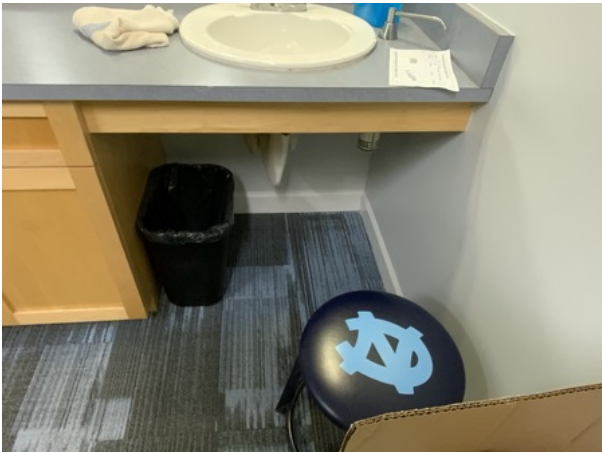
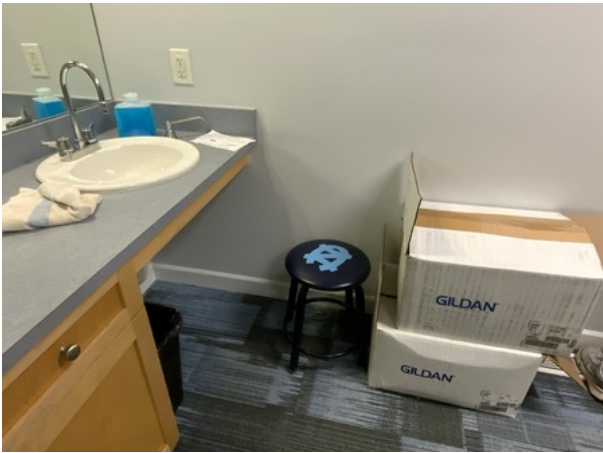
Photos for Barrier ID: AX468723

Assembly	Restroom
Type	Restroom/Bathroom - Lavatory
ADA Standard	606.2; 305
Barrier Detail	
The lavatory does not have the required clear floor space of minimum 30" by minimum 48".	
Location Description	Head Coach Office - Restroom
Observed	May 16, 2024 by javondrick.orange@bureauveritas.com
Site Conditions	The lavatory clear floor space is obstructed by furniture.

Relocate the furniture to provide minimum 30" by minimum 48" clear floor space positioned for a forward approach to the lavatory. Compliant knee and toe clearance shall be provided. [EXCEPTIONS: 2. A lavatory in a toilet room or bathing facility for a single occupant accessed only through a private office and not for common use or public use shall not be required to provide knee and toe clearance. 3. In residential dwelling units, cabinetry shall be permitted under lavatories and kitchen sinks provided that all of the following conditions are met: (a) the cabinetry can be removed without removal or replacement of the fixture; (b) the finish floor extends under the cabinetry; and (c) the walls behind and surrounding the cabinetry are finished. 4. A knee clearance of 24" minimum above the finish floor or ground shall be permitted at lavatories and sinks used primarily by children 6 through 12 years where the rim or counter surface is 31" maximum above the finish floor or ground. 5. A parallel approach complying with 305 shall be permitted to lavatories and sinks used primarily by children 5 years and younger. 6. The dip of the overflow shall not be considered in determining knee and toe clearances. 7. No more than one bowl of a multi-bowl sink shall be required to provide knee and toe clearance.] Space under an element between 9" and 27" above the finish floor or ground shall be considered knee clearance and shall comply. Knee clearance shall extend 25" maximum under an element at 9" above the finish floor or ground. Floor or ground surfaces of a clear floor or ground space shall comply. Changes in level are not permitted. [EXCEPTION: Slopes not steeper than 1:48 shall be permitted.] The clear floor or ground space shall be 30" minimum by 48" minimum. One full unobstructed side of the clear floor or ground space shall adjoin an accessible route or adjoin another clear floor or ground space. Where a clear floor or ground space is located in an alcove or otherwise confined on all or part of three sides, additional maneuvering clearance shall be provided. Alcoves shall be 36" wide minimum where the depth exceeds 24". Alcoves shall be 60" wide minimum where the depth exceeds 15".

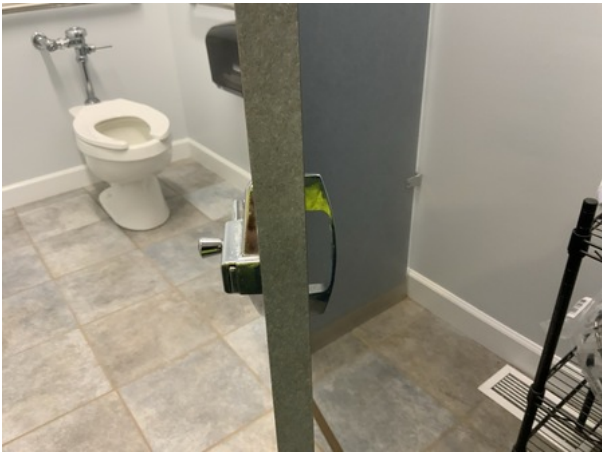
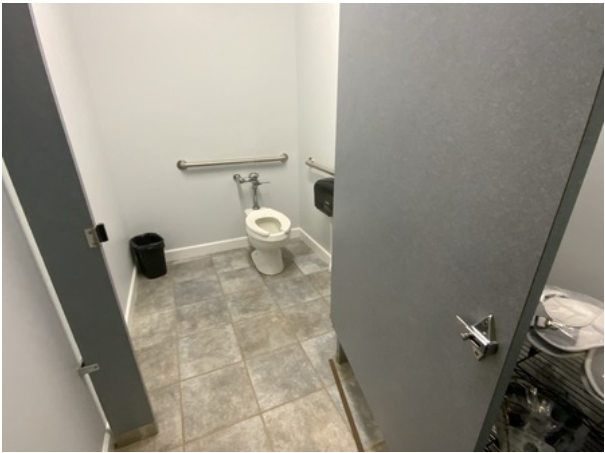
Photos for Barrier ID: AX468721

Assembly	Restroom
Type	Restroom/Bathroom - Toilet Stall
ADA Standard	309, 404.2.7, 604.8.1.2
Barrier Detail	The wheelchair stall door is not compliant.
Location Description	Head Coach Office - Restroom
Observed	May 16, 2024 by javondrick.orange@bureauveritas.com

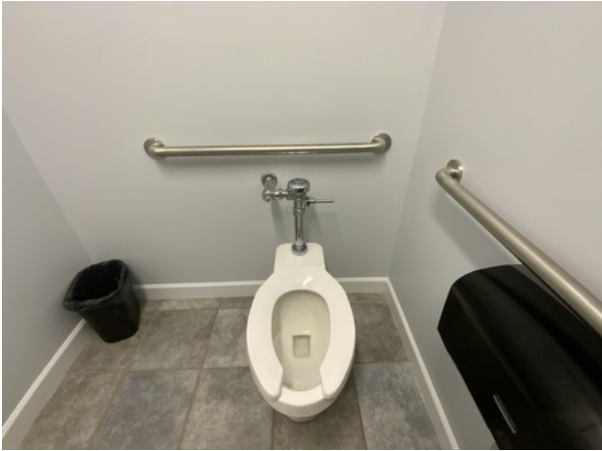
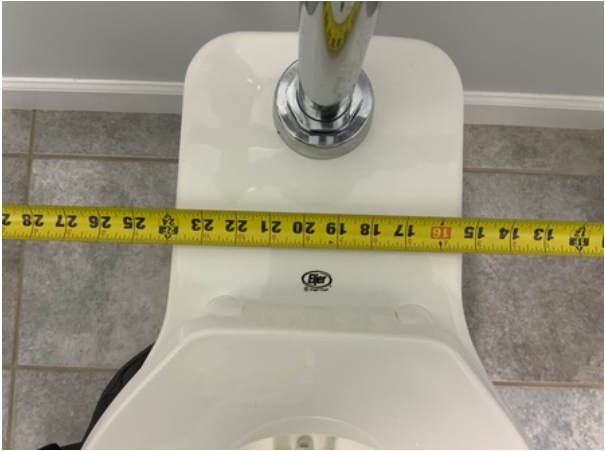
Photos for Barrier ID: AX468719

Assembly	Restroom	
Type	Restroom/Bathroom - Water Closet	
ADA Standard	604.2	
Barrier Detail		
The centerline of the toilet in the wheelchair stall is not 16" minimum to 18" maximum from the sidewall.		
Location Description	Head Coach Office - Restroom	
Observed	May 16, 2024 by javondrick.orange@bureauveritas.com	
Site Conditions	The centerline of the water closet is 19 1/2" from the side wall.	
Resolution		
Provide a water closet with centerline 16" minimum to 18" maximum from the side wall or partition. The water closet shall be positioned with a wall or partition to the rear and to one side. The centerline of the water closet shall be 16" minimum to 18" maximum from the side wall or partition in a wheelchair stall. Water closets shall be arranged for a left-hand or right-hand approach. Clearance around a water closet shall be 60" minimum measured perpendicular from the side wall and 56" minimum measured perpendicular from the rear wall. The required clearance around the water closet shall be permitted to overlap the water closet, associated grab bars, dispensers, personal product disposal units, coat hooks, shelves, accessible routes, clear floor space and clearances required at other fixtures, and the turning space. No other fixtures or obstructions shall be located within the required water closet clearance. [ADVISORY: It is advisable, but not required, to use the specifications for children where children are the primary users of the restroom. Guidance in applying the specifications for children according to the age group served reflects the differences in the size, stature, and reach ranges of children ages 3 to 12. The specifications chosen should correspond to the age of the primary user group. The specifications of one age group should be applied consistently in the installation of a water closet and related elements. Water Closet Centerline: Ages 3 and 4- 12"; Ages 5 through 8- 12" to 15"; Ages 9 through 12- 15" to 18". Toilet Seat Height: Ages 3 and 4- 11" to 12"; Ages 5 through 8- 12" to 15"; Ages 9 through 12- 15" to 17". Grab Bar Height: Ages 3 and 4- 18" to 20"; Ages 5 through 8- 20" to 25"; Ages 9 through 12- 25" to 27"; Dispenser Height: Ages 3 and 4- 14"; Ages 5 through 8- 14" to 17"; Ages 9 through 12- 17" to 19"].

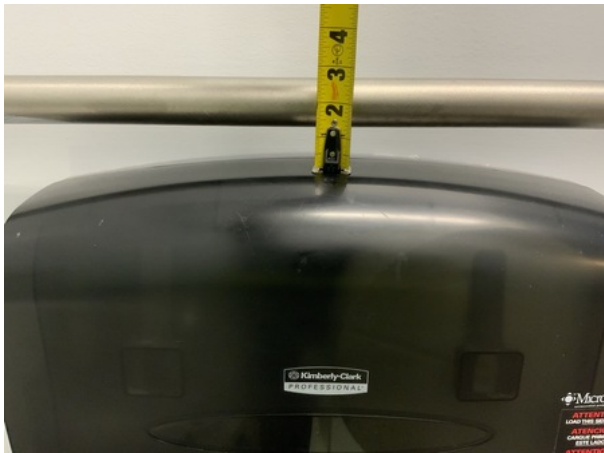
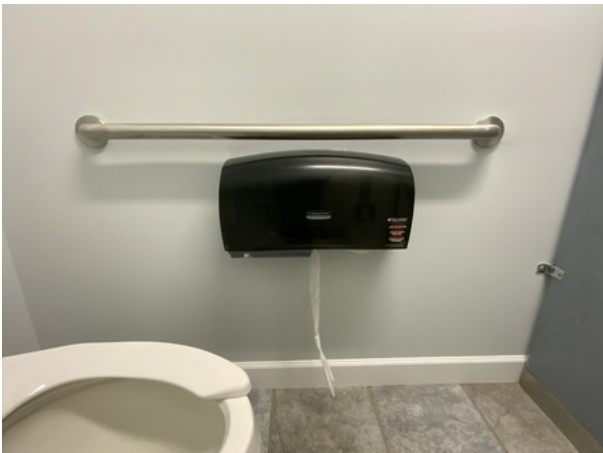
Photos for Barrier ID: AX468720

Assembly	Restroom	
Type	Restroom/Bathroom - Water Closet	
ADA Standard	609.3	
Barrier Detail		
The space between the grab bar and projecting objects below and at the ends of the bar is less than 1-1/2".		
Location Description	Head Coach Office - Restroom	
Observed	May 16, 2024 by javondrick.orange@bureauveritas.com	
Site Conditions		
The space between the top of the toilet paper dispenser and bottom of the side grab bar is 1 1/4".		
Resolution		
Move the projecting object below or at the ends of the grab bar to a minimum of 1-1/2" from the grab bar. [EXCEPTION: The space between grab bars and shower controls, shower fittings, and other grab bars above shall be permitted to be 1-1/2" minimum.]		
Quantity	Unit Cost	Total Cost
1 EA	125.00	\$ 125
Priority	3

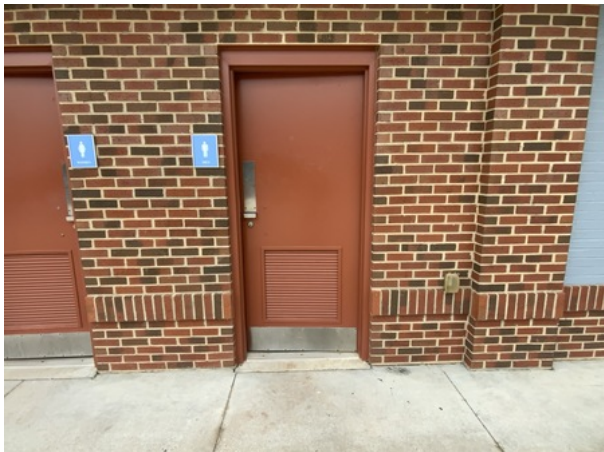
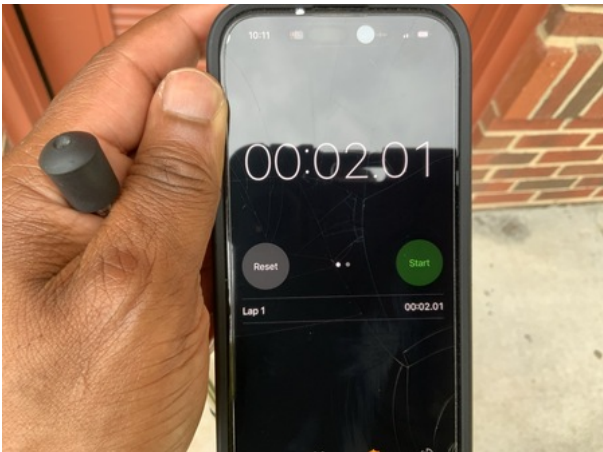
**Photos for Barrier ID: AX468752**

Location Description	Men's Restroom
Observed	May 16, 2024 by javondrick.orange@bureauveritas.com

Adjust closer or remove and replace closer to ensure that the door has a closure time of at least 5 seconds within 12 degrees of the latch. This barrier must be removed in conjunction with barrier ID 468750. The cost of this barrier removal is covered under ID 468750 and therefore, the cost of this ID is shown as \$0. Door closers and gate closers shall be adjusted so that from an open position of 90 degrees, the time required to move the door to a position of 12 degrees from the latch is 5 seconds minimum.

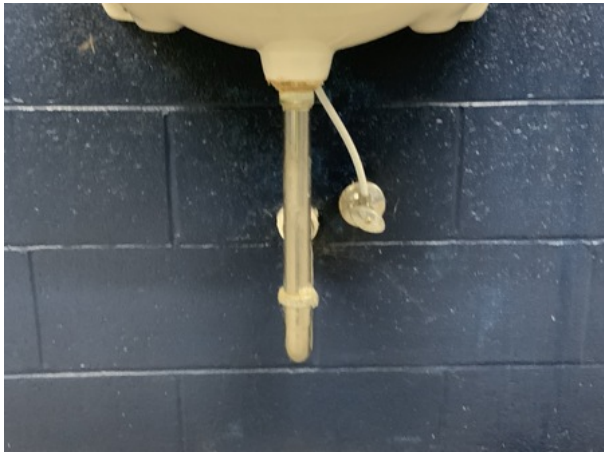
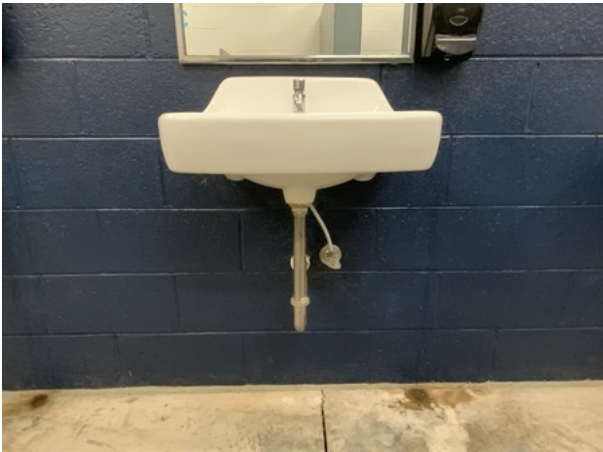
**Photos for Barrier ID: AX468744**

Assembly	Restroom
Type	Restroom/Bathroom - Lavatory
ADA Standard	213.3.4, 606.5
Barrier Detail	Pipes are not insulated.
Location Description	Men's Restroom
Observed	May 16, 2024 by javondrick.orange@bureauveritas.com
Site Conditions	The lavatory drainpipe and water supply lines are not insulated.

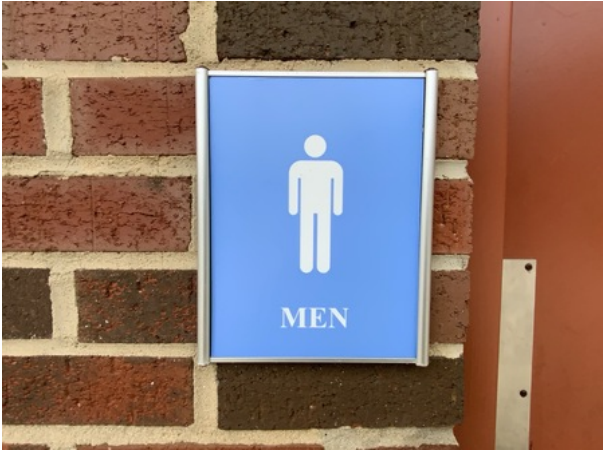
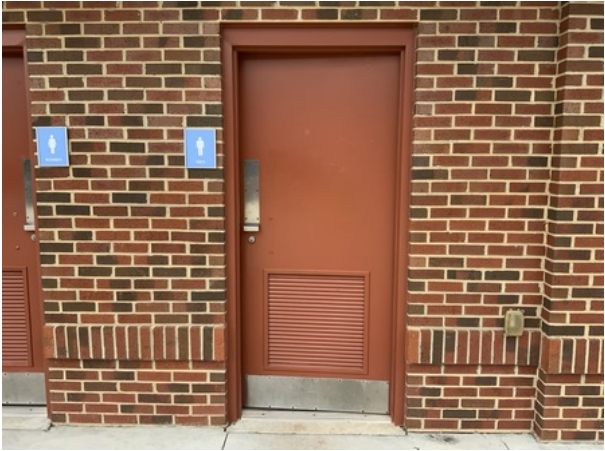
Location Description	Men's Restroom
Observed	May 16, 2024 by javondrick.orange@bureauveritas.com

Mount compliant signage on the wall at the latch side of the restroom door at a compliant height. All signs for accessible restrooms, including directional signs indicating the restroom location, shall comply with the requirement for the International Symbol of Accessibility (ISA), where not all restrooms are accessible. The pictogram field shall be minimum 6" high. Signage shall include raised letters and Braille, either one sign with both visual and tactile characters, or two separate signs, one with visual, and one with tactile characters, shall be provided. Tactile characters on signs shall be located 48" minimum above the finish floor or ground surface, measured from the baseline of the lowest tactile character and 60" maximum above the finish floor or ground surface, measured from the baseline of the highest tactile character. Accessible restrooms shall have signs with the International Symbol of Accessibility. Where a tactile sign is provided at a door, the sign shall be located alongside the door at the latch side. Where a tactile sign is provided at double doors with one active leaf, the sign shall be located on the inactive leaf. Where a tactile sign is provided at double doors with two active leaves, the sign shall be located to the right of the right hand door. Where there is no wall space at the latch side of a single door or at the right side of double doors, signs shall be located on the nearest adjacent wall. Signs containing tactile characters shall be located so that a clear floor space of 18" minimum by 18" minimum, centered on the tactile characters, is provided beyond the arc of any door swing between the closed position and 45 degree open position. [EXCEPTION: Signs with tactile characters shall be permitted on the push side of doors with closers and without hold-open devices.] Raised characters shall be as follows: Depth: Raised characters shall be 1/32" minimum above their background. Case: Characters shall be uppercase. Style: Characters shall be sans serif. Characters shall not be italic, oblique, script, highly decorative, or of other unusual forms. Character Proportions: Characters shall be selected from fonts where the width of the uppercase letter "O" is 55 % minimum and 110 % maximum of the height of the uppercase letter "I". Character Height: Character height measured vertically from the baseline of the character shall be 5/8" minimum and 2" maximum based on the height of the uppercase letter "I". [EXCEPTION: Where separate raised and visual characters with the same information are provided, raised character height shall be permitted to be 1/2" minimum.] The visual characters of the sign shall be installed at minimum 40" above finish floor.

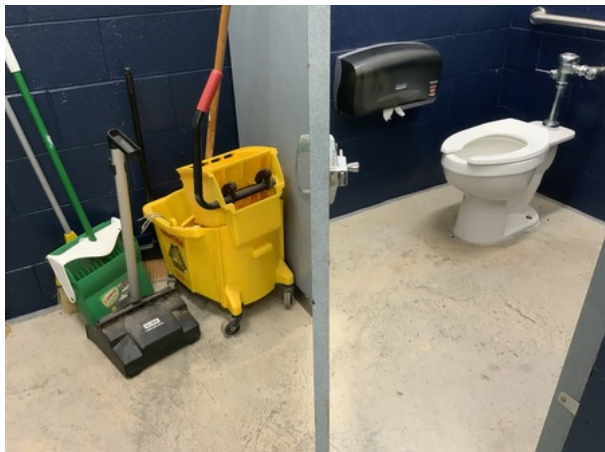
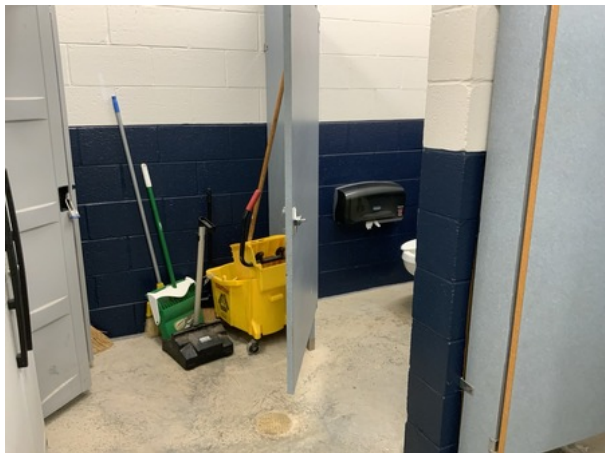
Assembly	Restroom
Type	Restroom/Bathroom - Toilet Stall
ADA Standard	309, 404.2.7, 604.8.1.2
Barrier Detail	The wheelchair stall door is not compliant.
Location Description	Men's Restroom
Observed	May 16, 2024 by javondrick.orange@bureauveritas.com

Toilet compartment doors for wheelchair stalls, including door hardware, shall comply except that if the approach is to the latch side of the compartment door, clearance between the door side of the compartment and any obstruction shall be 42" minimum. Doors shall be located in the front partition or in the side wall or partition farthest from the water closet. Where located in the front partition, the door opening shall be 4" maximum from the side wall or partition farthest from the water closet. Where located in the side wall or partition, the door opening shall be 4" maximum from the front partition. The door shall be self-closing. A compliant door pull shall be placed on both sides of the door near the latch. Toilet compartment doors shall not swing into the minimum required compartment area, 60" wide minimum measured perpendicular to the side wall, and 56" deep minimum for a wall hung water closet or 59" deep minimum for a floor mounted water closet measured perpendicular to the rear wall.

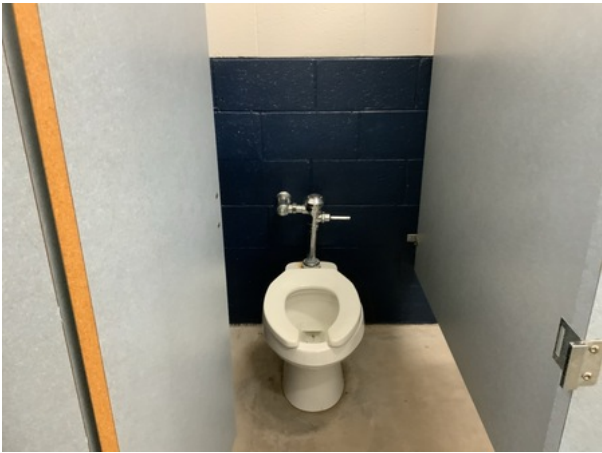
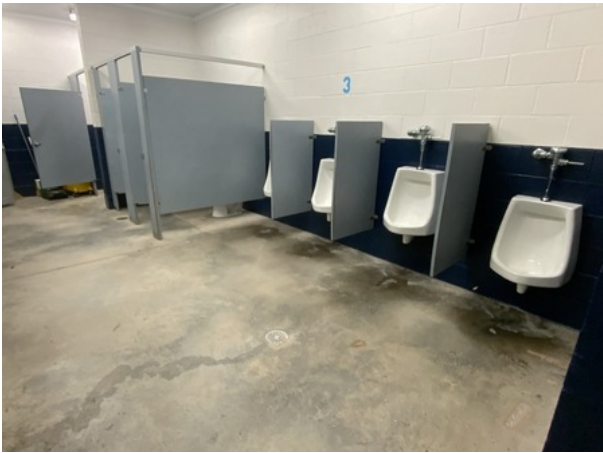
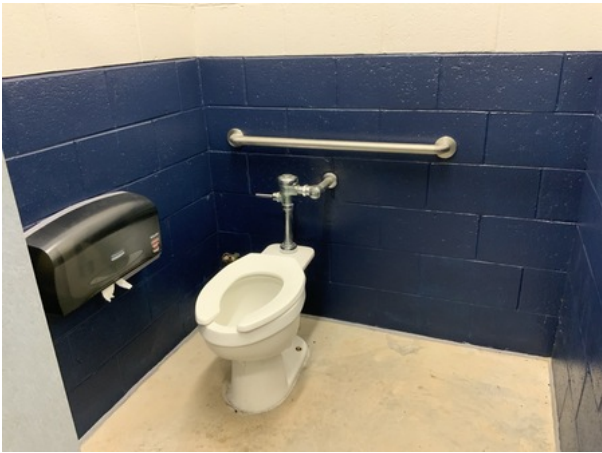
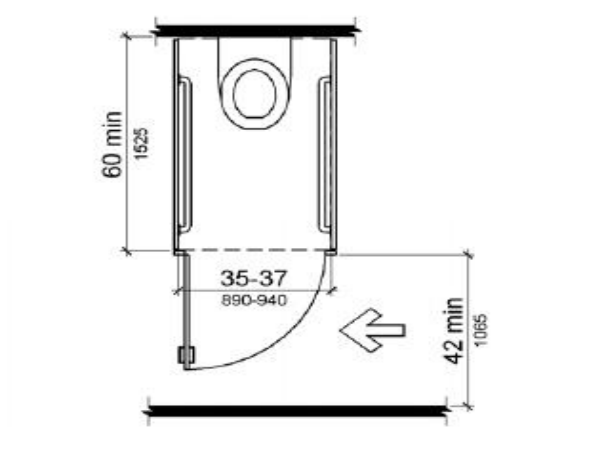
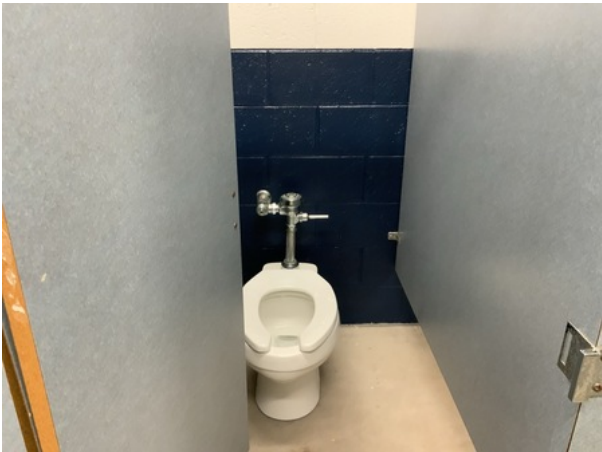
Location Description	Men's Restroom
Observed	May 16, 2024 by javondrick.orange@bureauveritas.com

Provide a compliant ambulatory stall, where six or more toilet compartments are provided or where the combination of urinals and water closets totals six or more fixtures. An ambulatory stall is minimum 60" deep and the width is minimum 35" and maximum 37". Grab bars shall be provided on both sides of the compartment. The side grab bars shall be 33" minimum to 36" maximum above finish floor to the top of the gripping surface, except in children's (ages 3-12) water closets where horizontal grab bars shall be 18" minimum and 27" maximum above the finish floor to the top of the gripping surface. Horizontal grab bars should be installed at a consistent height. The side wall grab bars shall be 42" long minimum, located 12" maximum from the rear wall and extending 54" minimum from the rear wall. The centerline of the toilet shall be minimum 17" to maximum 19" from the side wall. Toilet compartment doors for ambulatory stalls shall be minimum 32" wide when open 90 degrees and have minimum 80" high clearance. If the approach is to the latch side of the compartment door, clearance between the exterior side of the door of the compartment and any obstruction shall be 42" minimum. The door shall be self-closing. A compliant door pull shall be placed on both sides of the door near the latch. Toilet compartment doors shall not swing into the minimum required compartment area. [ADVISORY: It is advisable, but not required, to use the specifications for children where children are the primary users of the restroom. Guidance in applying the specifications for children according to the age group served reflects the differences in the size, stature, and reach ranges of children ages 3 to 12. The specifications chosen should correspond to the age of the primary user group. The specifications of one age group should be applied consistently in the installation of a water closet and related elements. Water Closet Centerline: Ages 3 and 4- 12"; Ages 5 through 8- 12" to 15"; Ages 9 through 12- 15" to 18". Toilet Seat Height: Ages 3 and 4- 11" to 12"; Ages 5 through 8- 12" to 15"; Ages 9 through 12- 15" to 17". Grab Bar Height: Ages 3 and 4- 18" to 20"; Ages 5 through 8- 20" to 25"; Ages 9 through 12- 25" to 27"; Dispenser Height: Ages 3 and 4- 14"; Ages 5 through 8- 14" to 17"; Ages 9 through 12- 17" to 19".]

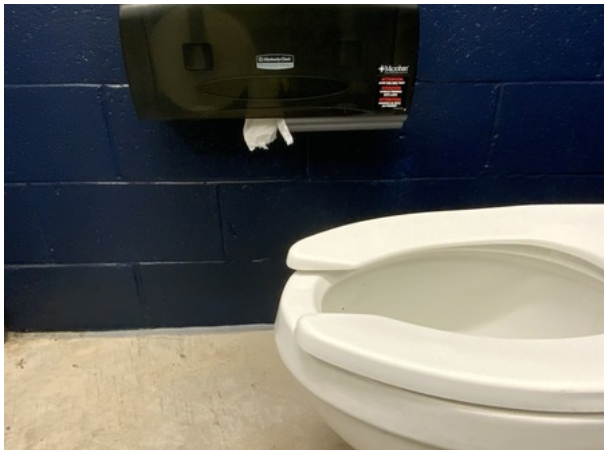
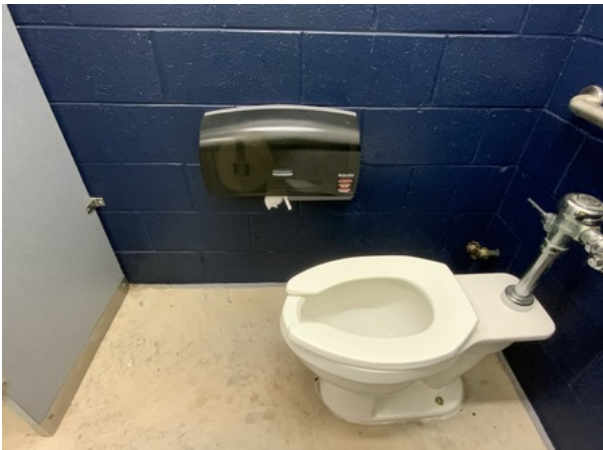
**Photos for Barrier ID: AX468748**

Assembly	Restroom
Type	Restroom/Bathroom - Water Closet
ADA Standard	ADA 604.7, 609.3; 2009 ANSI A117.1-604.7
Barrier Detail	NORTH CAROLINA: The toilet paper dispenser location is not compliant.
Location Description	Men's Restroom
Observed	May 16, 2024 by javondrick.orange@bureauveritas.com
Site Conditions	The centerline of the toilet paper dispenser is 0" in front of the water closet.

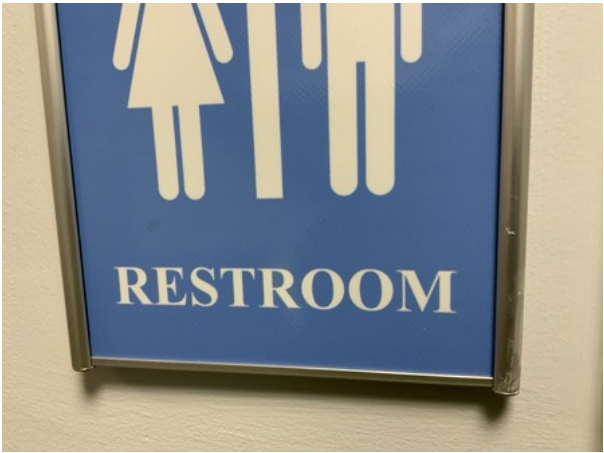
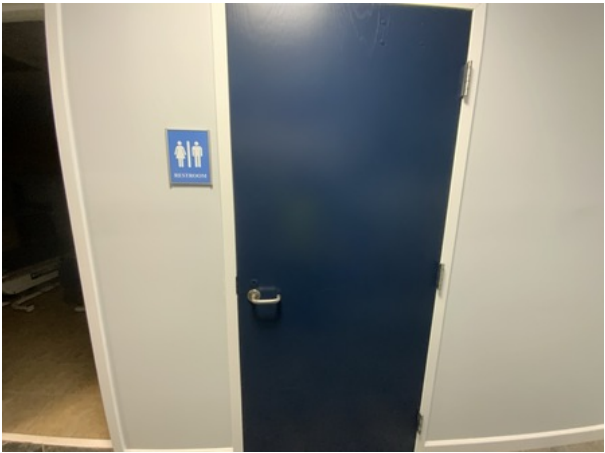
Location Description	Unisex Restroom
Observed	May 16, 2024 by javondrick.orange@bureauveritas.com

Mount compliant signage on the wall at the latch side of the restroom door at a compliant height. All signs for accessible restrooms, including directional signs indicating the restroom location, shall comply with the requirement for the International Symbol of Accessibility (ISA), where not all restrooms are accessible. The pictogram field shall be minimum 6" high. Signage shall include raised letters and Braille, either one sign with both visual and tactile characters, or two separate signs, one with visual, and one with tactile characters, shall be provided. Tactile characters on signs shall be located 48" minimum above the finish floor or ground surface, measured from the baseline of the lowest tactile character and 60" maximum above the finish floor or ground surface, measured from the baseline of the highest tactile character. Accessible restrooms shall have signs with the International Symbol of Accessibility. Where a tactile sign is provided at a door, the sign shall be located alongside the door at the latch side. Where a tactile sign is provided at double doors with one active leaf, the sign shall be located on the inactive leaf. Where a tactile sign is provided at double doors with two active leaves, the sign shall be located to the right of the right hand door. Where there is no wall space at the latch side of a single door or at the right side of double doors, signs shall be located on the nearest adjacent wall. Signs containing tactile characters shall be located so that a clear floor space of 18" minimum by 18" minimum, centered on the tactile characters, is provided beyond the arc of any door swing between the closed position and 45 degree open position. [EXCEPTION: Signs with tactile characters shall be permitted on the push side of doors with closers and without hold-open devices.] Raised characters shall be as follows: Depth: Raised characters shall be 1/32" minimum above their background. Case: Characters shall be uppercase. Style: Characters shall be sans serif. Characters shall not be italic, oblique, script, highly decorative, or of other unusual forms. Character Proportions: Characters shall be selected from fonts where the width of the uppercase letter "O" is 55 % minimum and 110 % maximum of the height of the uppercase letter "I". Character Height: Character height measured vertically from the baseline of the character shall be 5/8" minimum and 2" maximum based on the height of the uppercase letter "I". [EXCEPTION: Where separate raised and visual characters with the same information are provided, raised character height shall be permitted to be 1/2" minimum.] The visual characters of the sign shall be installed at minimum 40" above finish floor.
