# ACCESSIBILITY ASSESSMENT

July 1, 2024

## **ADA TITLE II ASSESSMENT**

Anderson Stadium  
910 Raleigh Road  
Chapel Hill, North Carolina 27514

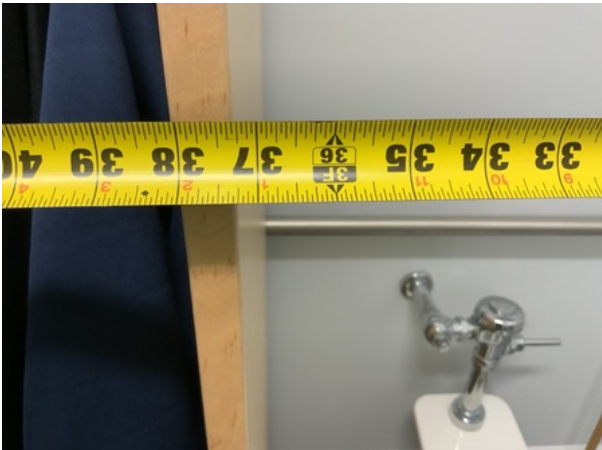
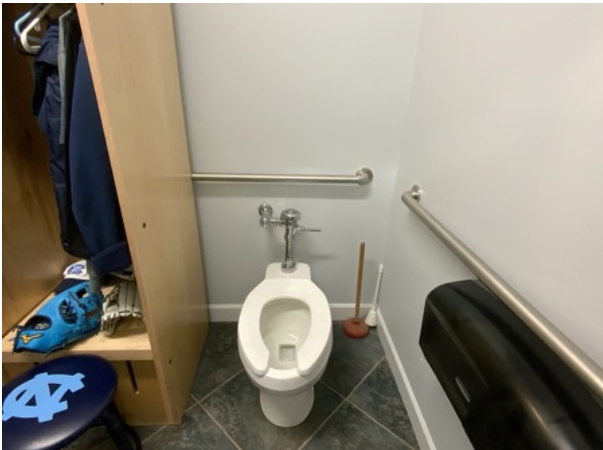
Photos for Barrier ID: AX468735

Assembly	Restroom
Type	Restroom/Bathroom - Water Closet
ADA Standard	604.5.1
Barrier Detail	The side grab bar at the water closet is not compliant.
Location Description	Unisex Restroom
Observed	May 16, 2024 by javondrick.orange@bureauveritas.com
Site Conditions	The side wall grab bar extends 53" from the rear wall.

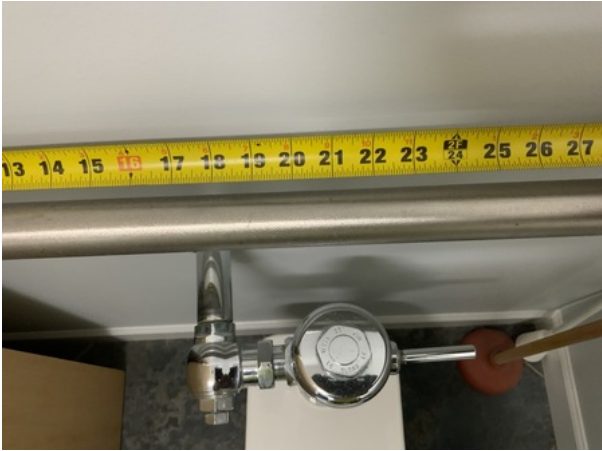
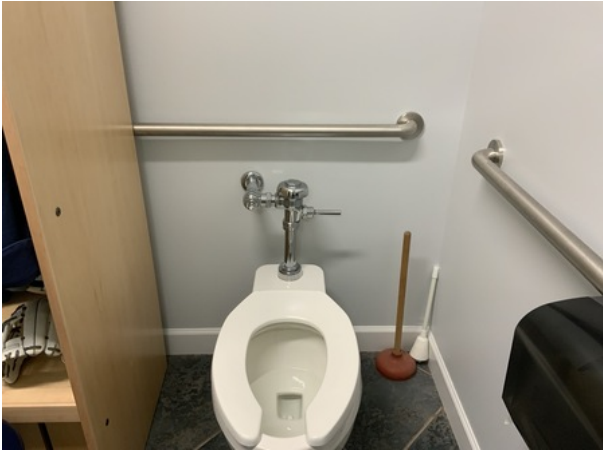
Photos for Barrier ID: AX468736

Assembly	Restroom
Type	Restroom/Bathroom - Water Closet
ADA Standard	604.5.2
Barrier Detail	The rear grab bar at the water closet is not compliant.
Location Description	Unisex Restroom
Observed	May 16, 2024 by javondrick.orange@bureauveritas.com

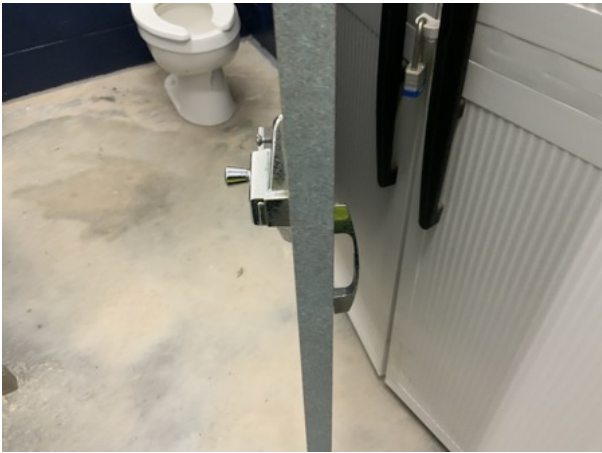
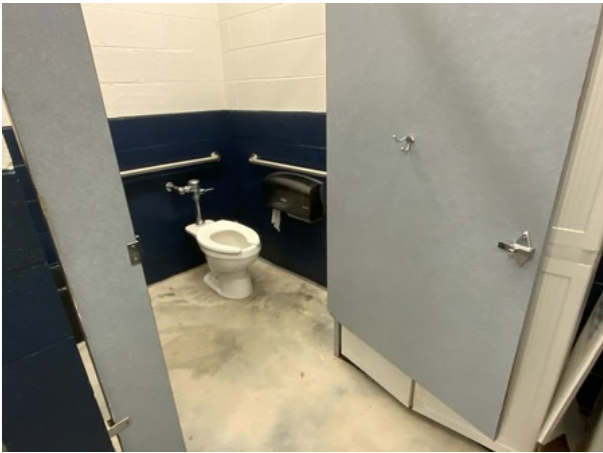
Assembly	Restroom
Type	Restroom/Bathroom - Toilet Stall
ADA Standard	309, 404.2.7, 604.8.1.2
Barrier Detail	The wheelchair stall door is not compliant.
Location Description	Women's Restroom
Observed	May 16, 2024 by javondrick.orange@bureauveritas.com

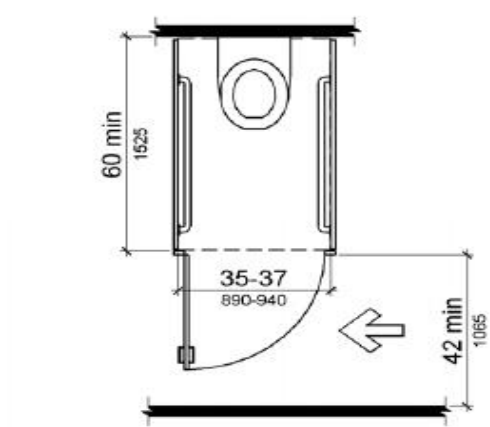
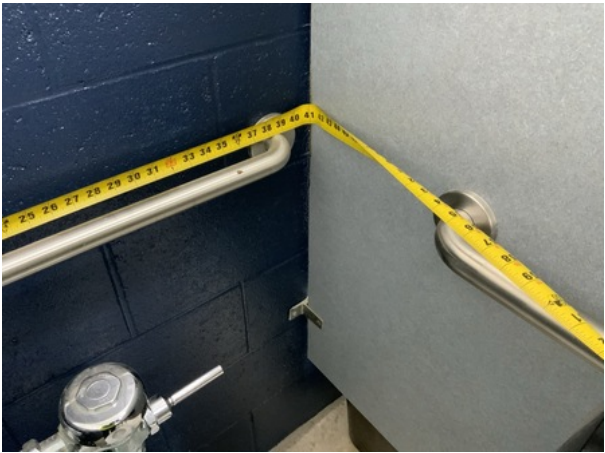
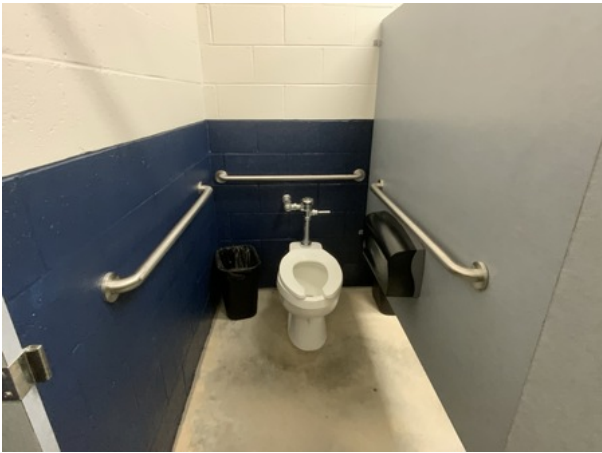
Assembly	Restroom	
Type	Restroom/Bathroom - Toilet Stall	
ADA Standard	213.3.1, 309, 404.2.7, 604.8.2	
Barrier Detail		
The ambulatory stall size is not compliant, or an ambulatory stall is not provided.		
Location Description	Women's Restroom	
Observed	May 16, 2024 by javondrick.orange@bureauveritas.com	
Site Conditions	The ambulatory stall is 41" wide.	
Resolution		
Provide a compliant ambulatory stall, where six or more toilet compartments are provided or where the combination of urinals and water closets totals six or more fixtures. An ambulatory stall is minimum 60" deep and the width is minimum 35" and maximum 37". Grab bars shall be provided on both sides of the compartment. The side grab bars shall be 33" minimum to 36" maximum above finish floor to the top of the gripping surface, except in children's (ages 3-12) water closets where horizontal grab bars shall be 18" minimum and 27" maximum above the finish floor to the top of the gripping surface. Horizontal grab bars should be installed at a consistent height. The side wall grab bars shall be 42" long minimum, located 12" maximum from the rear wall and extending 54" minimum from the rear wall. The centerline of the toilet shall be minimum 17" to maximum 19" from the side wall. Toilet compartment doors for ambulatory stalls shall be minimum 32" wide when open 90 degrees and have minimum 80" high clearance. If the approach is to the latch side of the compartment door, clearance between the exterior side of the door of the compartment and any obstruction shall be 42" minimum. The door shall be self-closing. A compliant door pull shall be placed on both sides of the door near the latch. Toilet compartment doors shall not swing into the minimum required compartment area. [ADVISORY: It is advisable, but not required, to use the specifications for children where children are the primary users of the restroom. Guidance in applying the specifications for children according to the age group served reflects the differences in the size, stature, and reach ranges of children ages 3 to 12. The specifications chosen should correspond to the age of the primary user group. The specifications of one age group should be applied consistently in the installation of a water closet and related elements. Water Closet Centerline: Ages 3 and 4- 12"; Ages 5 through 8- 12" to 15"; Ages 9 through 12- 15" to 18". Toilet Seat Height: Ages 3 and 4- 11" to 12"; Ages 5 through 8- 12" to 15"; Ages 9 through 12- 15" to 17". Grab Bar Height: Ages 3 and 4- 18" to 20"; Ages 5 through 8- 20" to 25"; Ages 9 through 12- 25" to 27"; Dispenser Height: Ages 3 and 4- 14"; Ages 5 through 8- 14" to 17"; Ages 9 through 12- 17" to 19".]

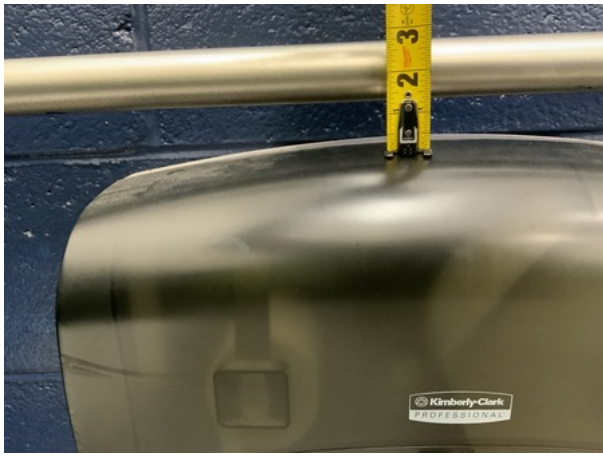
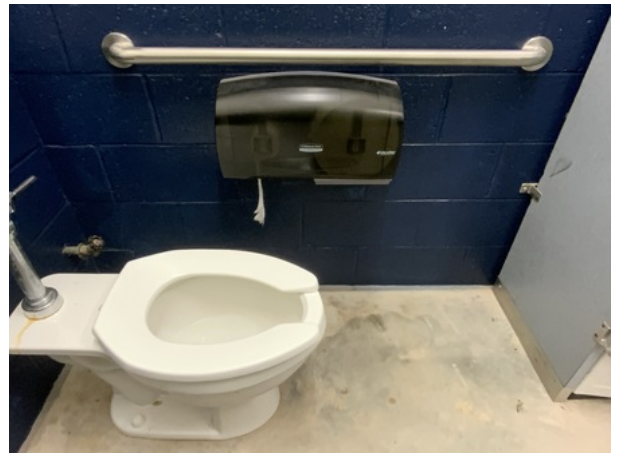
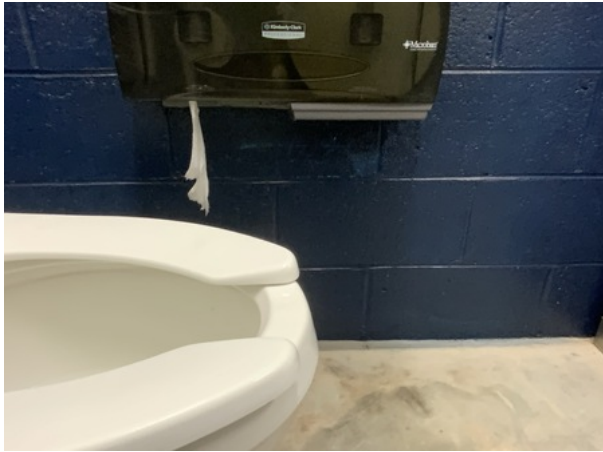
Assembly	Restroom
Type	Restroom/Bathroom - Water Closet
ADA Standard	ADA 604.7, 609.3; 2009 ANSI A117.1-604.7
Barrier Detail	NORTH CAROLINA: The toilet paper dispenser location is not compliant.
Location Description	Women's Restroom
Observed	May 16, 2024 by javondrick.orange@bureauveritas.com
