ACCESSIBILITY ASSESSMENT

ADA TITLE II ASSESSMENT

Abernethy Hall
131 South Columbia Street
Chapel Hill, North Carolina 27514

July 22, 2024

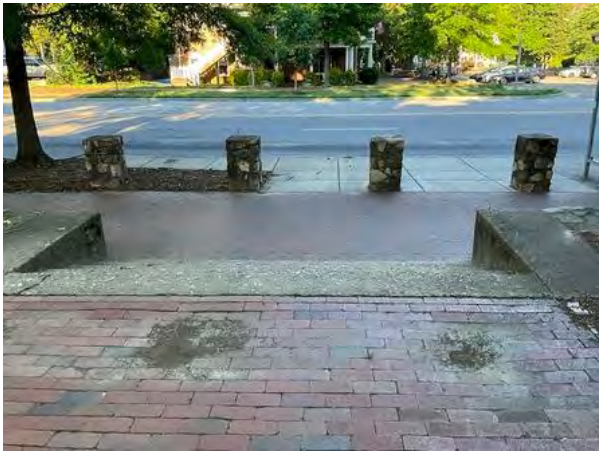
Photos for Barrier ID: AX455995

Assembly	Exterior Access Route
Type	Stairs
ADA Standard	505
Barrier Detail	Handrails are not compliant or are not provided.
Location Description	Columbia Street
Observed	May 20, 2024 by Brian.rogers@bureauveritas.com
Site Conditions	Handrails are not provided on the stairs.

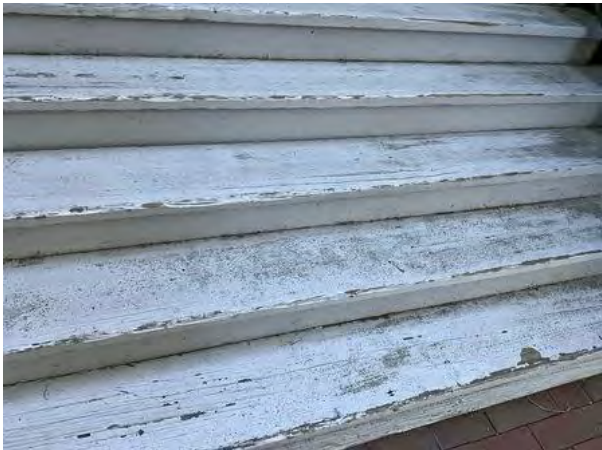
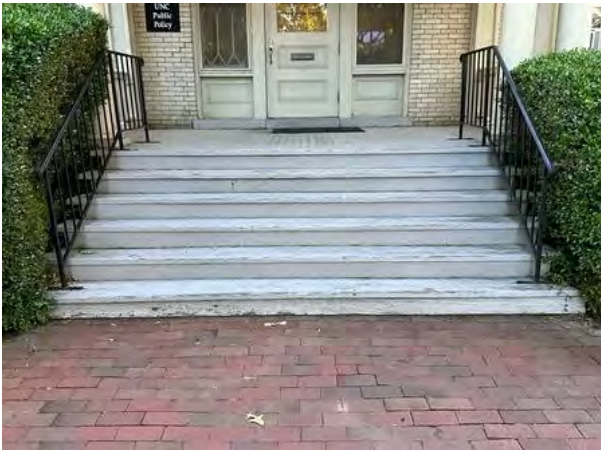
Photos for Barrier ID: AX455997

Assembly	Exterior Access Route	
Type	Stairs	
ADA Standard	2009 ANSI A117.1-504.5	
Barrier Detail		
NORTH CAROLINA: The stair tread, at the leading 2" at the stair nosing, does not have a visual contrast of dark-on-light or light-on-dark distinguished from the remainder of the tread.		
Location Description	Columbia Street Main Entrance	
Observed	May 20, 2024 by Brian.rogers@bureauveritas.com	
Site Conditions	The stair treads do not have visual contrast.	
Resolution		
Install a visual contrast on each stair tread at the nosing. At stair nosings, the leading 2" of tread shall have visual contrast of dark-on-light or light-on-dark from the remainder of the tread.		
Quantity	Unit Cost	Total Cost
6 Riser	125.00	\$ 750
Priority	1

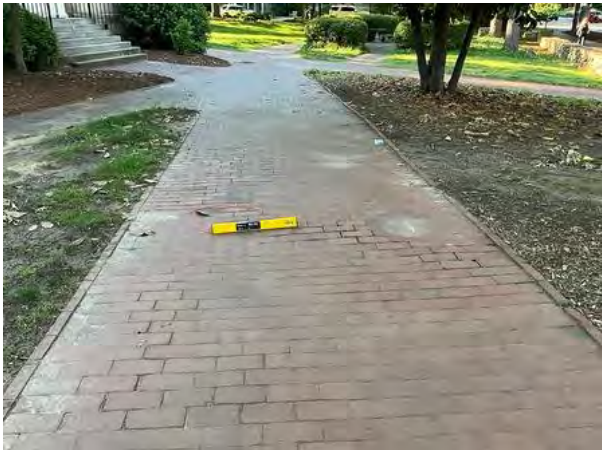
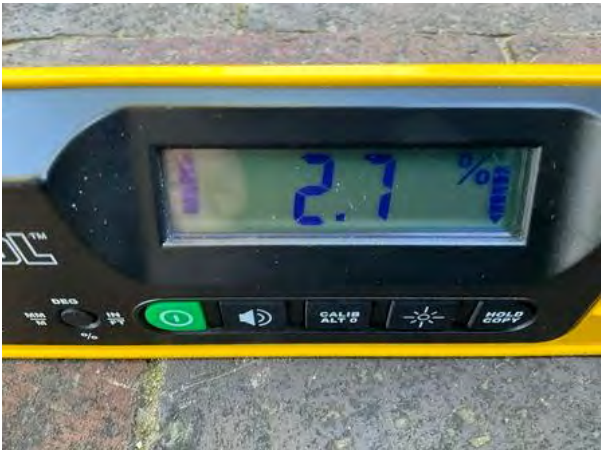
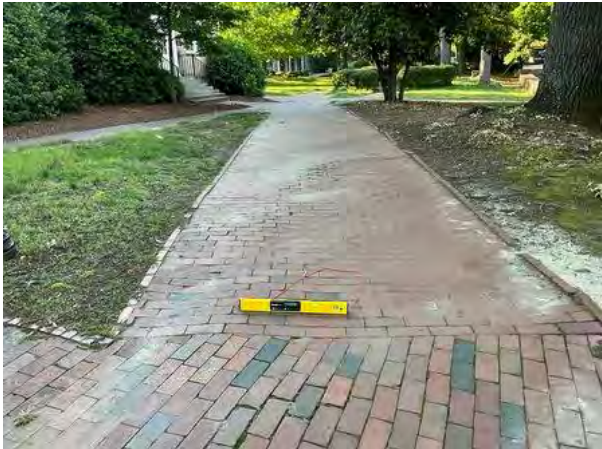
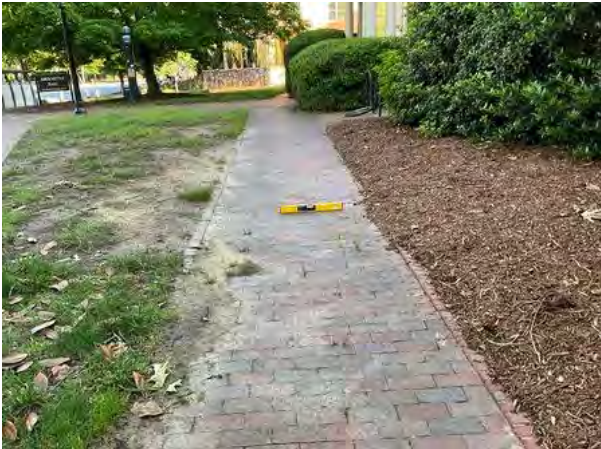
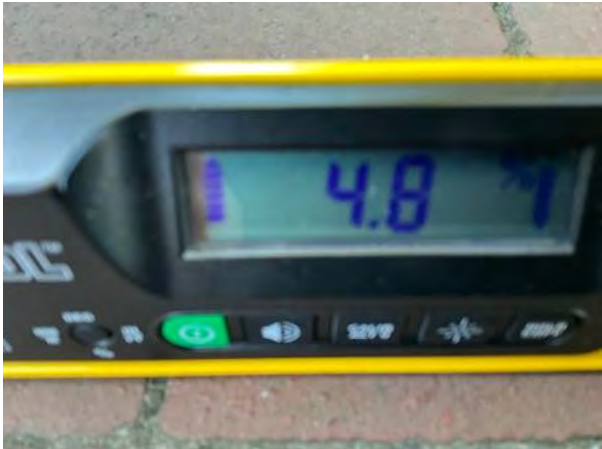
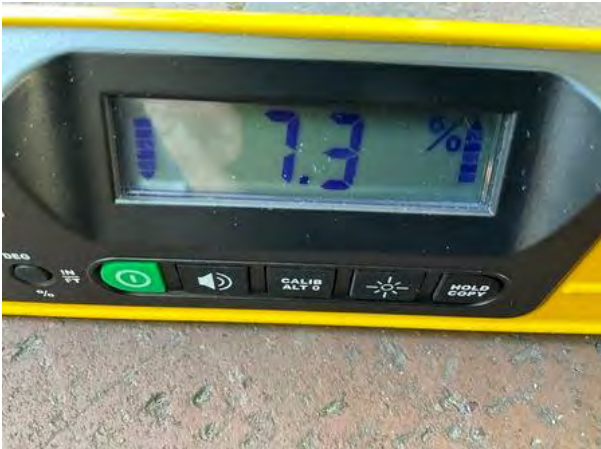
Assembly	Exterior Access Route
Type	Exterior Accessible Route
ADA Standard	403.3
Barrier Detail	The accessible route has cross slopes greater than 1:50 (2%).
Location Description	Exterior Brick Walk
Observed	May 20, 2024 by Brian.rogers@bureauveritas.com

The walkway should be graded to a maximum 1:50 (2%) cross slope. An accessible route has maximum 1:20 (5%) running slope and maximum 1:50 (2%) cross slope. [EXCEPTION: Cross slopes not exceeding 1:48 (2.08%) are permitted.] The clear width of walking surfaces shall be 36" minimum. [EXCEPTION: The clear width shall be permitted to be reduced to 32" minimum for a length of 24" maximum provided that reduced width segments are separated by segments that are 48" long minimum and 36" wide minimum.] Where grading to maximum running slope of 1:20 (5% running slope) is not possible, provide a compliant ramped surface within the walkway with maximum slope 1:12 (8.33%) and maximum ramp run rise of 6" without handrails. If a ramped surface with running slopes greater than 1:20 (5%) and maximum 1:12 (8.33%) rises more than 6", handrails are required. The cost estimate for this barrier removal is based on grading the running slope to maximum 1:20 (5%). The quantity and order of magnitude cost estimate provided for this barrier are limited to the extent of the area identified as non-compliant. Additional costs that may be associated with removal of the barrier are not included.

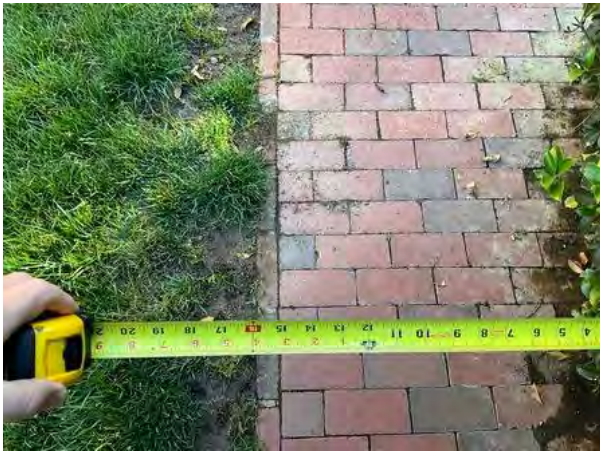
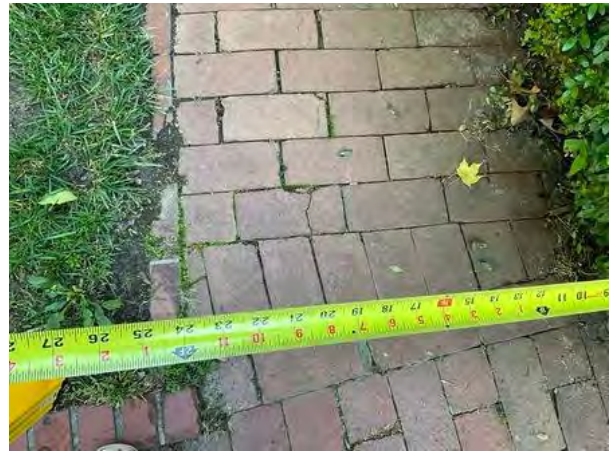
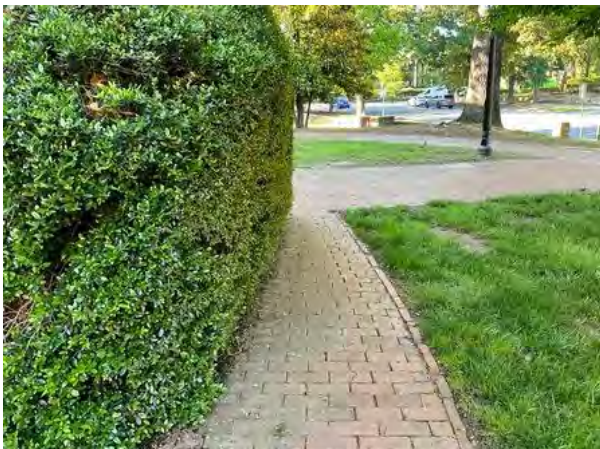
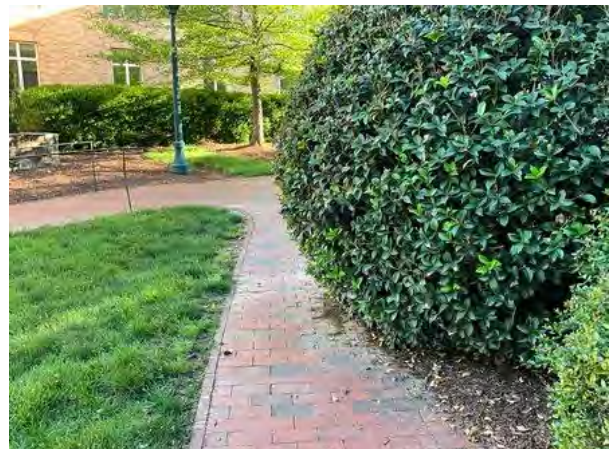
Photos for Barrier ID: AX456000

Assembly	Exterior Access Route	
Type	Protruding Object	
ADA Standard	403.5.1; 403.5.3	
Barrier Detail		
Sidewalk does not meet the 36" minimum clear width requirement (60" minimum where passing areas are present).		
Location Description	Exterior Brick Walk	
Observed	May 20, 2024 by Brian.rogers@bureauveritas.com	
Site Conditions	Vegetation reduces the brick walkway to 16" to 24" in 2 spots each 10' wide	
Resolution		
Remove vegetation that is encroaching into the required clear width. The sidewalk should be removed and replaced with a compliant sidewalk. The clear width of walking surfaces shall be 36" minimum. [EXCEPTION: The clear width shall be permitted to be reduced to 32" minimum for a length of 24" maximum provided that reduced width segments are separated by segments that are 48" long minimum and 36" wide minimum.] An accessible route has maximum 1:20 (5%) running slope and maximum 1:50 (2%) cross slope. [EXCEPTION: Cross slopes not greater than 1:48 (2.08%) are permitted.]

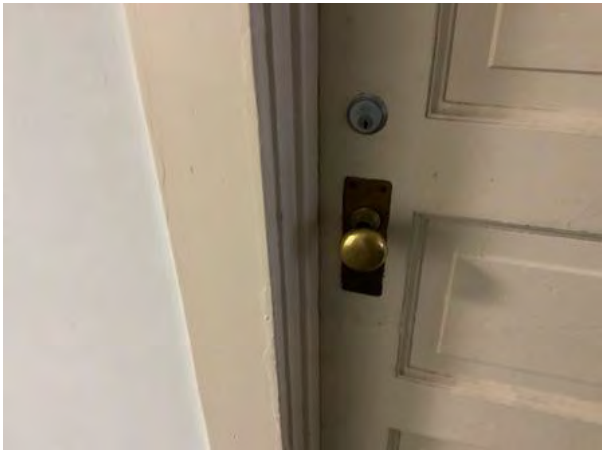
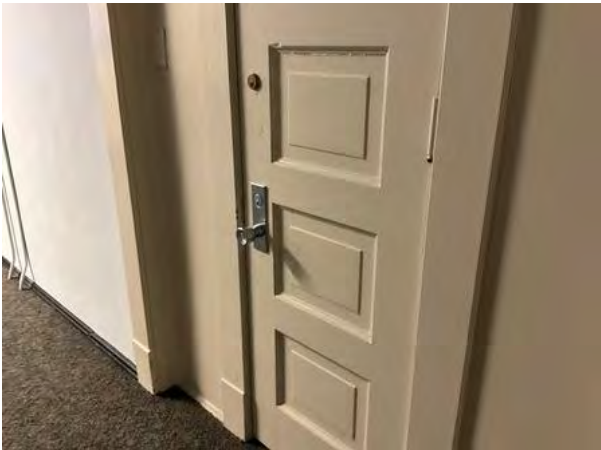
Assembly	Interior Access Route
Type	Door
ADA Standard	309, 404.2.7

Resolution
Remove hardware and replace with hardware that has a shape that is easy to grasp such as lever, push-type or U-shaped handles. Handles, pulls, latches, locks, and other operable parts on doors and gates shall be compliant. Operable parts of such hardware shall be 34" minimum and 48" maximum above the finish floor or ground. Where sliding doors are in the fully open position, operating hardware shall be exposed and usable from both sides. [EXCEPTIONS: 1. Existing locks shall be permitted in any location at existing glazed doors without stiles, existing overhead rolling doors or grilles, and similar existing doors or grilles that are designed with locks that are activated only at the top or bottom rail. 2. Access gates in barrier walls and fences protecting pools, spas, and hot tubs shall be permitted to have operable parts of the release of latch on self-latching devices at 54" maximum above the finish floor or ground provided the self-latching devices are not also self-locking devices and operated by means of a key, electronic opener, or integral combination lock.]

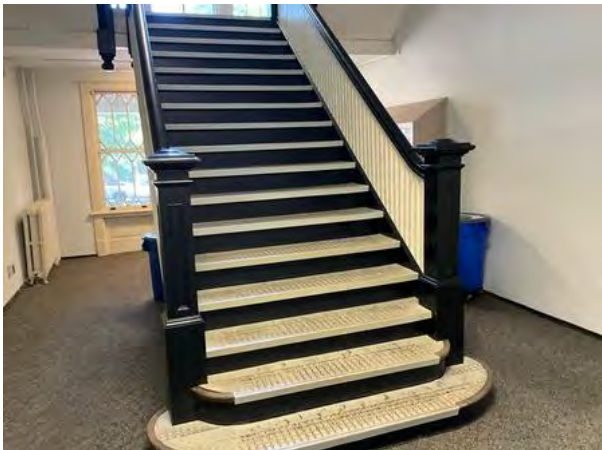
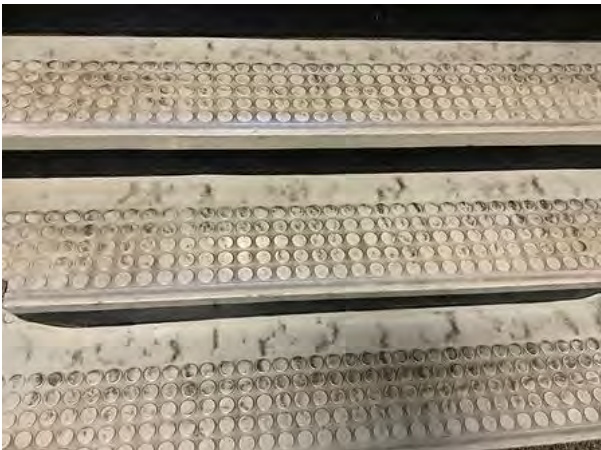
Photos for Barrier ID: AX456045

Site Conditions Stair treads do not have contrast at the nose of the steps

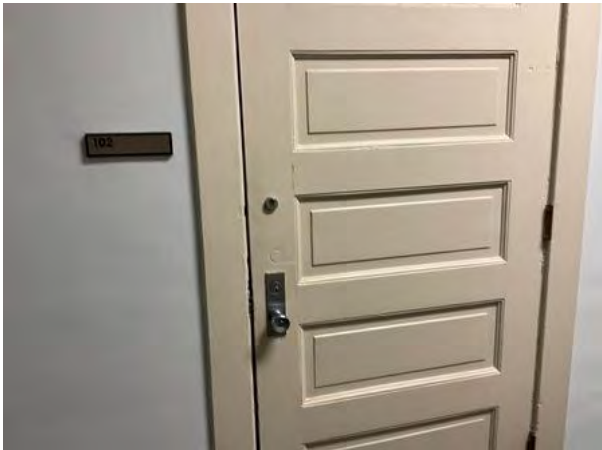
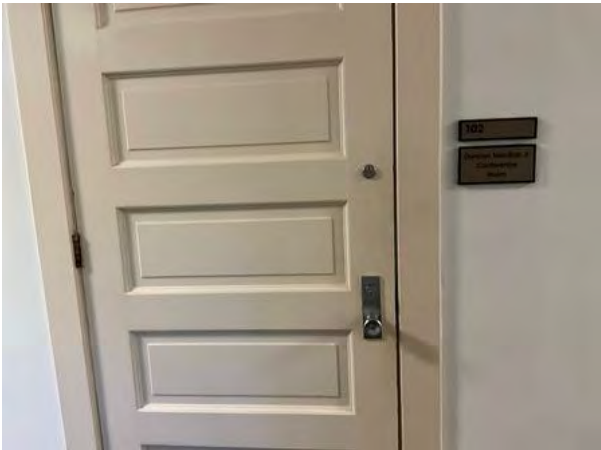
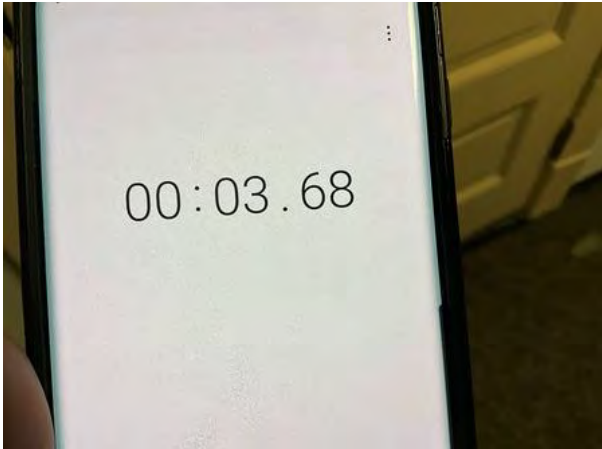
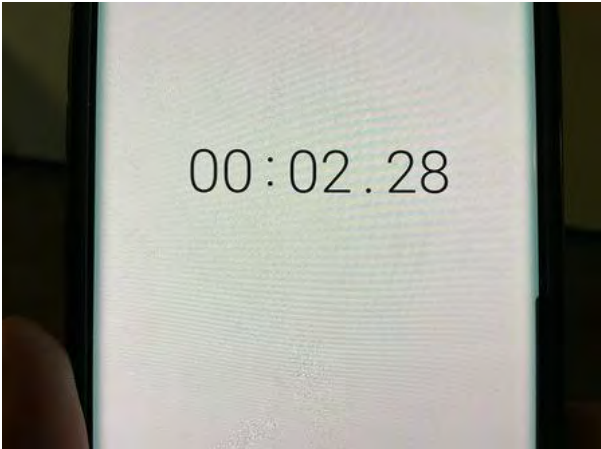
Assembly	Interior Access Route	
Type	Door	
ADA Standard	404.2.8	
Barrier Detail		
The accessible door with door closer has a sweep period of less than 5 seconds from 90 degrees to a position 12 degrees from latch.		
Location Description	Room 102	
Observed	May 20, 2024 by Brian.rogers@bureauveritas.com	
Site Conditions		
The two 3 1/2" thick sound proof doors take 2.28 seconds and 3.68 seconds to close from 90° to 12° off of the latch.		
Resolution		
Adjust closer or remove and replace closer to ensure that the door has a closure time of at least 5 seconds within 12 degrees of the latch. Door closers and gate closers shall be adjusted so that from an open position of 90 degrees, the time required to move the door to a position of 12 degrees from the latch is 5 seconds minimum.		
Quantity	Unit Cost	Total Cost
2 EA	457.50	\$ 915
Priority	1

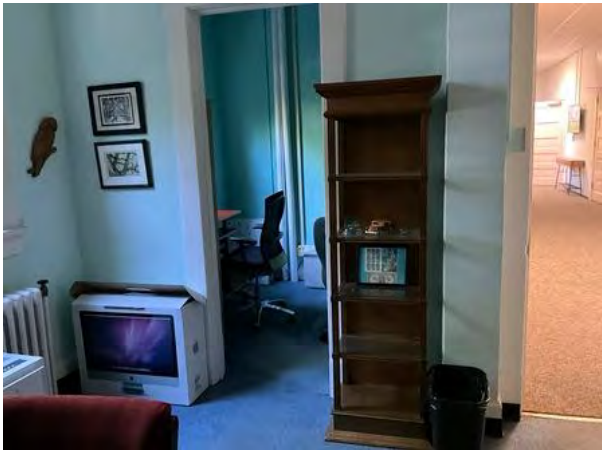
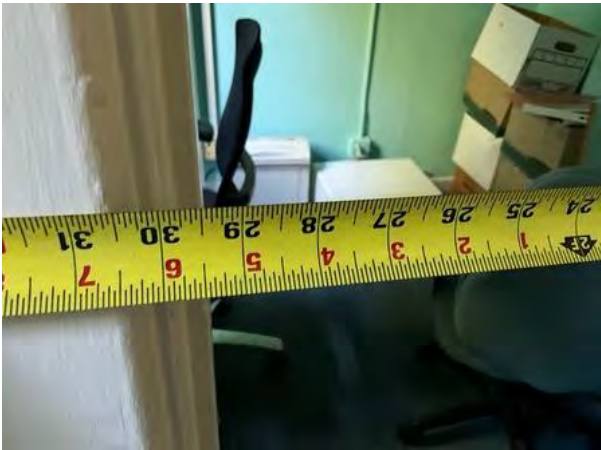
Photos for Barrier ID: AX456013

Assembly	Interior Access Route
Type	Door
ADA Standard	307.4, 404.2.3
Barrier Detail	The door has less than 32" clear width.
Location Description	Room 105 interior door
Observed	May 20, 2024 by Brian.rogers@bureauveritas.com
Site Conditions	The interior office door is 29 1/2" wide.
Width	29 1/2"

Remove and replace with a door that has a minimum clear opening of 32". Door openings shall provide a clear width of 32" minimum. Clear openings of doorways with swinging doors shall be measured between the face of the door and the stop, with the door open 90 degrees. Openings more than 24" deep shall provide a clear opening of 36" minimum. There shall be no projections into the required clear opening width lower than 34" above the finish floor or ground. Projections into the clear opening width between 34" and 80" above the finish floor or ground shall not exceed 4". [EXCEPTIONS: 1. In alterations, a projection of 5/8" maximum into the required clear width shall be permitted for the latch side stop. 2. Door closers and door stops shall be permitted to be 78" minimum above the finish floor or ground.]

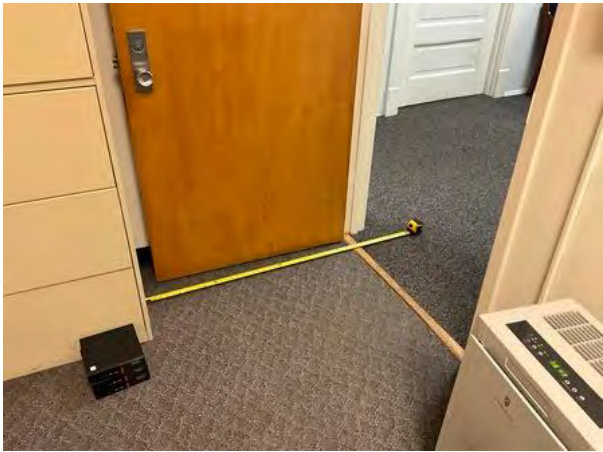
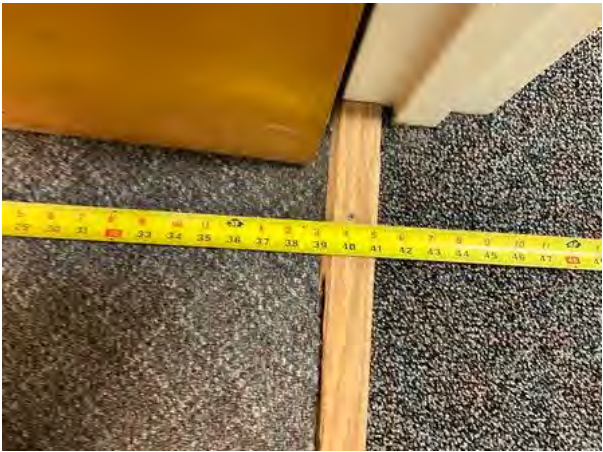
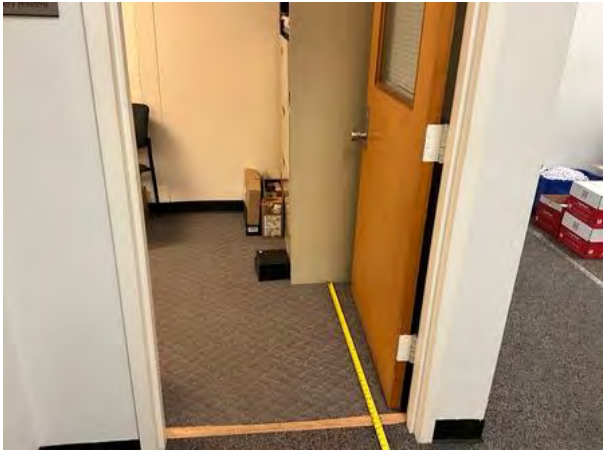
Photos for Barrier ID: AX456029

Assembly	Interior Access Route	
Type	Door	
ADA Standard	404.2.4; Table 404.2.4.1	
Barrier Detail		
The pull side of the accessible door does not have the required maneuvering clearances.		
Location Description	Room 119A	
Observed	May 20, 2024 by Brian.rogers@bureauveritas.com	
Site Conditions		
On the pull side of the door the hinge side the clear floor space clearance is 37" to a file cabinet.		
Dimensions	37"	
Resolution		
Relocate furniture to provide the required maneuvering clearance at the pull side of the door. The required depth of the maneuvering clearance is 60" minimum. The required side clearance is 18" minimum on the latch side of the door. Maneuvering clearance shall extend the full width of the doorway and the required latch side clearance. Floor or ground space within the required maneuvering clearance shall be maximum 1:48 (2.08%) slope. Changes in level are not permitted.		
Quantity	Unit Cost	Total Cost

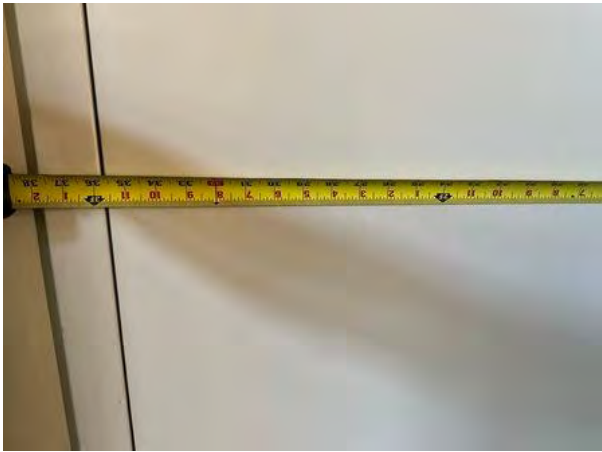
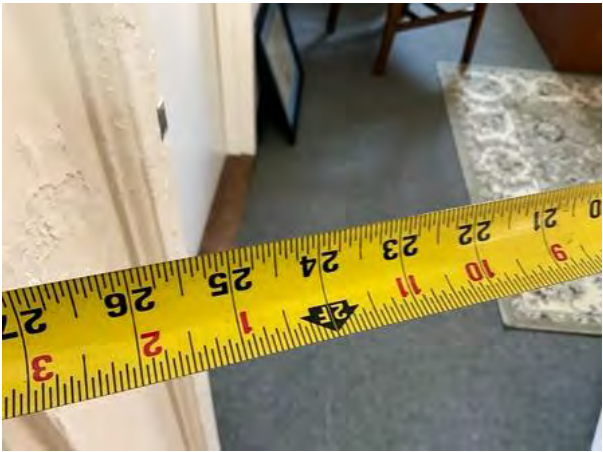
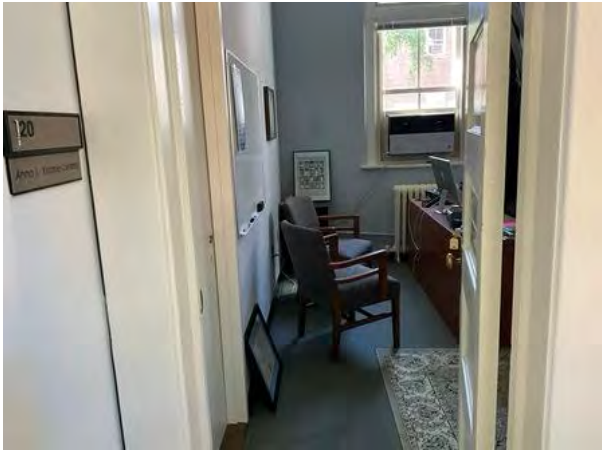
Assembly	Interior Access Route
Type	Door
ADA Standard	307.4, 404.2.3
Barrier Detail	The door has less than 32" clear width.
Location Description	Room 120
Observed	May 20, 2024 by Brian.rogers@bureauveritas.com

Remove and replace with a door that has a minimum clear opening of 32". Door openings shall provide a clear width of 32" minimum. Clear openings of doorways with swinging doors shall be measured between the face of the door and the stop, with the door open 90 degrees. Openings more than 24" deep shall provide a clear opening of 36" minimum. There shall be no projections into the required clear opening width lower than 34" above the finish floor or ground. Projections into the clear opening width between 34" and 80" above the finish floor or ground shall not exceed 4". [EXCEPTIONS: 1. In alterations, a projection of 5/8" maximum into the required clear width shall be permitted for the latch side stop. 2. Door closers and door stops shall be permitted to be 78" minimum above the finish floor or ground.]

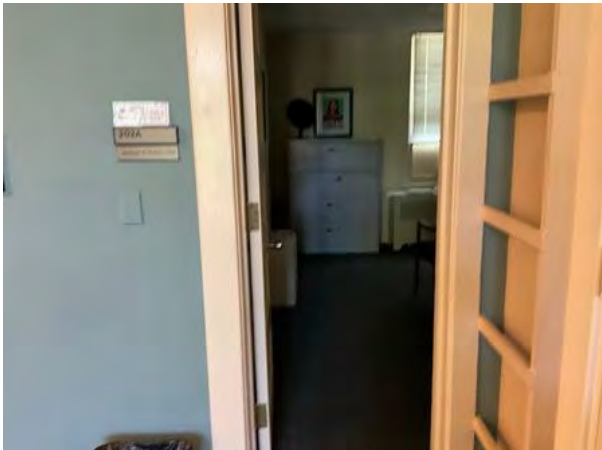
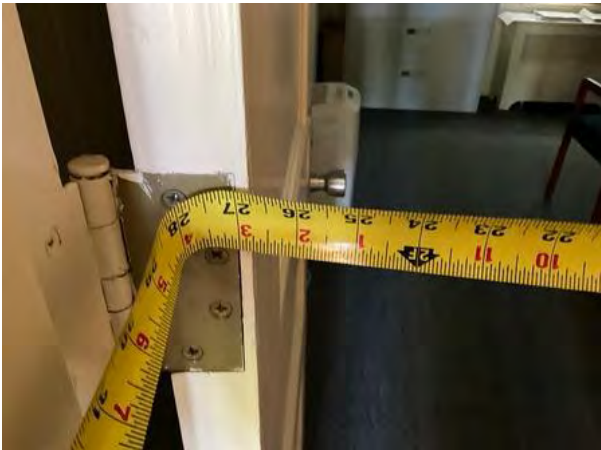
Photos for Barrier ID: AX456060

Assembly	Interior Access Route
Type	Door
ADA Standard	307.4, 404.2.3
Barrier Detail	The door has less than 32" clear width.
Location Description	Room 202A
Observed	May 20, 2024 by Brian.rogers@bureauveritas.com
Site Conditions	The door is 26 3/4 inches wide.
Width	26 3/4"

Remove and replace with a door that has a minimum clear opening of 32". Door openings shall provide a clear width of 32" minimum. Clear openings of doorways with swinging doors shall be measured between the face of the door and the stop, with the door open 90 degrees. Openings more than 24" deep shall provide a clear opening of 36" minimum. There shall be no projections into the required clear opening width lower than 34" above the finish floor or ground. Projections into the clear opening width between 34" and 80" above the finish floor or ground shall not exceed 4". [EXCEPTIONS: 1. In alterations, a projection of 5/8" maximum into the required clear width shall be permitted for the latch side stop. 2. Door closers and door stops shall be permitted to be 78" minimum above the finish floor or ground.]

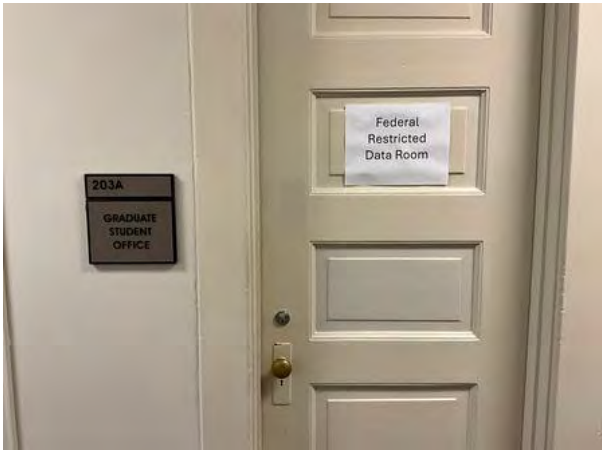
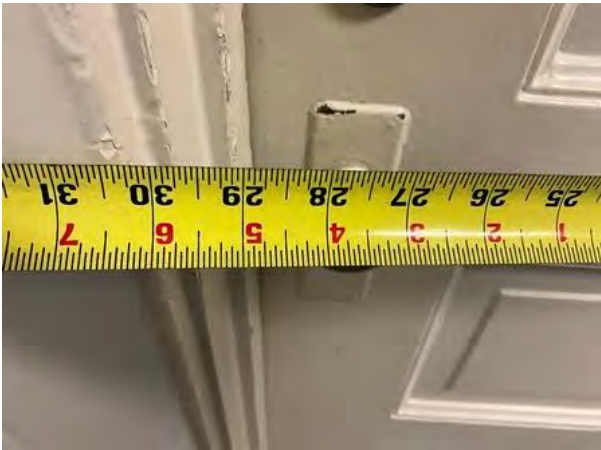
Photos for Barrier ID: AX456062

Assembly	Interior Access Route
Type	Door
ADA Standard	307.4, 404.2.3
Barrier Detail	The door has less than 32" clear width.
Location Description	Room 203A
Observed	May 20, 2024 by Brian.rogers@bureauveritas.com
Site Conditions	The door is 29 inches wide.
Width	29"

Remove and replace with a door that has a minimum clear opening of 32". Door openings shall provide a clear width of 32" minimum. Clear openings of doorways with swinging doors shall be measured between the face of the door and the stop, with the door open 90 degrees. Openings more than 24" deep shall provide a clear opening of 36" minimum. There shall be no projections into the required clear opening width lower than 34" above the finish floor or ground. Projections into the clear opening width between 34" and 80" above the finish floor or ground shall not exceed 4". [EXCEPTIONS: 1. In alterations, a projection of 5/8" maximum into the required clear width shall be permitted for the latch side stop. 2. Door closers and door stops shall be permitted to be 78" minimum above the finish floor or ground.]

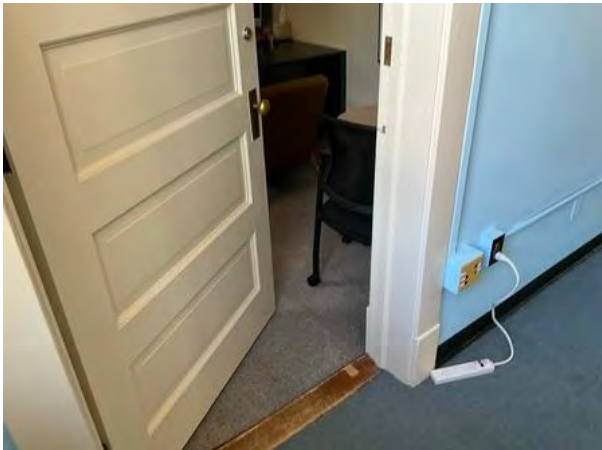
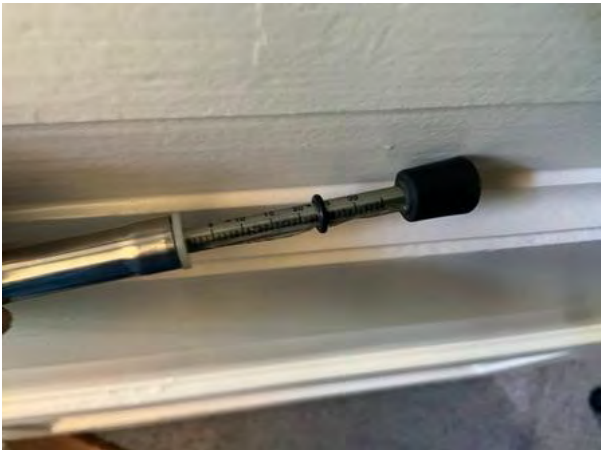
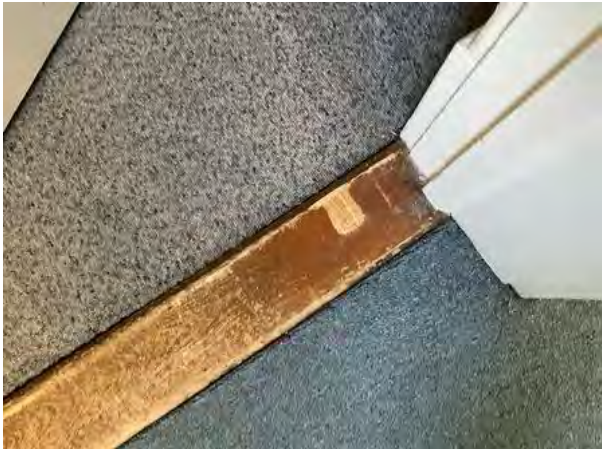
Assembly	Interior Access Route	
Type	Door	
ADA Standard	404.2.9	
Barrier Detail		
The opening force required to open the accessible, hinged, non-fire door is more than 5 pounds.		
Location Description	Room 218A	
Observed	May 20, 2024 by Brian.rogers@bureauveritas.com	
Site Conditions		
The door rubs on the threshold, creating an initial 23 pounds of pressure to open.		
Resolution		
Adjust the closer or replace with a door that requires no more than 5 pounds of force for pushing or pulling the door open. The force at the latch, the force to set the door in motion, and the force to fully open the door shall be maximum 5 pounds. These forces do not apply to the force required to retract latch bolts or disengage other devices that hold the door or gate in a closed position.		
Quantity	Unit Cost	Total Cost
1 EA	458.00	\$ 458
Priority	1

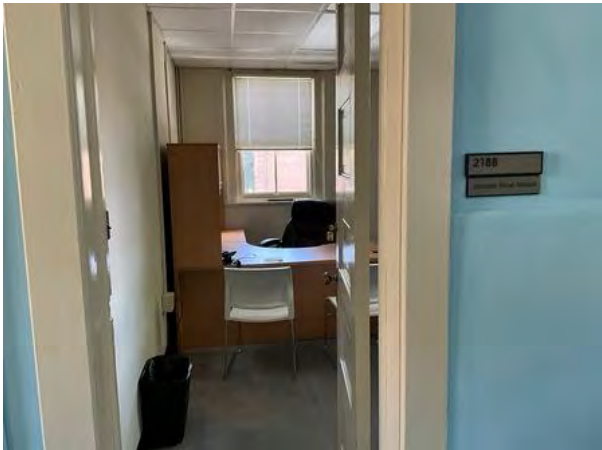
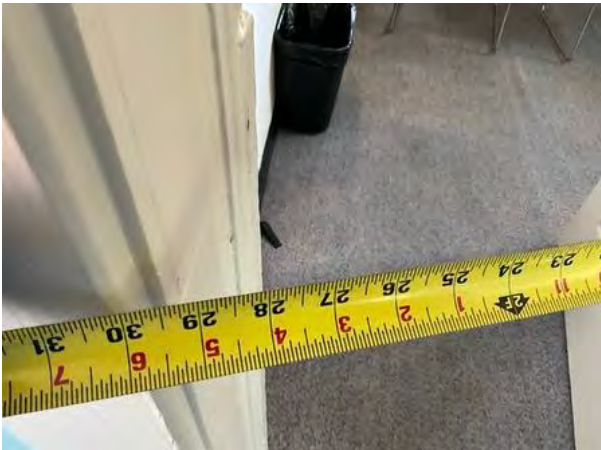
Photos for Barrier ID: AX456077

Assembly	Interior Access Route
Type	Door
ADA Standard	307.4, 404.2.3
Barrier Detail	The door has less than 32" clear width.
Location Description	Room 218B
Observed	May 20, 2024 by Brian.rogers@bureauveritas.com
Site Conditions	The width of the opening of the door is 28 inches.
Width	28"

Remove and replace with a door that has a minimum clear opening of 32". Door openings shall provide a clear width of 32" minimum. Clear openings of doorways with swinging doors shall be measured between the face of the door and the stop, with the door open 90 degrees. Openings more than 24" deep shall provide a clear opening of 36" minimum. There shall be no projections into the required clear opening width lower than 34" above the finish floor or ground. Projections into the clear opening width between 34" and 80" above the finish floor or ground shall not exceed 4". [EXCEPTIONS: 1. In alterations, a projection of 5/8" maximum into the required clear width shall be permitted for the latch side stop. 2. Door closers and door stops shall be permitted to be 78" minimum above the finish floor or ground.]

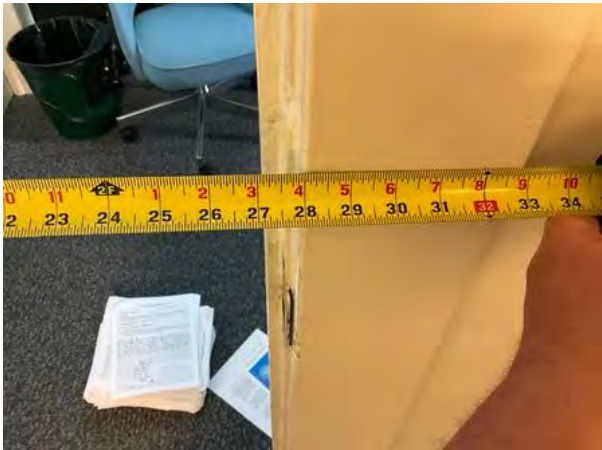
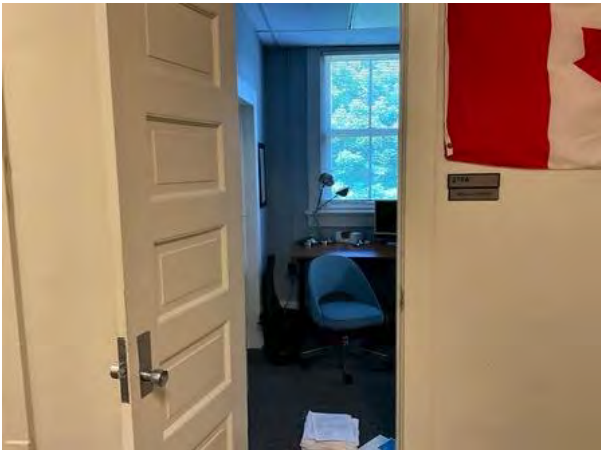
Photos for Barrier ID: AX456068

Assembly	Interior Access Route
Type	Door
ADA Standard	307.4, 404.2.3
Barrier Detail	The door has less than 32" clear width.
Location Description	Room 219A
Observed	May 20, 2024 by Brian.rogers@bureauveritas.com
Site Conditions	The door is 27 inches wide.
Width	27"

Remove and replace with a door that has a minimum clear opening of 32". Door openings shall provide a clear width of 32" minimum. Clear openings of doorways with swinging doors shall be measured between the face of the door and the stop, with the door open 90 degrees. Openings more than 24" deep shall provide a clear opening of 36" minimum. There shall be no projections into the required clear opening width lower than 34" above the finish floor or ground. Projections into the clear opening width between 34" and 80" above the finish floor or ground shall not exceed 4". [EXCEPTIONS: 1. In alterations, a projection of 5/8" maximum into the required clear width shall be permitted for the latch side stop. 2. Door closers and door stops shall be permitted to be 78" minimum above the finish floor or ground.]

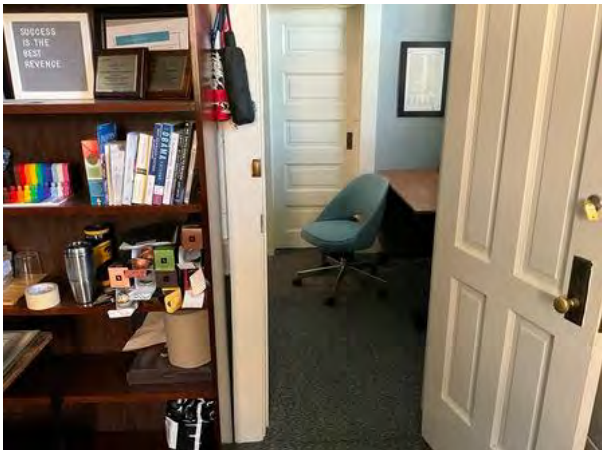
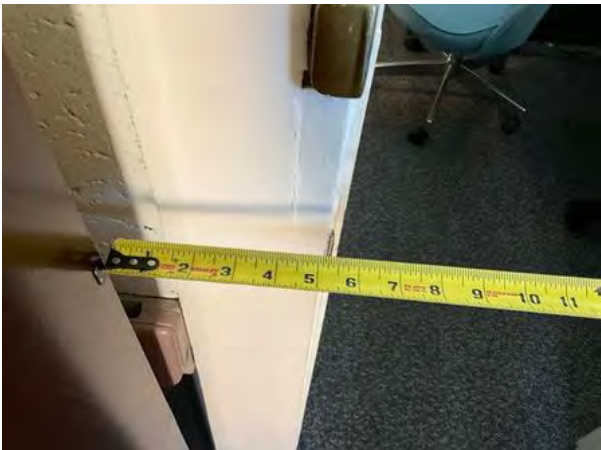
Photos for Barrier ID: AX456070

Assembly	Interior Access Route
Type	Door
ADA Standard	307.4, 404.2.3
Barrier Detail	The door has less than 32" clear width.
Location Description	Room 219A inner doors
Observed	May 20, 2024 by Brian.rogers@bureauveritas.com
Site Conditions	The inner office doors are 25 inches wide and 27 inches wide.
Width	25" - 27"

Remove and replace with a door that has a minimum clear opening of 32". Door openings shall provide a clear width of 32" minimum. Clear openings of doorways with swinging doors shall be measured between the face of the door and the stop, with the door open 90 degrees. Openings more than 24" deep shall provide a clear opening of 36" minimum. There shall be no projections into the required clear opening width lower than 34" above the finish floor or ground. Projections into the clear opening width between 34" and 80" above the finish floor or ground shall not exceed 4". [EXCEPTIONS: 1. In alterations, a projection of 5/8" maximum into the required clear width shall be permitted for the latch side stop. 2. Door closers and door stops shall be permitted to be 78" minimum above the finish floor or ground.]

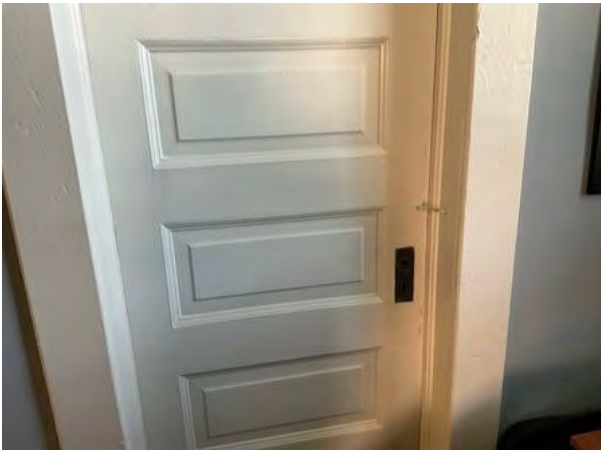
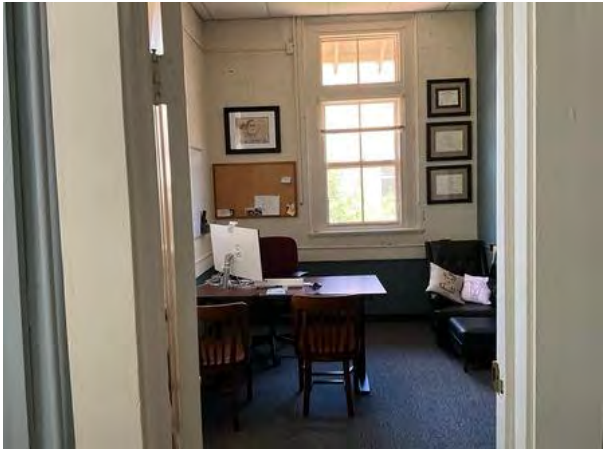
Assembly	Interior Access Route
Type	Door
ADA Standard	307.4, 404.2.3
Barrier Detail	The door has less than 32" clear width.
Location Description	Room 219B
Observed	May 20, 2024 by Brian.rogers@bureauveritas.com
Site Conditions	The door is 27 1/2 inches wide.
Width	27 1/2"

Remove and replace with a door that has a minimum clear opening of 32". Door openings shall provide a clear width of 32" minimum. Clear openings of doorways with swinging doors shall be measured between the face of the door and the stop, with the door open 90 degrees. Openings more than 24" deep shall provide a clear opening of 36" minimum. There shall be no projections into the required clear opening width lower than 34" above the finish floor or ground. Projections into the clear opening width between 34" and 80" above the finish floor or ground shall not exceed 4". [EXCEPTIONS: 1. In alterations, a projection of 5/8" maximum into the required clear width shall be permitted for the latch side stop. 2. Door closers and door stops shall be permitted to be 78" minimum above the finish floor or ground.]

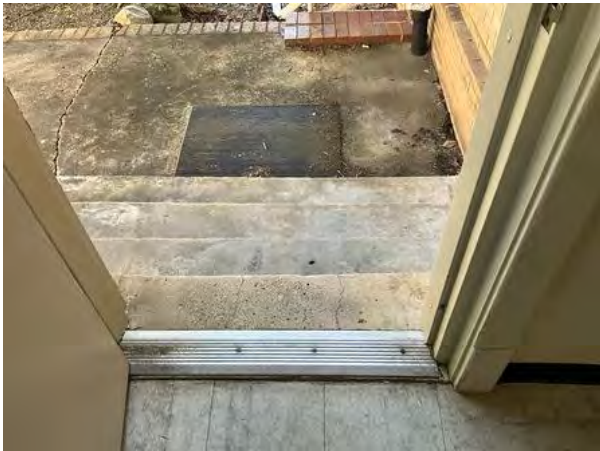
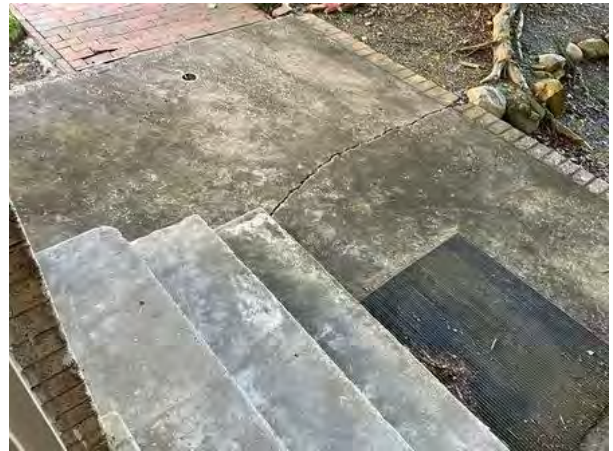
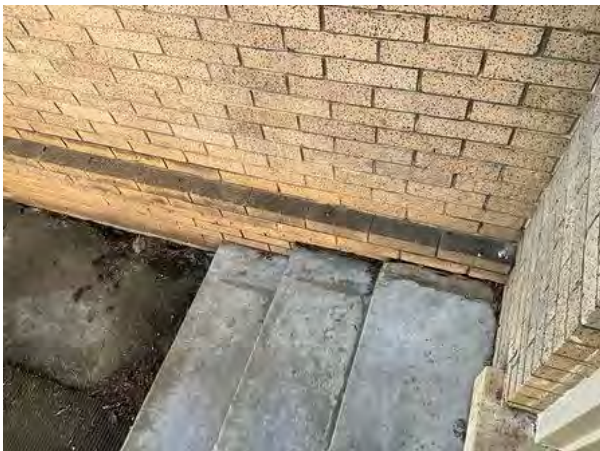
Photos for Barrier ID: AX456032

Site Conditions The stair treads do not have visual contrast.

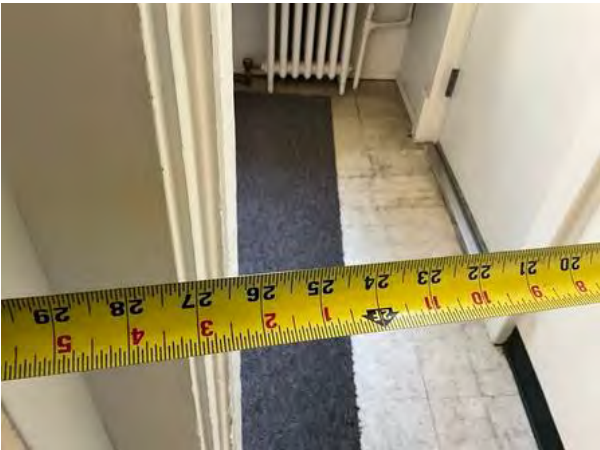
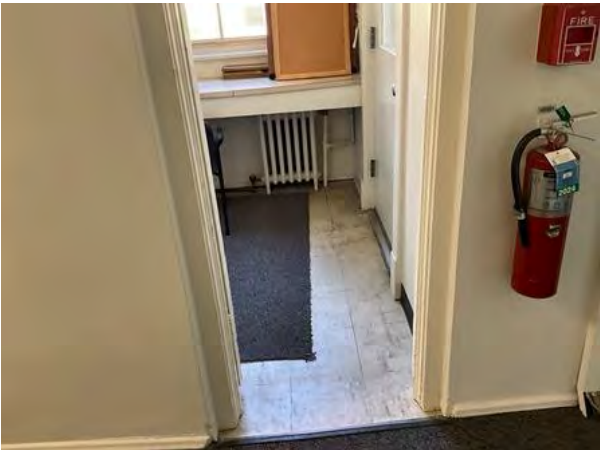
Photos for Barrier ID: AX456031

Assembly	Interior Access Route	
Type	Door	
ADA Standard	307.4, 404.2.3	
Barrier Detail	The door has less than 32" clear width.	
Location Description	Stair 100B	
Observed	May 20, 2024 by Brian.rogers@bureauveritas.com	
Site Conditions	The door to the steps is 29 1/2 inches wide.	
Width	29 1/2"	
Resolution	<p>Remove and replace with a door that has a minimum clear opening of 32". Door openings shall provide a clear width of 32" minimum. Clear openings of doorways with swinging doors shall be measured between the face of the door and the stop, with the door open 90 degrees. Openings more than 24" deep shall provide a clear opening of 36" minimum. There shall be no projections into the required clear opening width lower than 34" above the finish floor or ground. Projections into the clear opening width between 34" and 80" above the finish floor or ground shall not exceed 4". [EXCEPTIONS: 1. In alterations, a projection of 5/8" maximum into the required clear width shall be permitted for the latch side stop. 2. Door closers and door stops shall be permitted to be 78" minimum above the finish floor or ground.]</p>

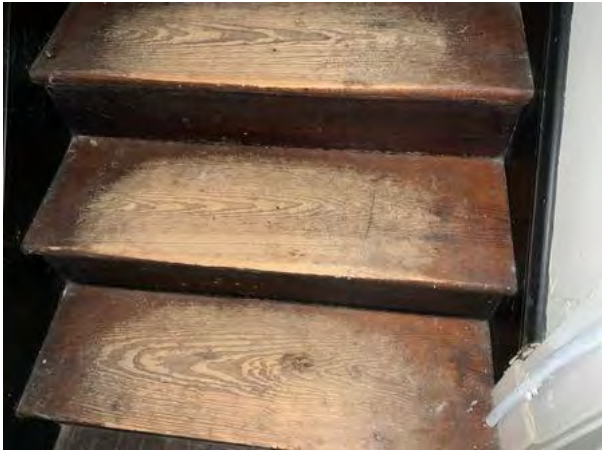
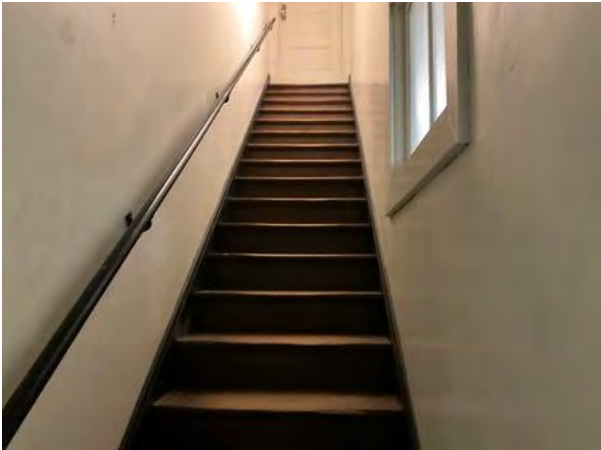
Photos for Barrier ID: AX456034

Assembly	Interior Access Route
Type	Stairs
ADA Standard	505
Barrier Detail	Handrails are not compliant.
Location Description	Stair 100B
Observed	May 20, 2024 by Brian.rogers@bureauveritas.com
Site Conditions	Handrail is missing on one side of the stair.

[EXCEPTIONS: 1. Where handrails are provided along walking surfaces with slopes not steeper than 1:20, the bottoms of handrail gripping surfaces shall be permitted to be obstructed along their entire length where they are integral to crash rails or bumper guards. 2. The distance between horizontal projections and the bottom of the gripping surface shall be permitted to be reduced by 1/8" for each 1/2" of additional handrail perimeter dimension that exceeds 4". Handrail gripping surfaces with a circular cross section shall have an outside diameter of 1-1/4" minimum and 2" maximum. Handrail gripping surfaces with a non-circular cross section shall have a perimeter dimension of 4" minimum and 6-1/4" maximum, and a cross-section dimension of 2-1/4" maximum. Handrail gripping surfaces and any surfaces adjacent to them shall be free of sharp or abrasive elements and shall have rounded edges. Handrails shall not rotate within their fittings. Handrail gripping surfaces shall extend beyond and in the same direction of stair flights. At the top of a stair flight, handrails shall extend horizontally above the landing for 12" minimum beginning directly above the first riser nosing. At the bottom of a stair flight, handrails shall extend at the slope of the stair flight for a horizontal distance at least equal to one tread depth beyond the last riser nosing. Extensions shall return to a wall, guard, or the landing surface, or shall be continuous to the handrail of an adjacent stair flight. [EXCEPTIONS: 1. Extensions shall not be required for continuous handrails at the inside turn of switchback or dogleg stairs and ramps AND 3. In alterations, full extensions of handrails shall not be required where such extensions would be hazardous due to plan configuration.] [ADVISORY: It is advisable, but not required, to provide a handrail at a height designed for children. When children are the principal users in a building or facility (e.g., elementary schools), a second set of handrails at an appropriate height can assist them and aid in preventing accidents. A maximum height of 28" measured to the top of the gripping surface from the ramp surface or stair nosing is recommended for handrails designed for children. Sufficient vertical clearance between upper and lower handrails, 9" minimum, should be provided to help prevent entrapment.]

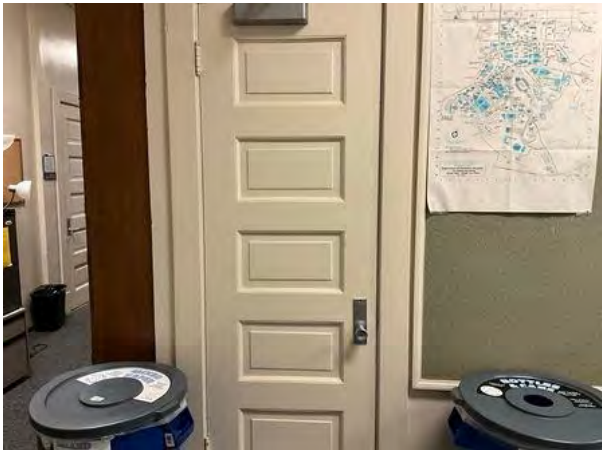
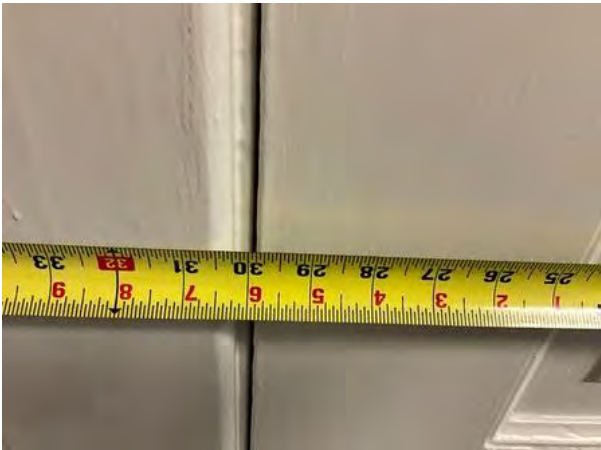
Photos for Barrier ID: AX456067

Assembly	Interior Access Route	
Type	Door	
ADA Standard	404.2.9	
Barrier Detail		
The opening force required to open the accessible, hinged, non-fire door is more than 5 pounds.		
Location Description	Top Staircase Doors	
Observed	May 20, 2024 by Brian.rogers@bureauveritas.com	
Site Conditions	All three doors require 10 pounds of pressure to open	
Resolution		
Adjust the closer or replace with a door that requires no more than 5 pounds of force for pushing or pulling the door open. The force at the latch, the force to set the door in motion, and the force to fully open the door shall be maximum 5 pounds. These forces do not apply to the force required to retract latch bolts or disengage other devices that hold the door or gate in a closed position.		
Quantity	Unit Cost	Total Cost
3 EA	458.00	\$ 1,374
Priority	1

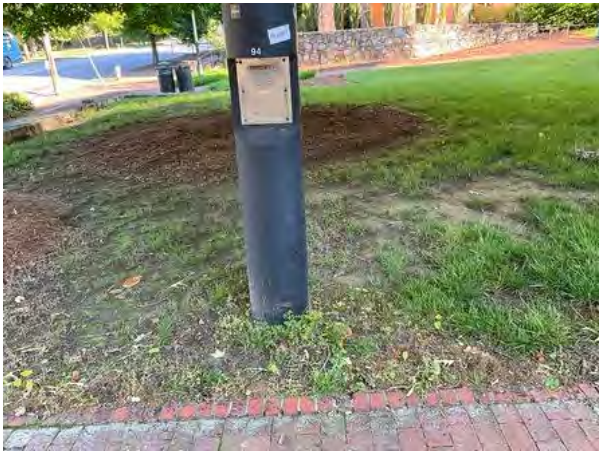
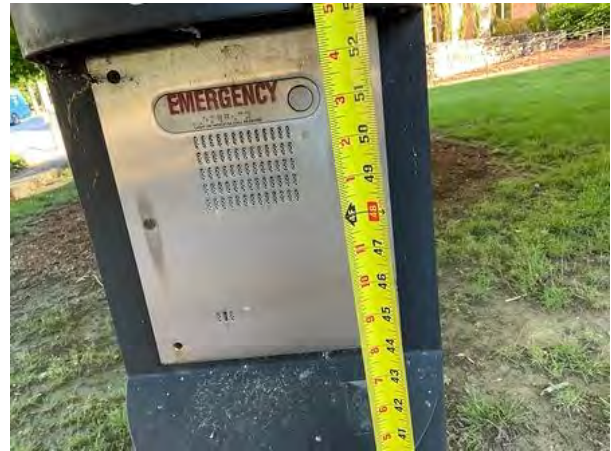
Photos for Barrier ID: AX456002

Assembly	Interior Access Route
Type	Reach Range
ADA Standard	308, 309

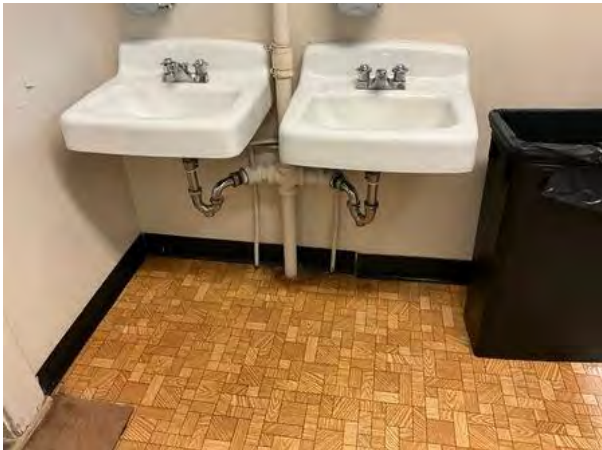
Photos for Barrier ID: AX456022

Assembly	Restroom
Type	Controls And Dispensers
ADA Standard	606.1; 309.3
Barrier Detail	The height of controls are not compliant.
Location Description	First Floor Women's Restroom
Observed	May 20, 2024 by Brian.rogers@bureauveritas.com

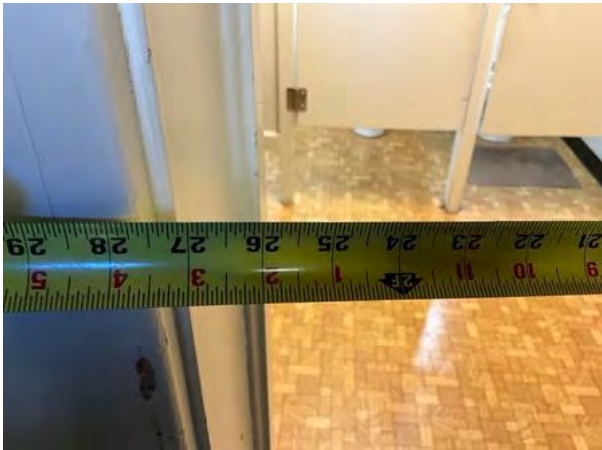
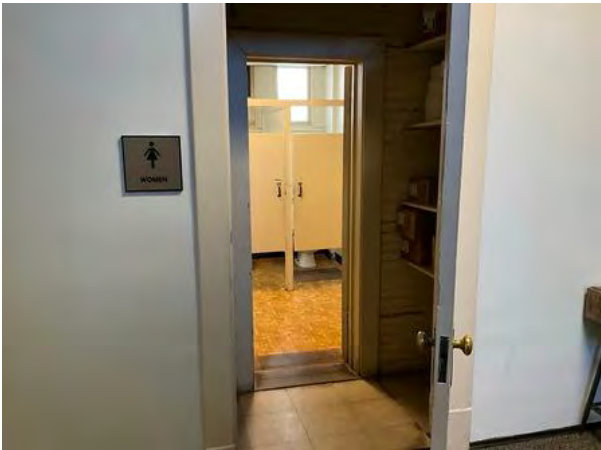
Photos for Barrier ID: AX456017

Assembly	Restroom
Type	Restroom/Bathroom - Door
ADA Standard	404.2.3
Barrier Detail	The door has less than 32" clear width.
Location Description	First Floor Women's Restroom
Observed	May 20, 2024 by Brian.rogers@bureauveritas.com
Site Conditions	The stall door is 28 1/2 inches wide.

Remove and replace with a door that has a minimum clear opening of 32"; measured with the door open at 90°, measured from the face of the door to the stop. Door openings shall provide a clear width of 32" minimum. Clear openings of doorways with swinging doors shall be measured between the face of the door and the stop, with the door open 90°. Openings more than 24" deep shall provide a clear opening of 36" minimum. There shall be no projections into the required clear opening width lower than 34" above the finish floor or ground. Projections into the clear opening width between 34" and 80" above the finish floor or ground shall not exceed 4".
[EXCEPTIONS: 1. In alterations, a projection of 5/8" maximum into the required clear width shall be permitted for the latch side stop. 2. Door closers and door stops shall be permitted to be 78" minimum above the finish floor or ground.]
