ACCESSIBILITY ASSESSMENT

ADA TITLE II ASSESSMENT

Abernethy Hall
131 South Columbia Street
Chapel Hill, North Carolina 27514

July 22, 2024

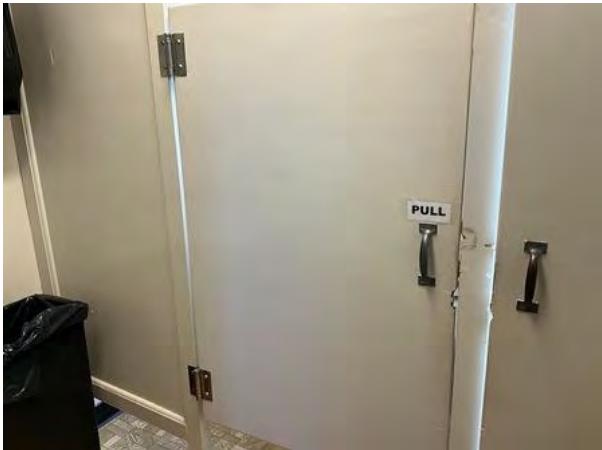
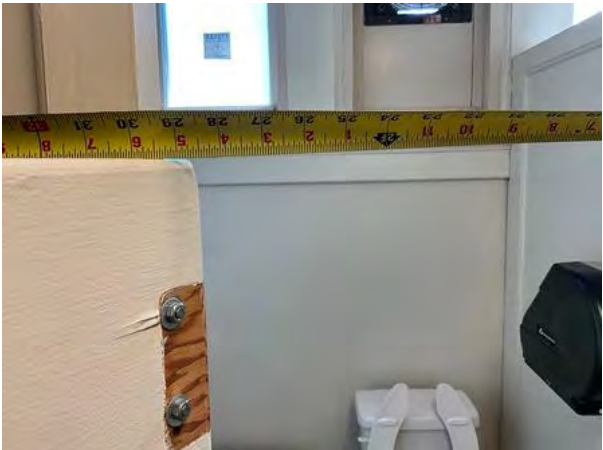
Photos for Barrier ID: AX456019

Assembly	Restroom
Type	Restroom/Bathroom - Floor Space
ADA Standard	304, 603.2.1; 603.2.2
Barrier Detail	The required turning space within the restroom is not provided.
Location Description	First Floor Women's Restroom
Observed	May 20, 2024 by Brian.rogers@bureauveritas.com

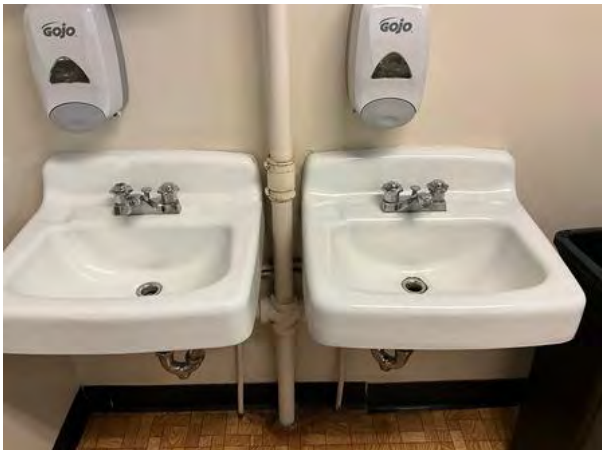
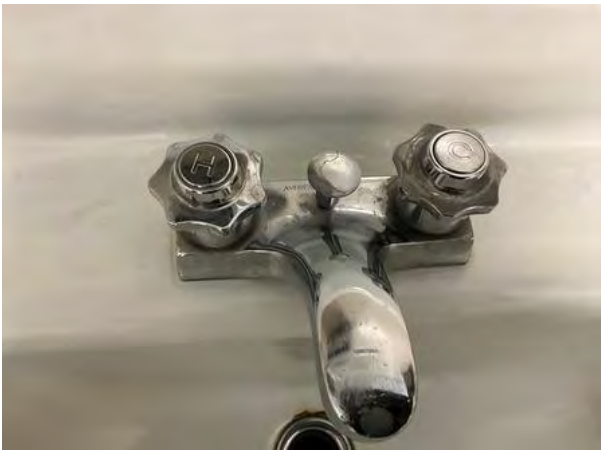
Photos for Barrier ID: AX456023

Assembly	Restroom
Type	Restroom/Bathroom - Mirror
ADA Standard	213.3.5; 603.3

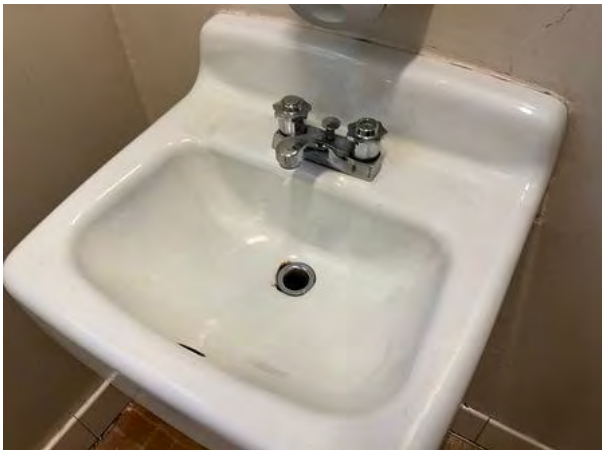
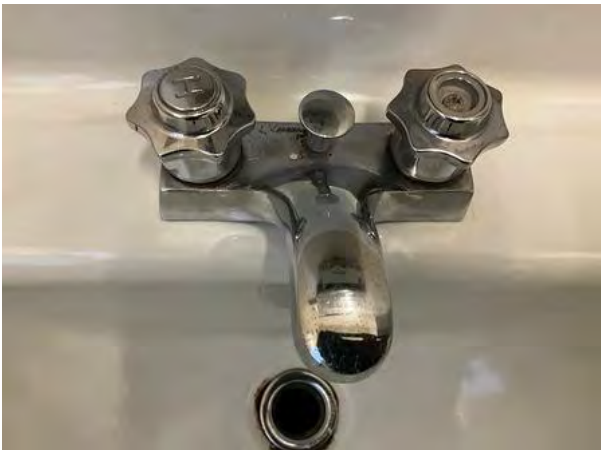
Photos for Barrier ID: AX456026

Assembly	Restroom
Type	Controls And Dispensers
ADA Standard	606.1; 309.3
Barrier Detail	The height of controls are not compliant.
Location Description	Second Floor Men's Restroom
Observed	May 20, 2024 by Brian.rogers@bureauveritas.com

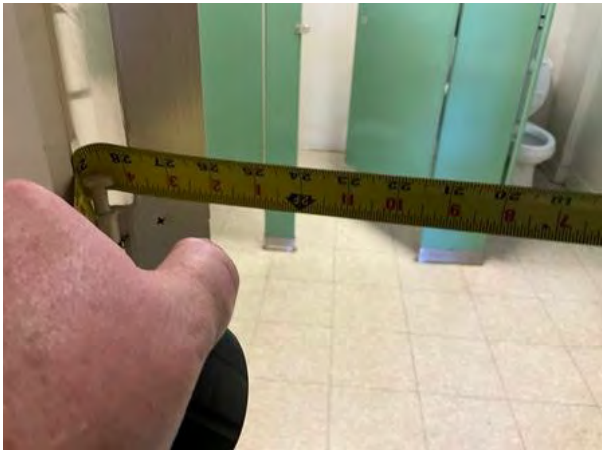
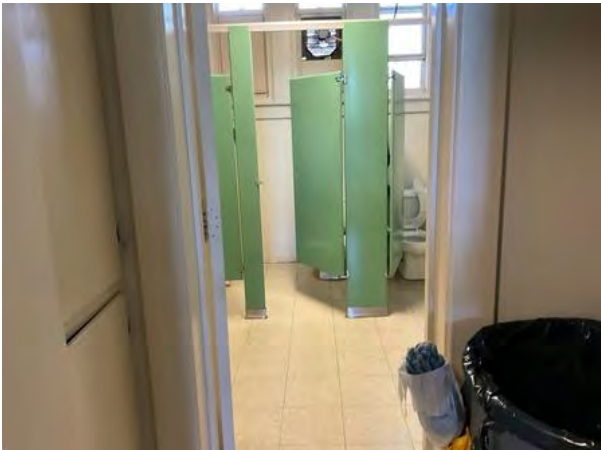
Photos for Barrier ID: AX456047

Assembly	Restroom
Type	Restroom/Bathroom - Door
ADA Standard	603.2.3
Barrier Detail	The door swings into the required clear space for a fixture.
Location Description	Second Floor Men's Restroom
Observed	May 20, 2024 by Brian.rogers@bureauveritas.com
Site Conditions	The stall door is 5 1/2 inches from the nose of the toilet when opened 90°.

Replace with out swing door. Doors shall not swing into the clear floor space or clearance required for any fixture. Doors shall be permitted to swing into the required turning space. EXCEPTIONS: 1. Doors to a toilet room or bathing room for a single occupant accessed only through a private office and not for common use or public use shall be permitted to swing into the clear floor space or clearance provided the swing of the door can be reversed. 2. Where the toilet room or bathing room is for individual use and a clear floor space is provided within the room beyond the arc of the door swing, doors shall be permitted to swing into the clear floor space or clearance required for any fixture.

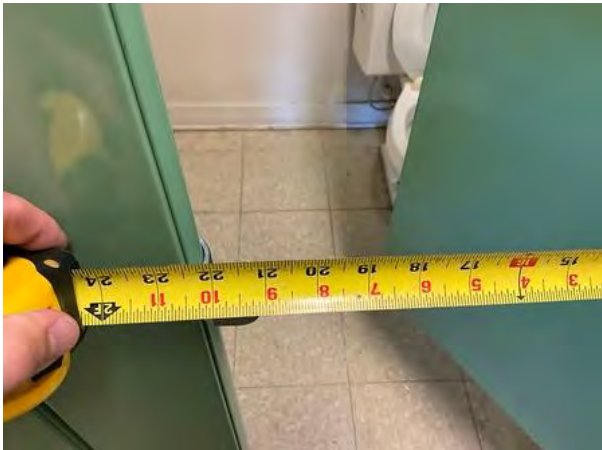
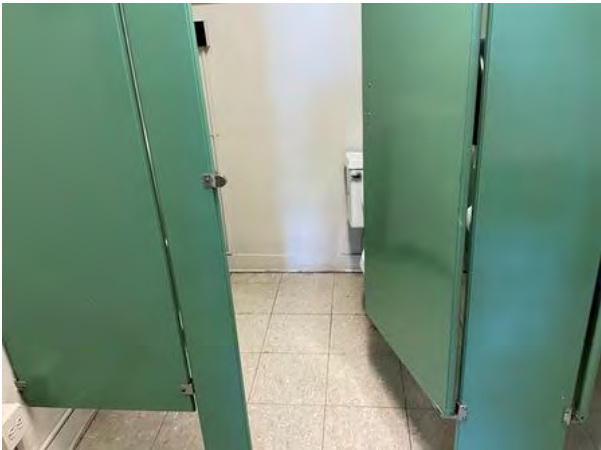
Photos for Barrier ID: AX456049

Assembly	Restroom
Type	Restroom/Bathroom - Floor Space
ADA Standard	304, 603.2.1; 603.2.2
Barrier Detail	The required turning space within the restroom is not provided.
Location Description	Second Floor Men's Restroom
Observed	May 20, 2024 by Brian.rogers@bureauveritas.com

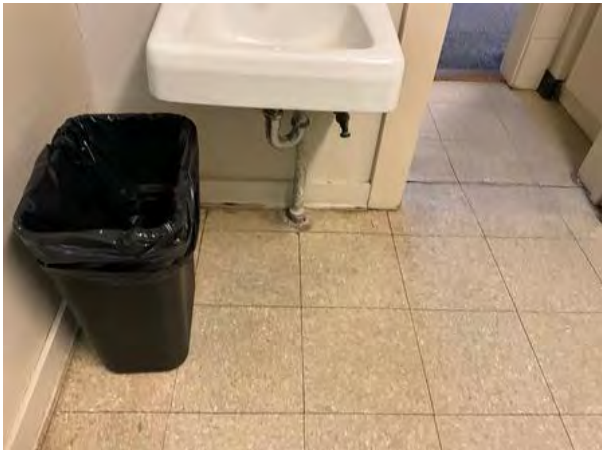
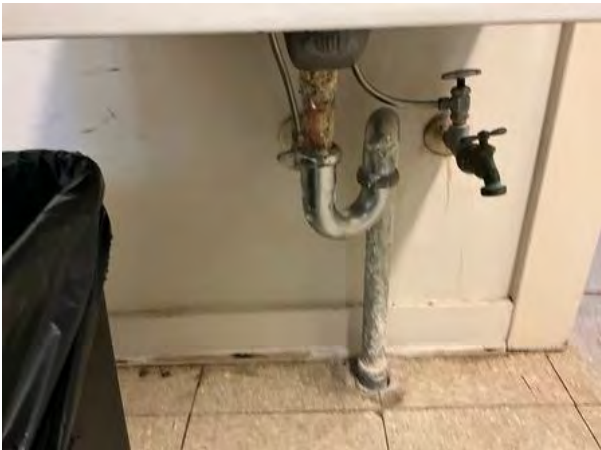
Photos for Barrier ID: AX456054

Assembly	Restroom
Type	Restroom/Bathroom - Lavatory
ADA Standard	606; 306
Barrier Detail	The lavatory does not have the required knee clearance.
Location Description	Second Floor Men's Restroom
Observed	May 20, 2024 by Brian.rogers@bureauveritas.com
Site Conditions	There is 24 1/4 inches knee clearance under the sink

Relocate the lavatory to provide compliant knee clearance. A compliant clear floor space, positioned for a forward approach, and compliant knee and toe clearance shall be provided. [EXCEPTIONS: 2. A lavatory in a toilet room or bathing facility for a single occupant accessed only through a private office and not for common use or public use shall not be required to provide knee and toe clearance. 3. In residential dwelling units, cabinetry shall be permitted under lavatories and kitchen sinks provided that all of the following conditions are met: (a) the cabinetry can be removed without removal or replacement of the fixture; (b) the finish floor extends under the cabinetry; and (c) the walls behind and surrounding the cabinetry are finished. 4. A knee clearance of 24" minimum above the finish floor or ground shall be permitted at lavatories and sinks used primarily by children 6 through 12 years where the rim or counter surface is 31" maximum above the finish floor or ground. 5. A parallel approach shall be permitted to lavatories and sinks used primarily by children 5 years and younger. 6. The dip of the overflow shall not be considered in determining knee and toe clearances. 7. No more than one bowl of a multi-bowl sink shall be required to provide knee and toe clearance. Space under an element between 9" and 27" above the finish floor or ground shall be considered knee clearance and shall comply. Knee clearance shall extend 25" maximum under an element at 9" above the finish floor or ground. Where knee clearance is required under an element as part of a clear floor space, the knee clearance shall be 11" deep minimum at 9" above the finish floor or ground, and 8" deep minimum at 27" above the finish floor or ground. Between 9" and 27" above the finish floor or ground, the knee clearance shall be permitted to reduce at a rate of 1" in depth for each 6" in height. Knee and toe clearance shall be 30" wide minimum.

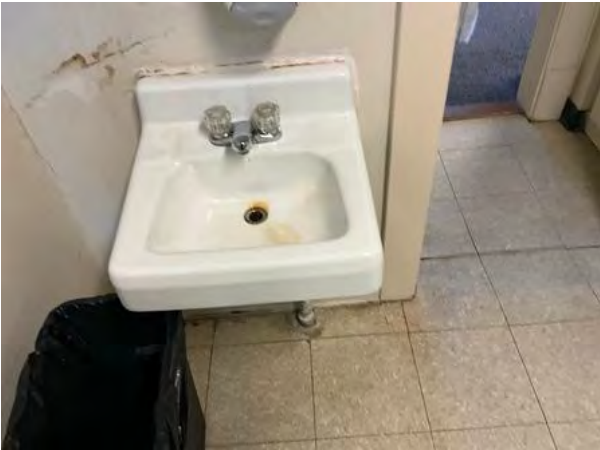
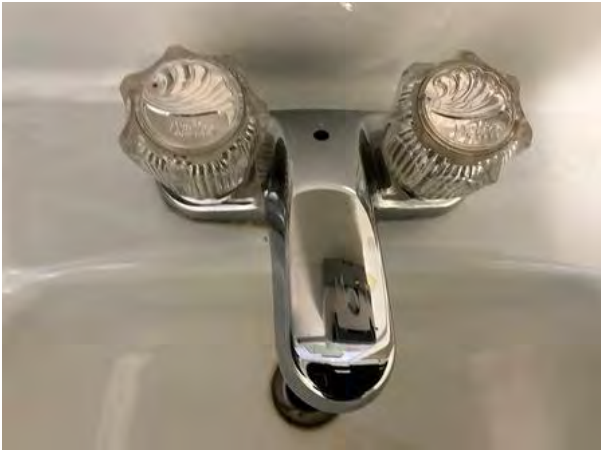
Photos for Barrier ID: AX456056

Assembly	Restroom
Type	Restroom/Bathroom - Lavatory
ADA Standard	606.4; 309
Barrier Detail	The lavatory faucet hardware is not compliant.
Location Description	Second Floor Men's Restroom
Observed	May 20, 2024 by Brian.rogers@bureauveritas.com
Site Conditions	Faucet hardware requires tight grasp to operate.

Provide push/lever hardware for the faucet. Replace faucet operating hardware with compliant handles. Operable parts, such as faucet hardware, shall be operable with one hand and shall not require tight grasping, pinching, or twisting of the wrist. The force required to activate operable parts shall be 5 pounds (22.2 N) maximum. Hand-operated metering faucets shall remain open for 10 seconds minimum. Provide a minimum of one accessible sink with push/lever hardware.

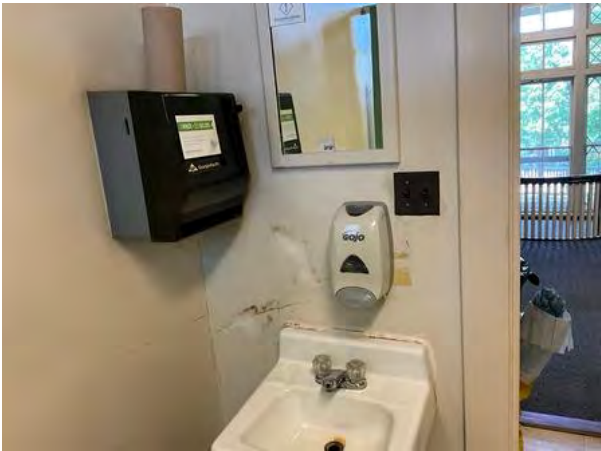
Photos for Barrier ID: AX456057

Assembly	Restroom
Type	Restroom/Bathroom - Mirror
ADA Standard	213.3.5; 603.3

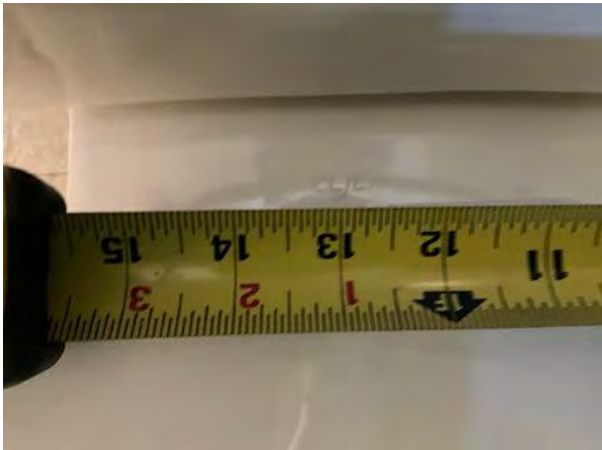
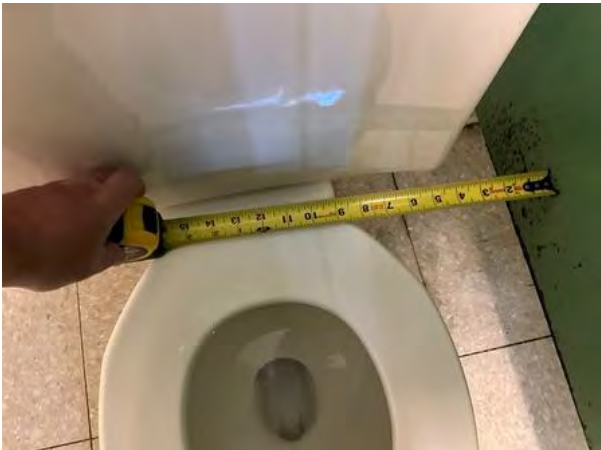
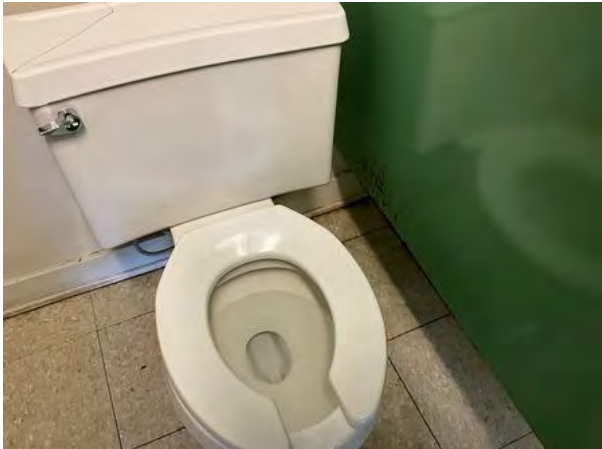
Assembly	Restroom	
Type	Restroom/Bathroom - Water Closet	
ADA Standard	604.2	
Barrier Detail		
The centerline of the toilet in the wheelchair stall is not 16" minimum to 18" maximum from the sidewall.		
Location Description	Second Floor Men's Restroom	
Observed	May 20, 2024 by Brian.rogers@bureauveritas.com	
Site Conditions	The center line of the toilet is 13 inches from the side wall.	
Resolution		
Provide a water closet with centerline 16" minimum to 18" maximum from the side wall or partition. The water closet shall be positioned with a wall or partition to the rear and to one side. The centerline of the water closet shall be 16" minimum to 18" maximum from the side wall or partition in a wheelchair stall. Water closets shall be arranged for a left-hand or right-hand approach. Clearance around a water closet shall be 60" minimum measured perpendicular from the side wall and 56" minimum measured perpendicular from the rear wall. The required clearance around the water closet shall be permitted to overlap the water closet, associated grab bars, dispensers, personal product disposal units, coat hooks, shelves, accessible routes, clear floor space and clearances required at other fixtures, and the turning space. No other fixtures or obstructions shall be located within the required water closet clearance. [ADVISORY: It is advisable, but not required, to use the specifications for children where children are the primary users of the restroom. Guidance in applying the specifications for children according to the age group served reflects the differences in the size, stature, and reach ranges of children ages 3 to 12. The specifications chosen should correspond to the age of the primary user group. The specifications of one age group should be applied consistently in the installation of a water closet and related elements. Water Closet Centerline: Ages 3 and 4- 12"; Ages 5 through 8- 12" to 15"; Ages 9 through 12- 15" to 18". Toilet Seat Height: Ages 3 and 4- 11" to 12"; Ages 5 through 8- 12" to 15"; Ages 9 through 12- 15" to 17". Grab Bar Height: Ages 3 and 4- 18" to 20"; Ages 5 through 8- 20" to 25"; Ages 9 through 12- 25" to 27"; Dispenser Height: Ages 3 and 4- 14"; Ages 5 through 8- 14" to 17"; Ages 9 through 12- 17" to 19"].

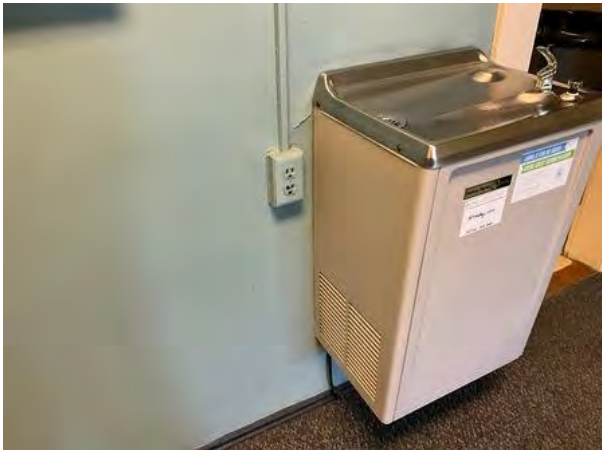
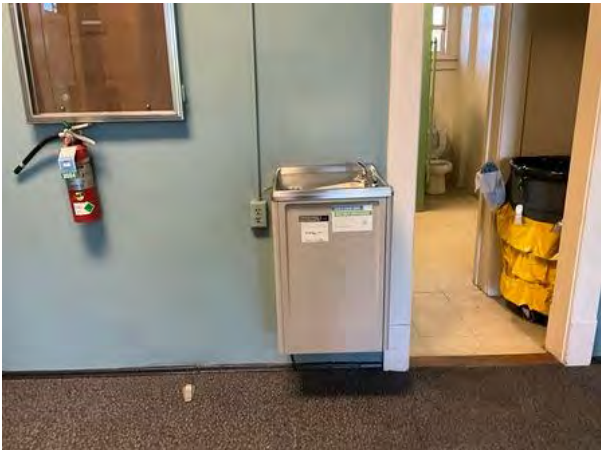
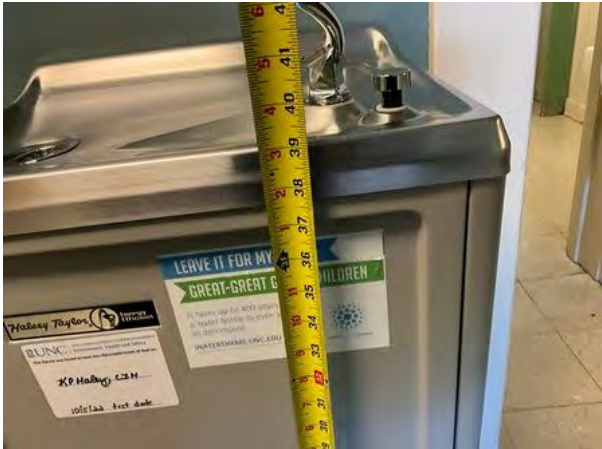
Photos for Barrier ID: AX456059

Assembly	Interior Access Route
Type	Drinking Fountain/Water Cooler
ADA Standard	211.1; 211.2; 602; 309
Barrier Detail	
The minimum number of drinking fountains is not provided. If the minimum number is provided, two levels or a hi-lo are not provided. If more than 2 are provided, less than 50% are high or less than 50% are low.	
Location Description	Drinking Fountain DF-2 at Second Floor Men's Restroom
Observed	May 20, 2024 by Brian.rogers@bureauveritas.com
Site Conditions	No lower drinking fountain is supplied.

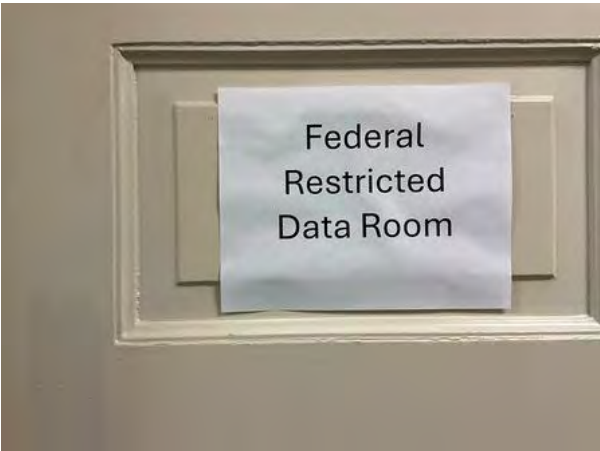
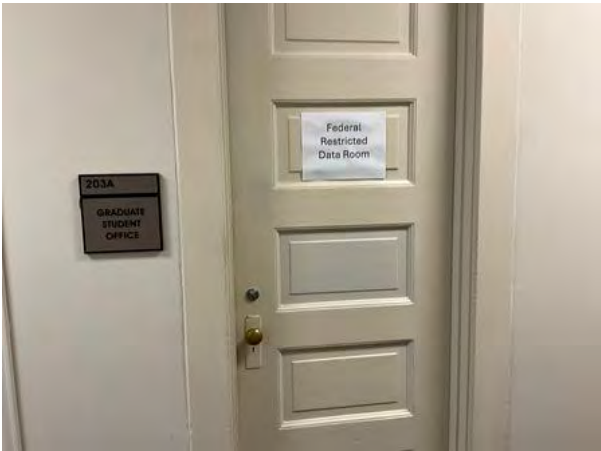
Photos for Barrier ID: AX456061

Assembly	Amenity Not Evaluated
Type	Amenity Not Evaluated
ADA Standard	None
Barrier Detail	The amenity cannot be accessed and, therefore, cannot be evaluated.
Location Description	Room 203A
Observed	May 20, 2024 by Brian.rogers@bureauveritas.com
Site Conditions	Access to the Restricted Data Room was not provided.
