ACCESSIBILITY ASSESSMENT

June 21, 2024

ADA TITLE II ASSESSMENT

Abernethy Annex

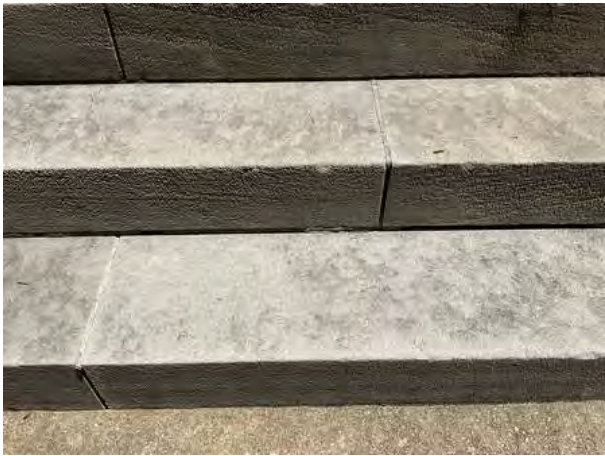
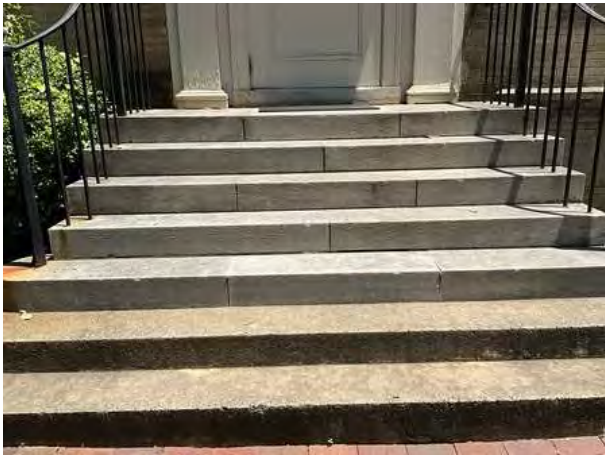
Assembly	Exterior Access Route	
Type	Stairs	
ADA Standard	2009 ANSI A117.1-504.5	
Barrier Detail		
NORTH CAROLINA: The stair tread, at the leading 2" at the stair nosing, does not have a visual contrast of dark-on-light or light-on-dark distinguished from the remainder of the tread.		
Location Description	Front entry	
Observed	May 22, 2024 by Brian.rogers@bureauveritas.com	
Site Conditions	The stairs do not have contrast on the top nose	
Resolution		
Install a visual contrast on each stair tread at the nosing. At stair nosings, the leading 2" of tread shall have visual contrast of dark-on-light or light-on-dark from the remainder of the tread.		
Quantity	Unit Cost	Total Cost
7 Riser	250.00	\$ 1,750
Priority	1
