# ACCESSIBILITY ASSESSMENT

July 1, 2024

## **ADA TITLE II ASSESSMENT**

Anderson Stadium  
910 Raleigh Road  
Chapel Hill, North Carolina 27514

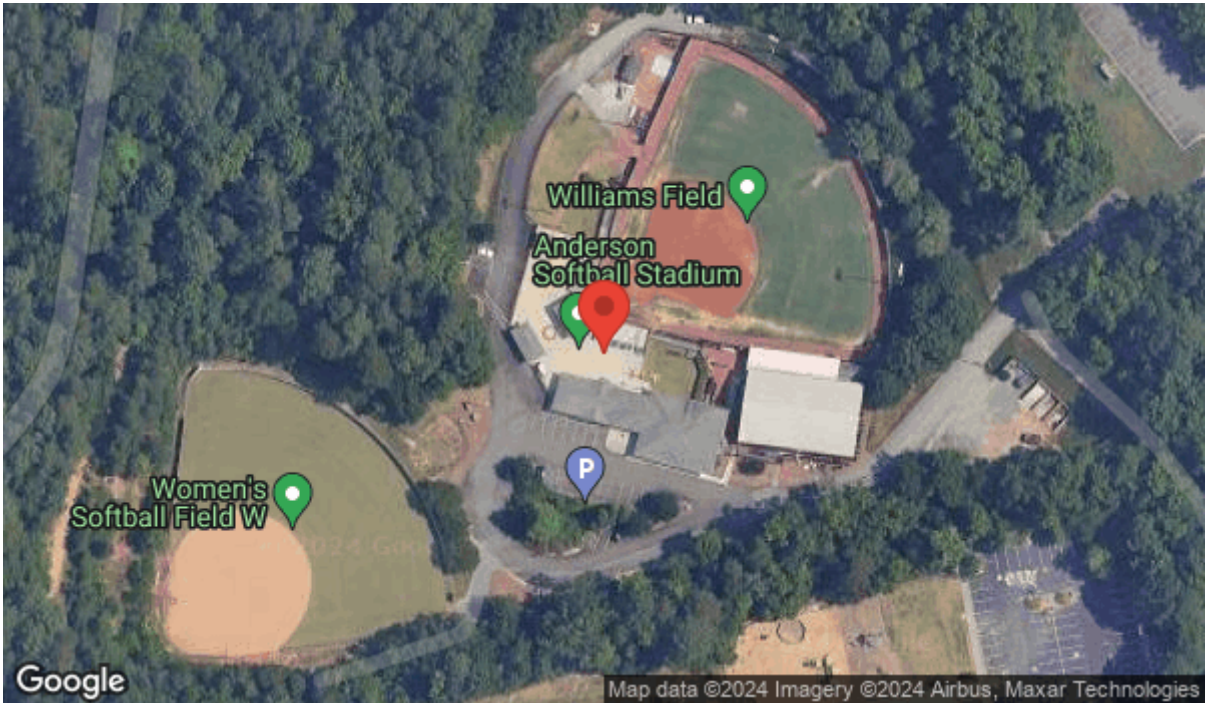
Map for Barrier ID: AX468718

Assembly	Exterior Access Route
Type	Exterior Accessible Route
ADA Standard	302.3
Barrier Detail	The accessible route has gaps in the surface greater than 1/2" wide.
Location Description	Accessible Route between Concession Stand & Bleachers
Observed	May 16, 2024 by javondrick.orange@bureauveritas.com
Site Conditions	The accessible route has 1/2" wide gaps in a 5' by 5' section of the concrete.

Repair the accessible route to eliminate openings in the surface greater than 1/2" wide. Openings in the ground surface of the accessible route shall not allow passage of a sphere more than 1/2" diameter. Elongated openings shall be placed so that the long dimension is perpendicular to the dominant direction of travel.

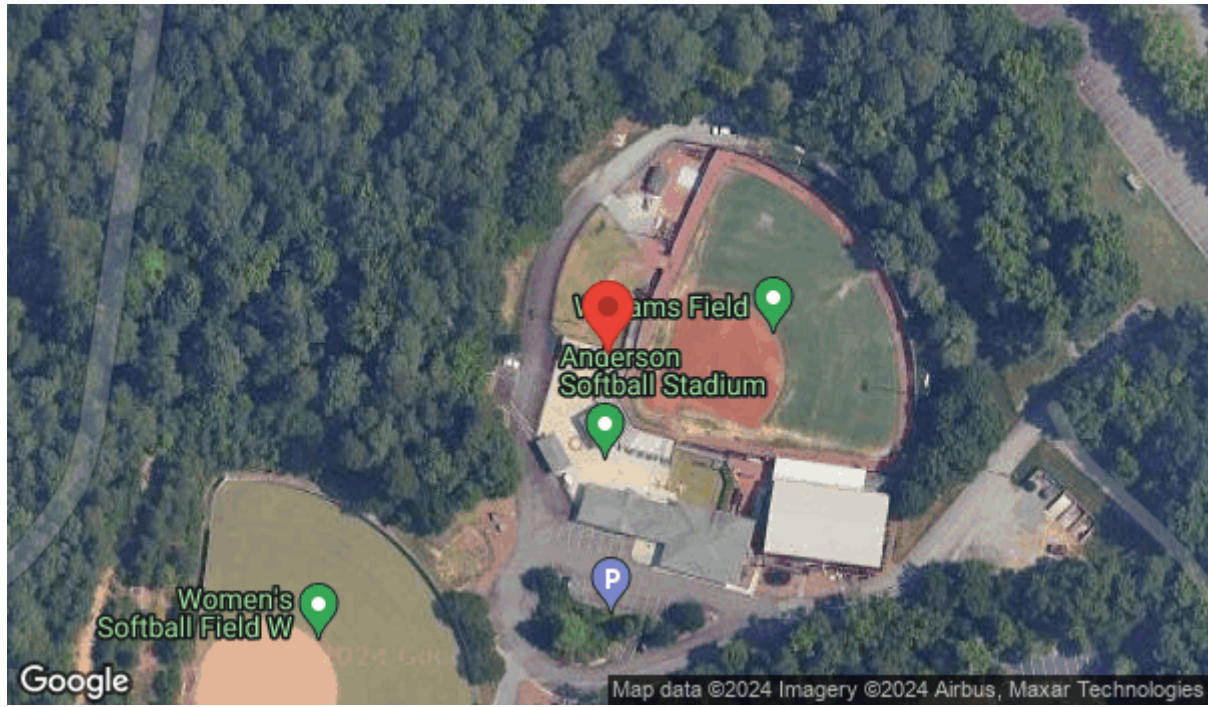
Map for Barrier ID: AX468765

Assembly	Exterior Access Route
Type	Exterior Accessible Route
ADA Standard	403.3
Barrier Detail	The accessible route has cross slopes greater than 1:50 (2%).
Location Description	Accessible Route between Concession Stand & Bleachers
Observed	May 16, 2024 by javondrick.orange@bureauveritas.com

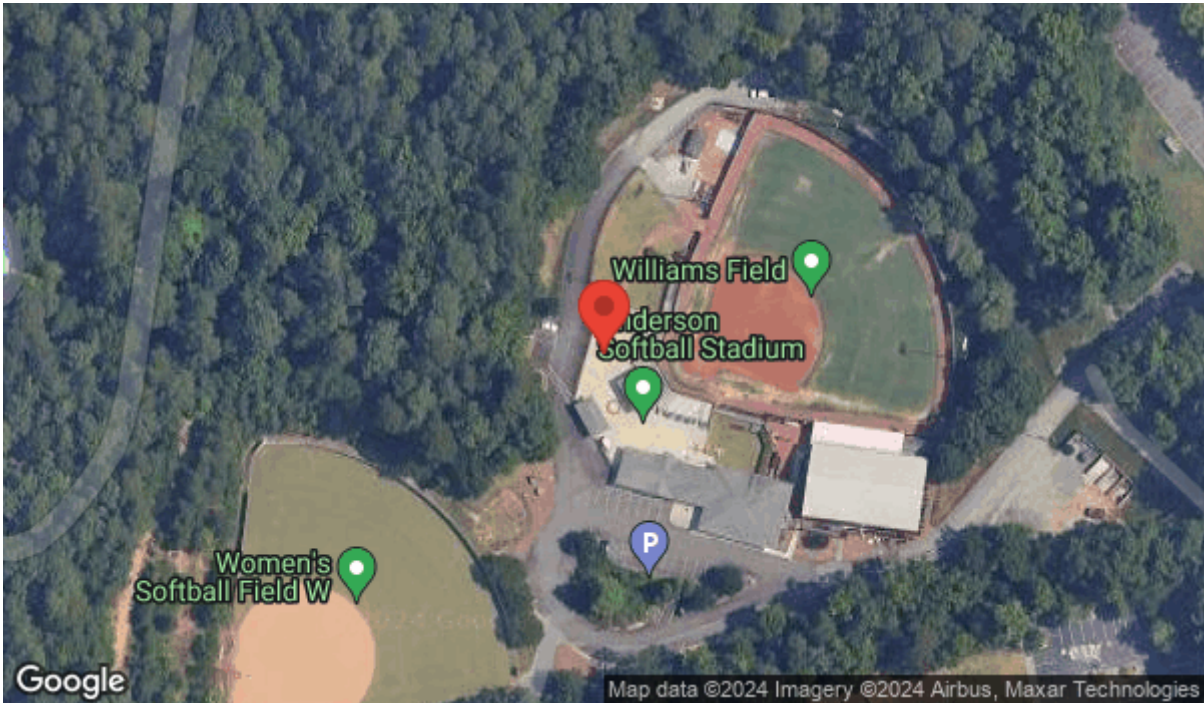
Map for Barrier ID: AX468766

Assembly	Exterior Access Route
Type	Exterior Accessible Route
ADA Standard	302.3
Barrier Detail	The accessible route has gaps in the surface greater than 1/2" wide.
Location Description	Accessible Route between Concession Stand & Bleachers
Observed	May 16, 2024 by javondrick.orange@bureauveritas.com
Site Conditions	The accessible route has 1/2" wide gaps in a 5' by 5' section of the concrete.

Repair the accessible route to eliminate openings in the surface greater than 1/2" wide. Openings in the ground surface of the accessible route shall not allow passage of a sphere more than 1/2" diameter. Elongated openings shall be placed so that the long dimension is perpendicular to the dominant direction of travel.

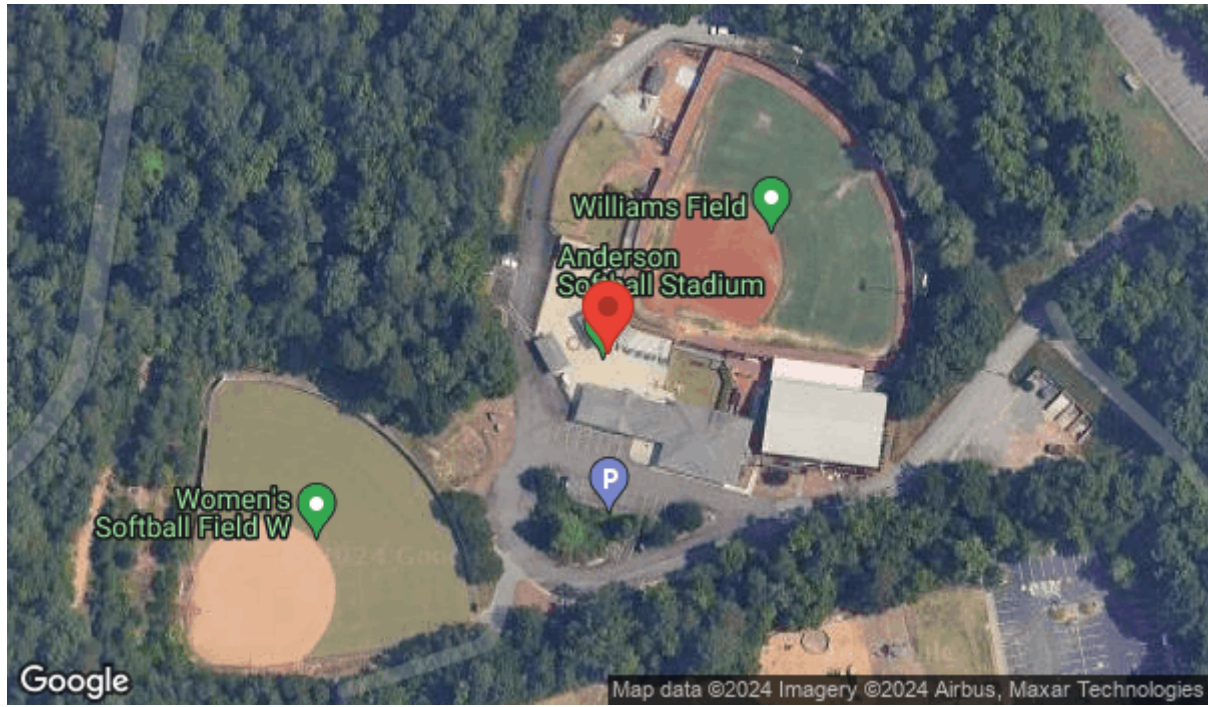
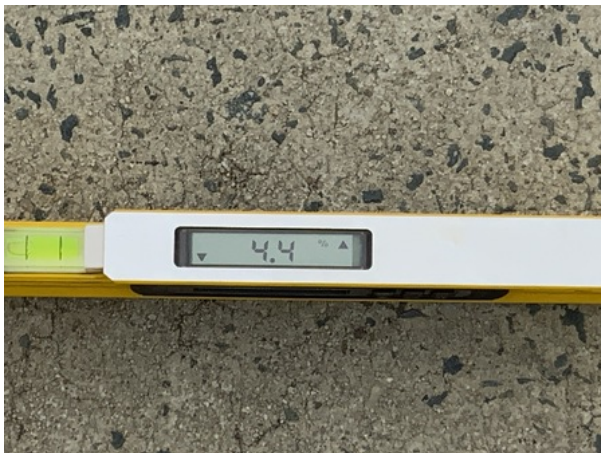
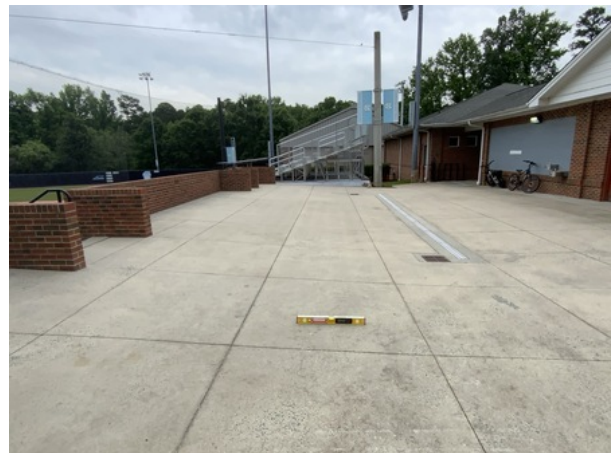
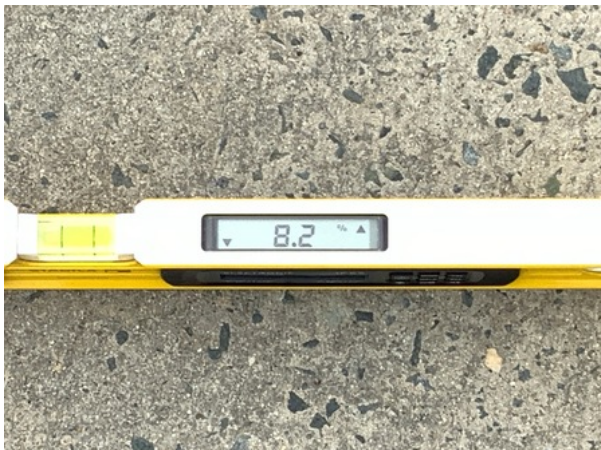
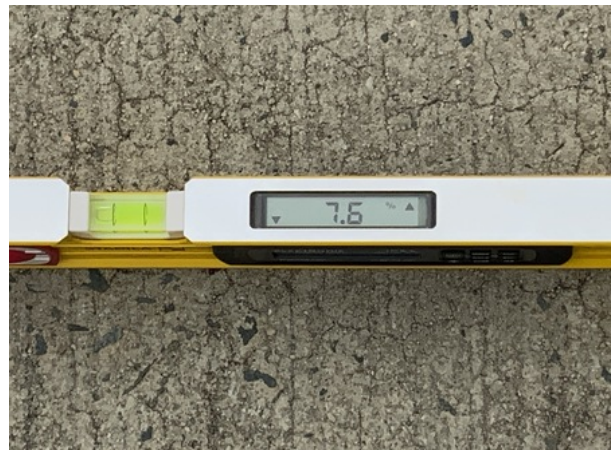
Photos for Barrier ID: AX468767

Assembly	Exterior Access Route
Type	Exterior Accessible Route
ADA Standard	403.3
Barrier Detail	The accessible route has cross slopes greater than 1:50 (2%).
Location Description	Accessible Route between Concession Stand & Bleachers
Observed	May 16, 2024 by javondrick.orange@bureauveritas.com

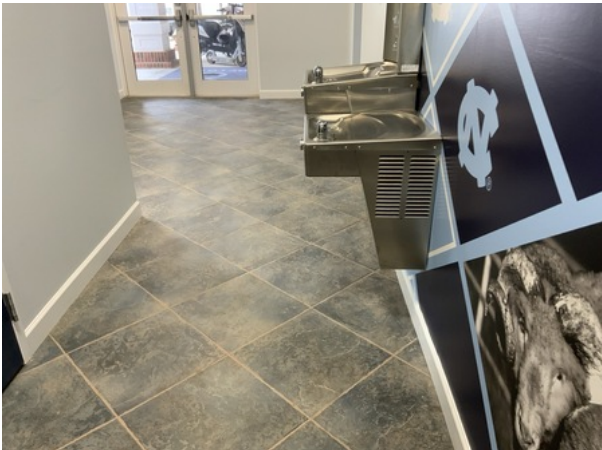
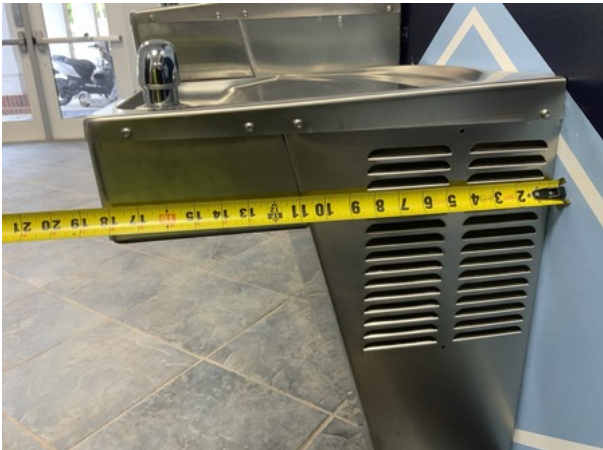
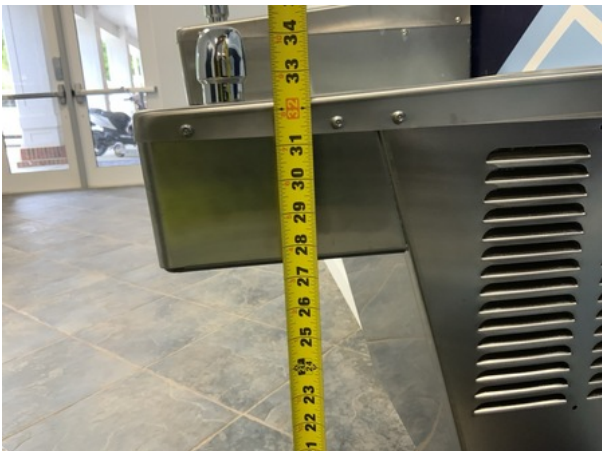
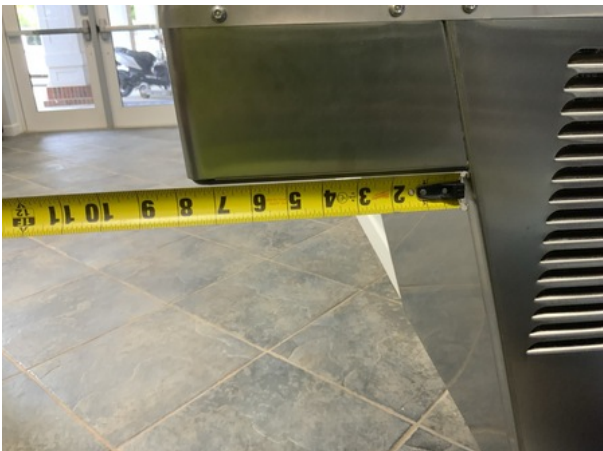
Photos for Barrier ID: AX468738

Assembly	Interior Access Route
Type	Protruding Object
ADA Standard	307.2

Location Description	Hallway
Observed	May 16, 2024 by javondrick.orange@bureauveritas.com

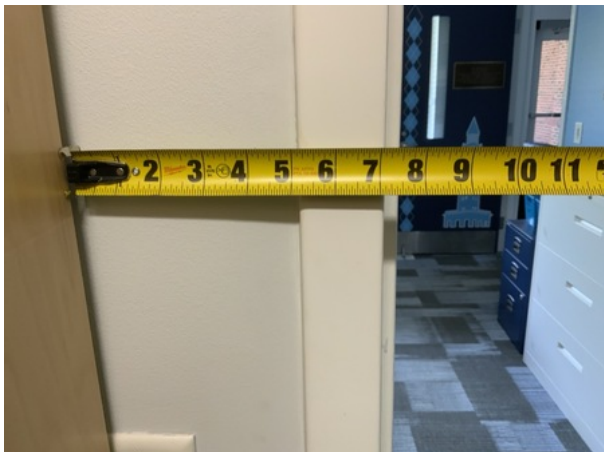
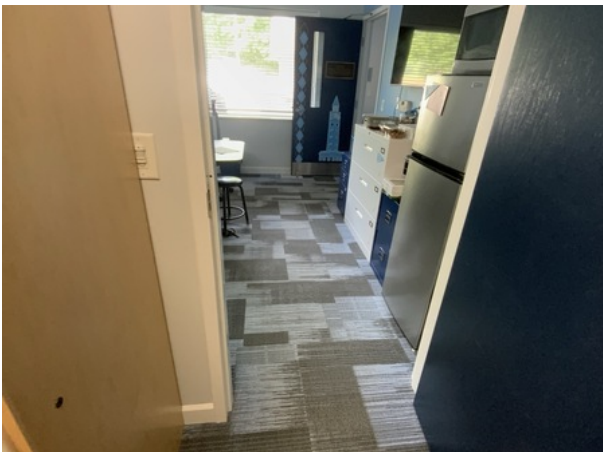
Photos for Barrier ID: AX468725

Assembly	Interior Access Route
Type	Door
ADA Standard	404.2.4; Table 404.2.4.1

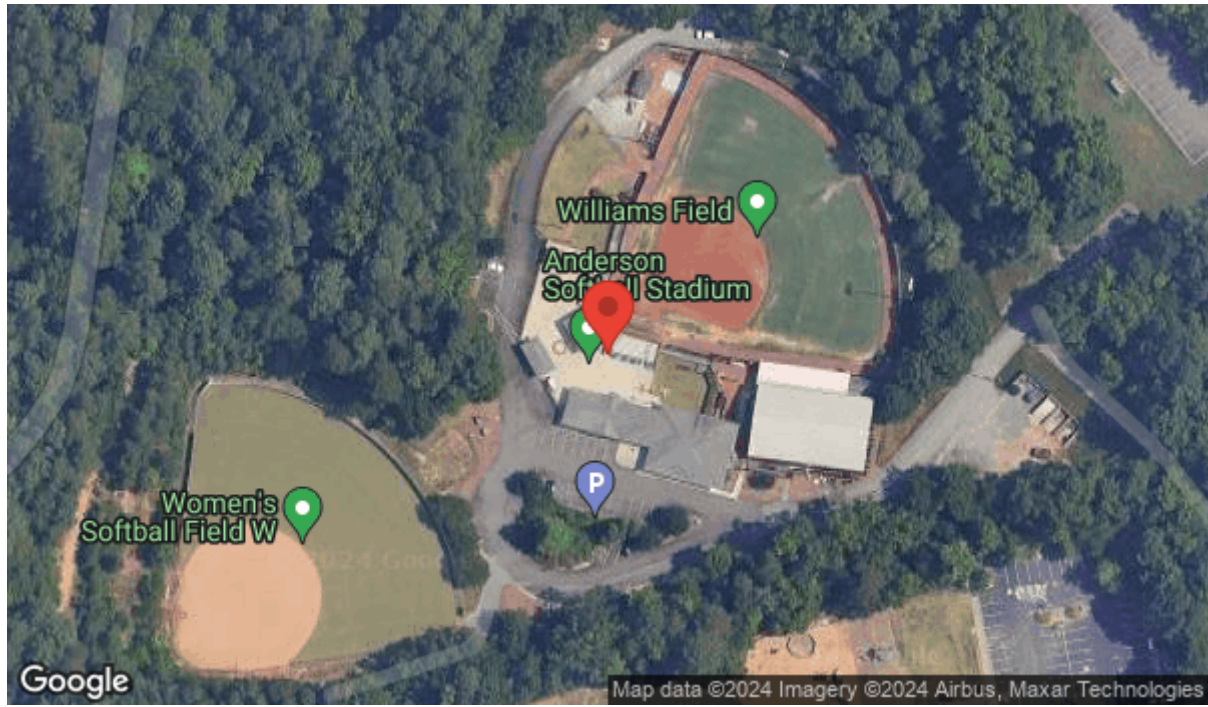
Map for Barrier ID: AX468768

Assembly	Exterior Access Route
Type	Protruding Object
ADA Standard	307.2

Location Description	Restroom Building
Observed	May 16, 2024 by javondrick.orange@bureauveritas.com

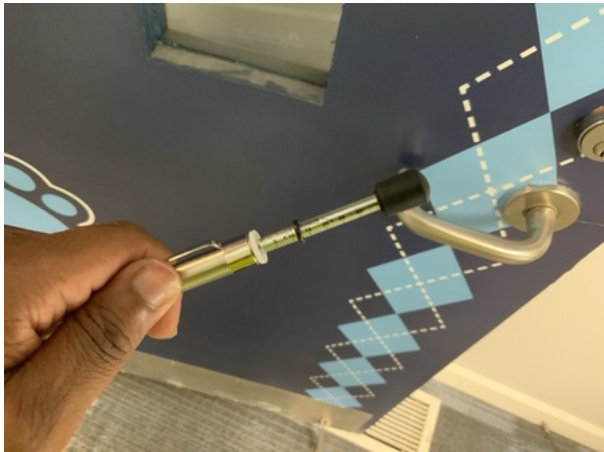
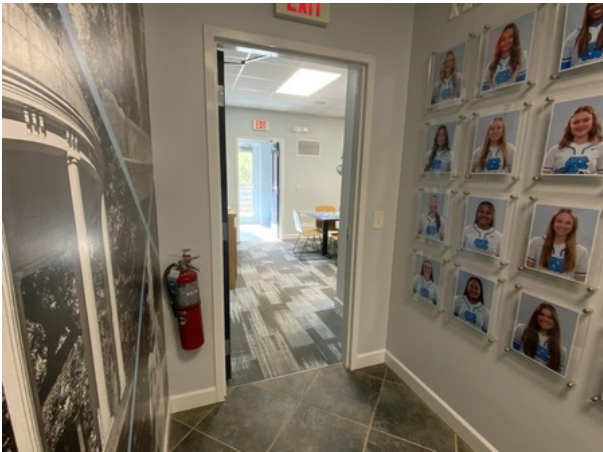
Photos for Barrier ID: AX468730

Assembly	Interior Access Route
Type	Door
ADA Standard	404.2.4; Table 404.2.4.1
<b>Barrier Detail</b>	
The pull side of the accessible door does not have the required maneuvering clearances.	
Location Description	Team Room
Observed	May 16, 2024 by javondrick.orange@bureauveritas.com
Site Conditions	For an approach from the front on the pull side the side clearance is 16".

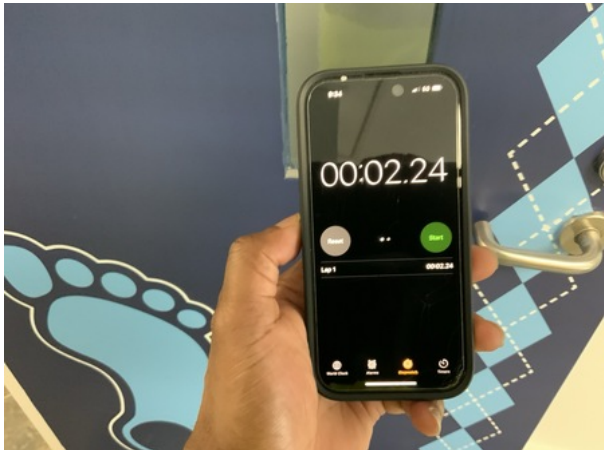
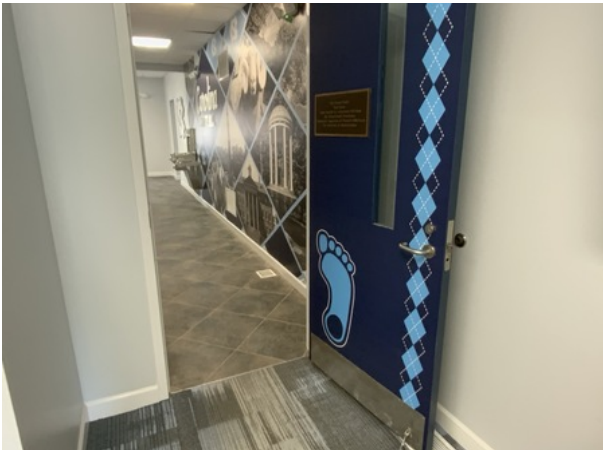
Photos for Barrier ID: AX468731

Assembly	Interior Access Route
Type	Door
ADA Standard	404.2.8

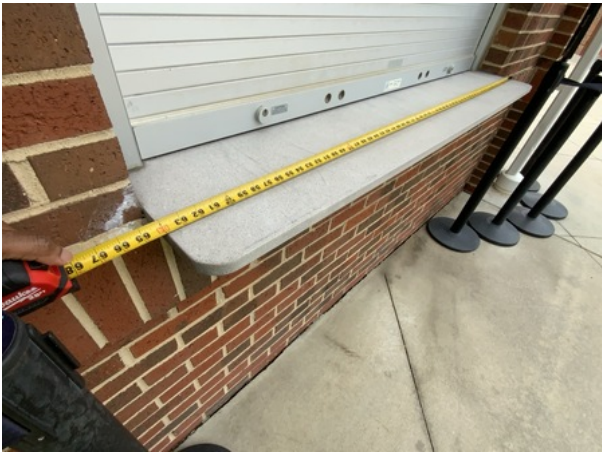
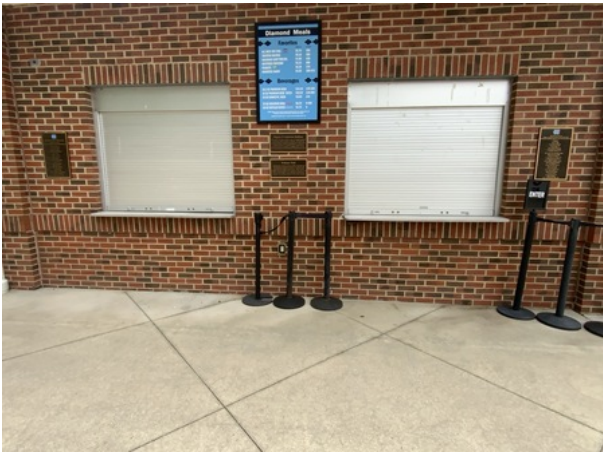
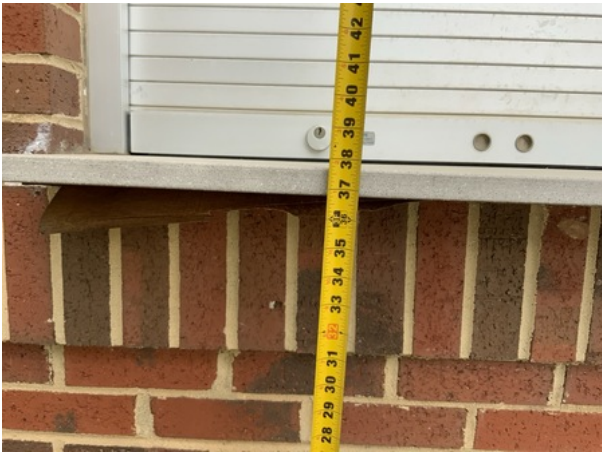
Assembly	Concession Stand
Type	Service Counter
ADA Standard	305; 904.4.1

Provide a compliant service counter for a parallel approach. An accessible portion of the service counter must be a minimum length of 36" and a maximum height of 36" for a parallel approach adjacent to the 36" minimum length of the counter. [EXCEPTION: Where the provided counter surface is less than 36" long, the entire counter surface shall be 36" high maximum above the finished floor.]

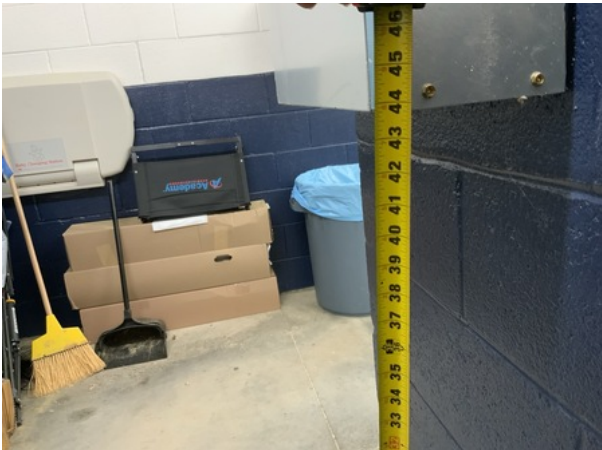
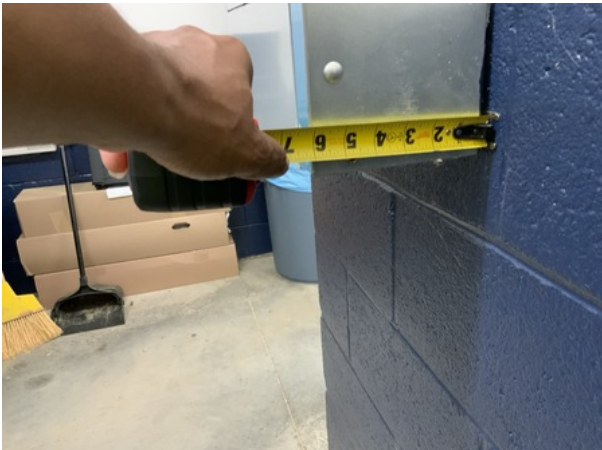
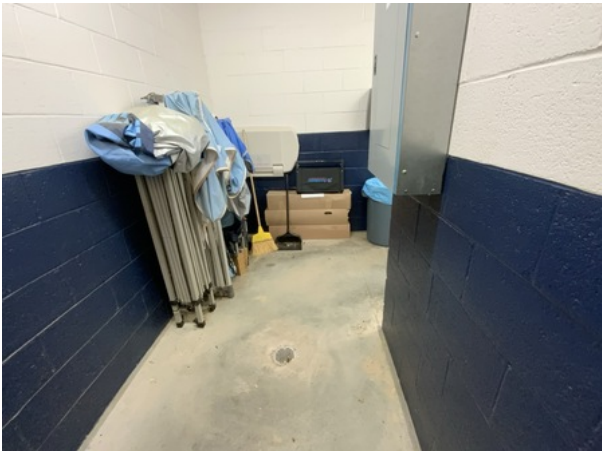
Photos for Barrier ID: AX468743

Assembly	Restroom
Type	Protruding Object
ADA Standard	307.2

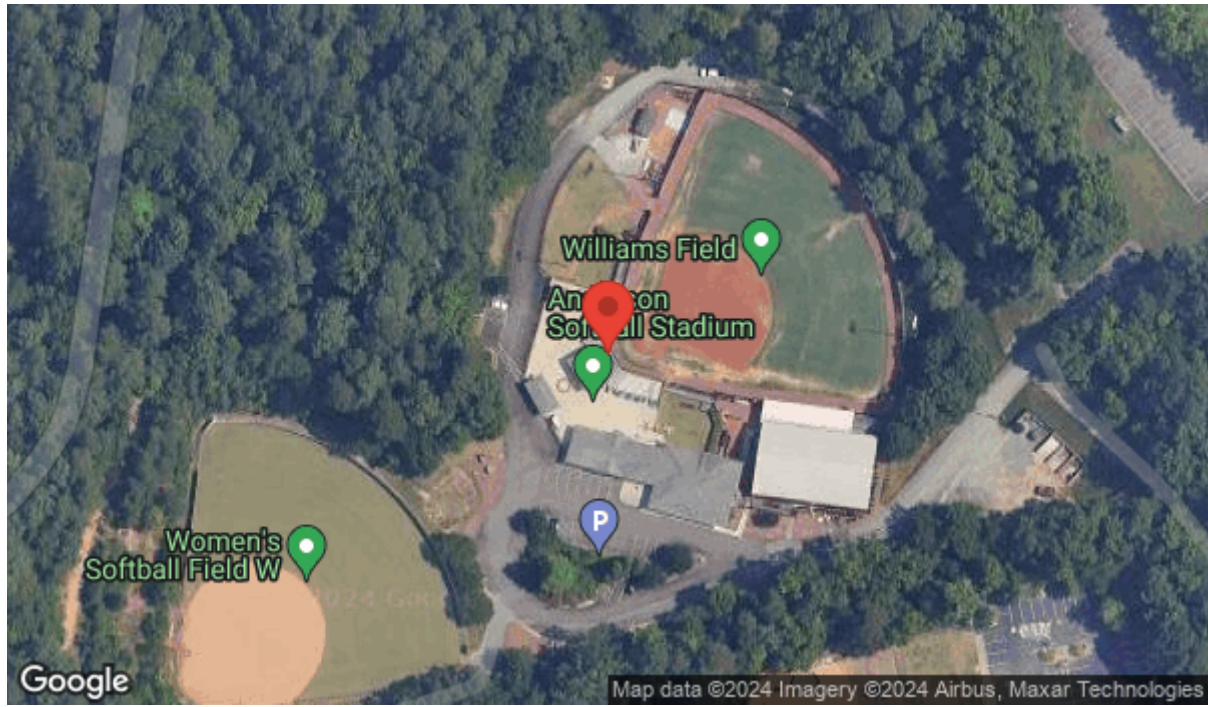
Map for Barrier ID: AX468910

Assembly	Interior Access Route
Type	Signage
ADA Standard	216.2, 703.2; 703.3; 703.5

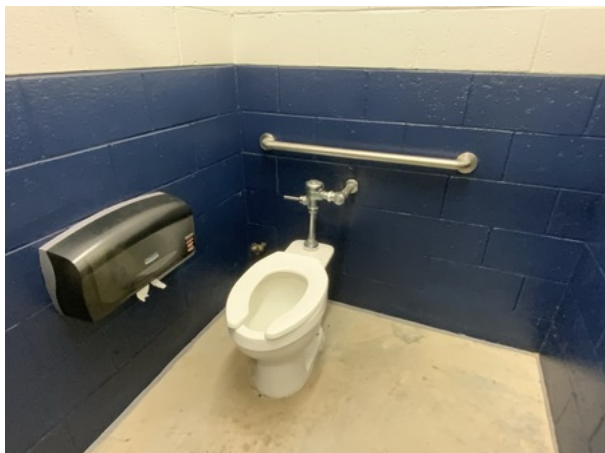
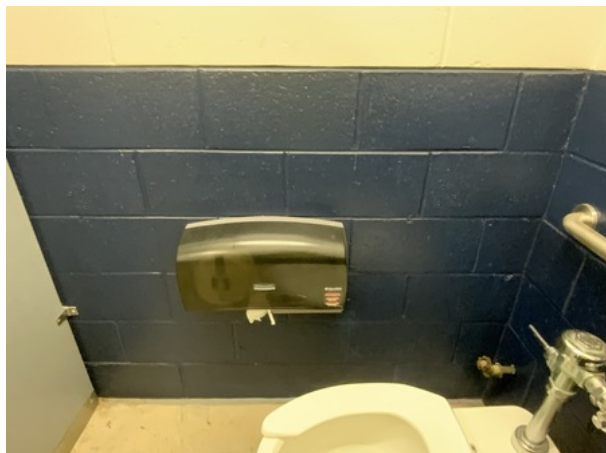
Assembly	Restroom
Type	Restroom/Bathroom - Toilet Stall
ADA Standard	604.5.1; 604.8.1.5
Barrier Detail	The side grab bar is not compliant in the wheelchair stall.
Location Description	Men's Restroom
Observed	May 16, 2024 by javondrick.orange@bureauveritas.com
Site Conditions	A side grab bar is not provided in the wheelchair stall.

Remove and install a compliant side grab bar in the wheelchair stall. The top of the gripping surface of horizontal grab bars shall be located minimum 33" and maximum 36" above the finished floor. The side wall grab bar shall be 42" long minimum, located 12" maximum from the rear wall and extending 54" minimum from the rear wall. A continuous grab bar is allowable in lieu of two grab bars (one side and one rear). .[ADVISORY: It is advisable, but not required, to use the specifications for children where children are the primary users of the restroom. Guidance in applying the specifications for children according to the age group served reflects the differences in the size, stature, and reach ranges of children ages 3 to 12. The specifications chosen should correspond to the age of the primary user group. The specifications of one age group should be applied consistently in the installation of a water closet and related elements. Water Closet Centerline: Ages 3 and 4- 12"; Ages 5 through 8- 12" to 15"; Ages 9 through 12- 15" to 18". Toilet Seat Height: Ages 3 and 4- 11" to 12"; Ages 5 through 8- 12" to 15"; Ages 9 through 12- 15" to 17". Grab Bar Height: Ages 3 and 4- 18" to 20"; Ages 5 through 8- 20" to 25"; Ages 9 through 12- 25" to 27"; Dispenser Height: Ages 3 and 4- 14"; Ages 5 through 8- 14" to 17"; Ages 9 through 12- 17" to 19"].

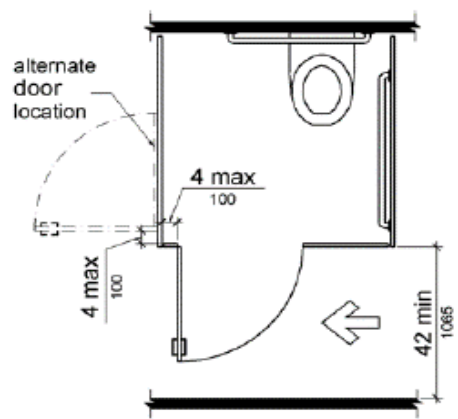
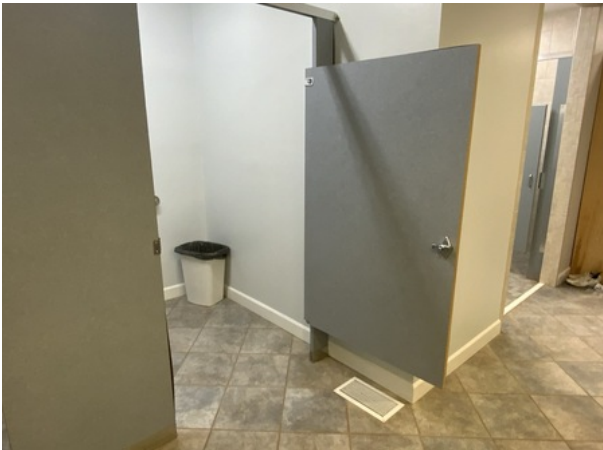
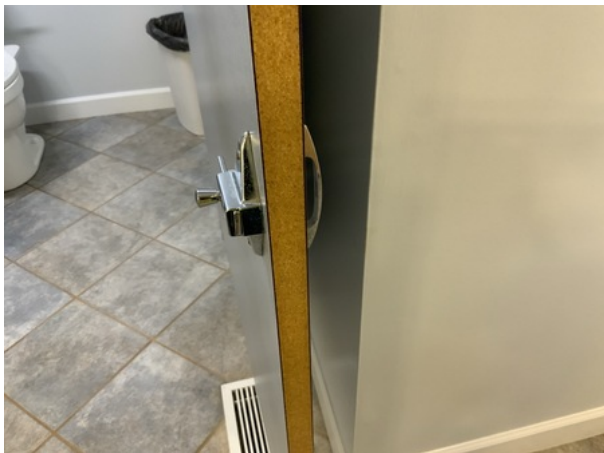
Photos for Barrier ID: AX468741

Assembly	Restroom
Type	Restroom/Bathroom - Toilet Stall
ADA Standard	213.3.1, 309, 404.2.7, 604.8.2

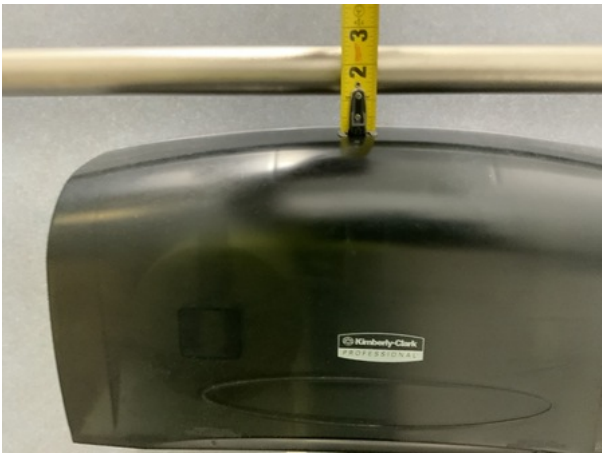
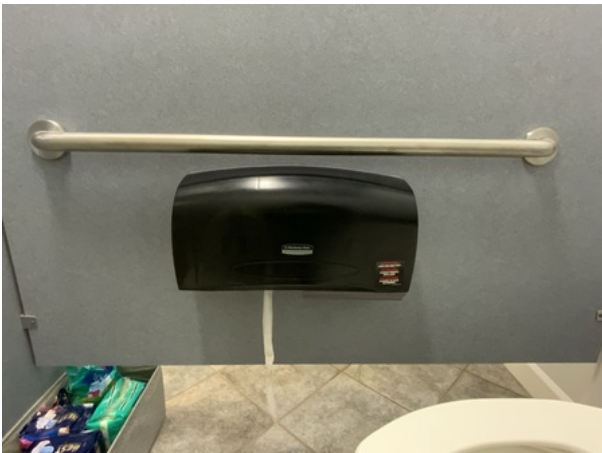
Photos for Barrier ID: AX468742

Location Description	Team Locker Room
Observed	May 16, 2024 by javondrick.orange@bureauveritas.com

Quantity	Unit Cost	Total Cost
1 EA	125.00	\$ 125
Priority	3

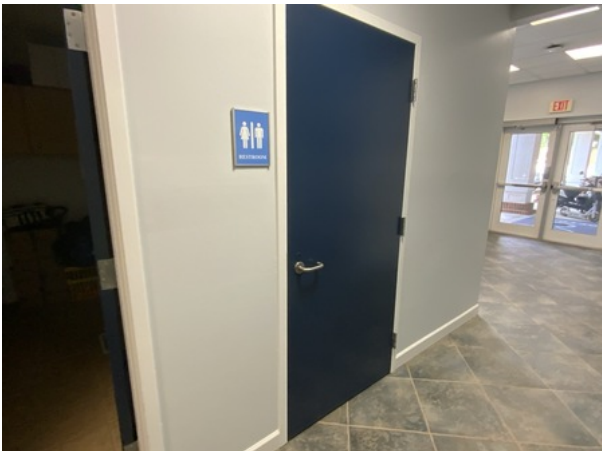
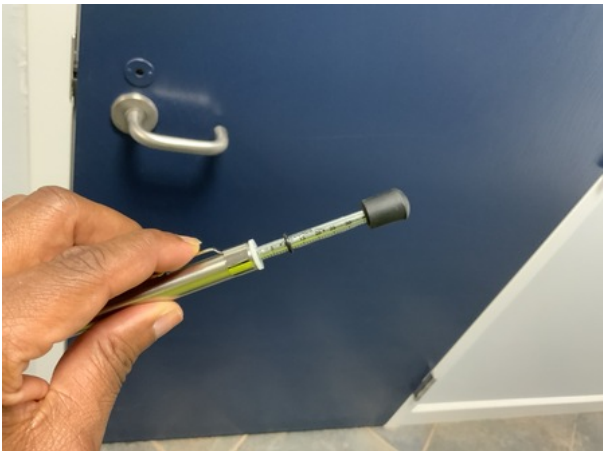
**Photos for Barrier ID: AX468733**

Assembly	Restroom
Type	Restroom/Bathroom - Door
ADA Standard	404.2.9

Location Description	Unisex Restroom
Observed	May 16, 2024 by javondrick.orange@bureauveritas.com
Site Conditions	The door requires 10 pounds of pressure to operate.

Adjust closer or replace with an closer that requires no more 5 pounds of force to stop the door motion. The maximum force for pushing or pulling open a door shall be for interior hinged doors: 5 lbs (22.2N). The force for pushing or pulling open a door or gate other than fire doors shall be as follows: 1. Interior hinged doors and gates: 5 pounds (22.2 N) maximum. 2. Sliding or folding doors: 5 pounds (22.2 N) maximum. These forces do not apply to the force required to retract latch bolts or disengage other devices that hold the door or gate in a closed position. Note: Fire doors shall have a minimum opening force allowable by the appropriate administrative authority.

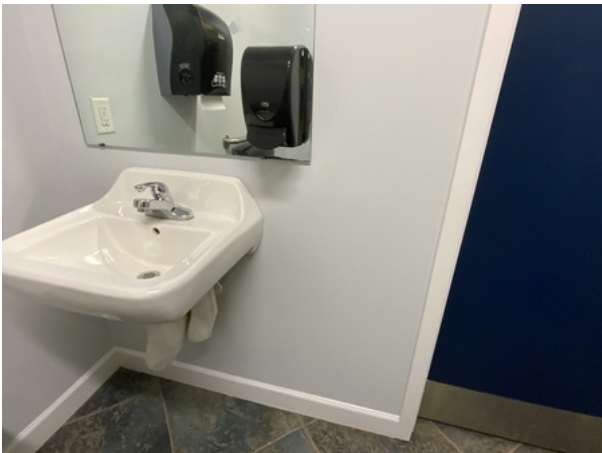
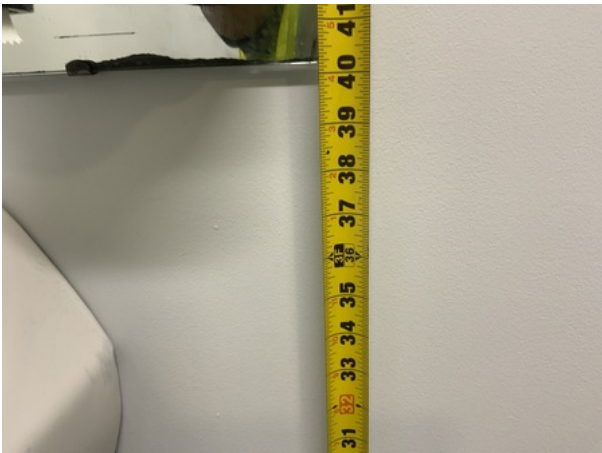
**Photos for Barrier ID: AX468737**

Assembly	Restroom
Type	Restroom/Bathroom - Mirror
ADA Standard	213.3.5; 603.3

Location Description	Unisex Restroom
Observed	May 16, 2024 by javondrick.orange@bureauveritas.com
Site Conditions	The bottom of the reflective surface of the mirror is 40 1/4" above the floor.

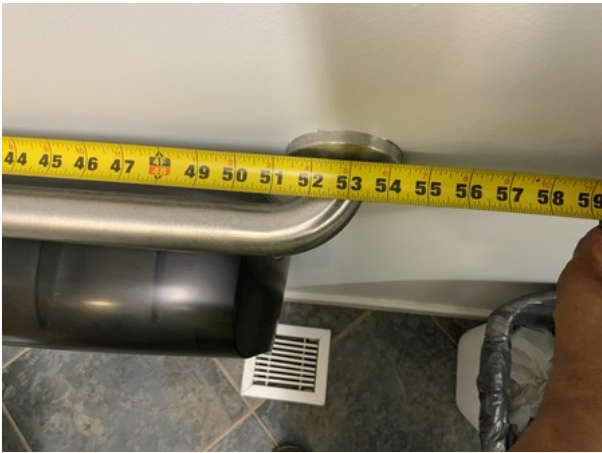
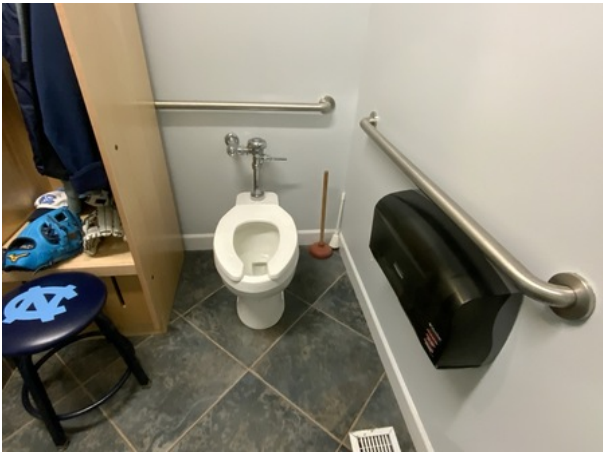
Photos for Barrier ID: AX468734

Assembly	Restroom
Type	Restroom/Bathroom - Water Closet
ADA Standard	604.5.1
Barrier Detail	The side grab bar at the water closet is not compliant.
Location Description	Unisex Restroom
Observed	May 16, 2024 by javondrick.orange@bureauveritas.com
Site Conditions	The side wall grab bar extends 53" from the rear wall.

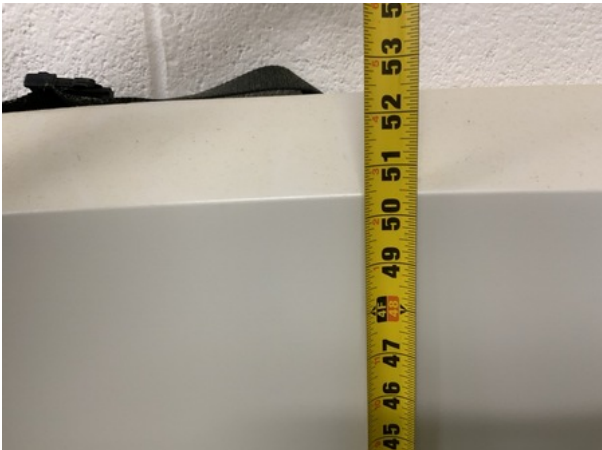
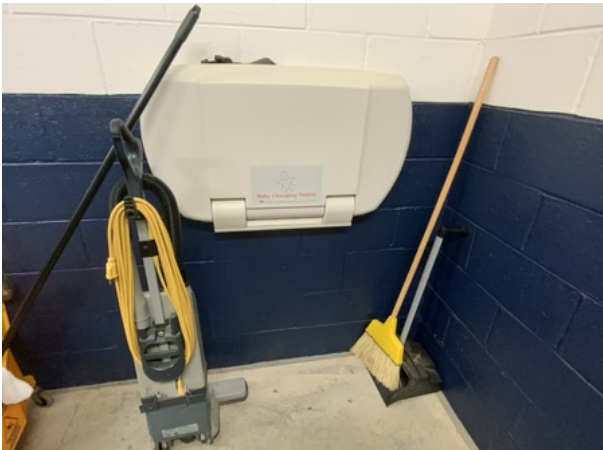
Photos for Barrier ID: AX468758

Assembly	Restroom
Type	Controls And Dispensers
ADA Standard	606.1; 309.3
Barrier Detail	The height of controls are not compliant.
Location Description	Women's Restroom
Observed	May 16, 2024 by javondrick.orange@bureauveritas.com
Site Conditions	The baby changing station handle is 52 1/2" above the floor.

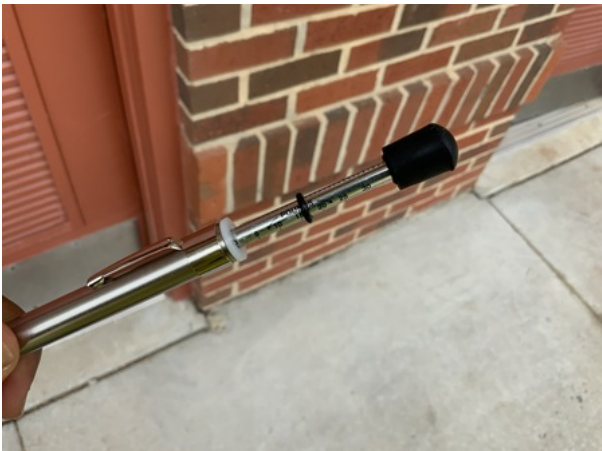
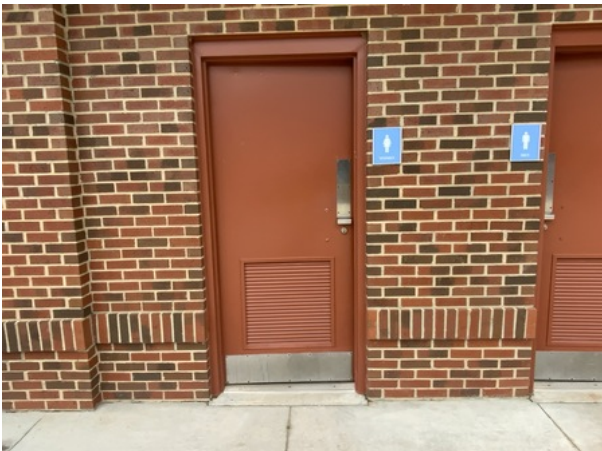
**Photos for Barrier ID: AX468759**

Assembly	Restroom
Type	Restroom/Bathroom - Door
ADA Standard	404.2.9

Location Description	Women's Restroom
Observed	May 16, 2024 by javondrick.orange@bureauveritas.com
Site Conditions	The door requires 16 pounds of pressure to operate.

Adjust closer or replace with an closer that requires no more 5 pounds of force to stop the door motion. This barrier must be removed in conjunction with barrier ID 468760. The maximum force for pushing or pulling open a door shall be for interior hinged doors: 5 lbs (22.2N). The force for pushing or pulling open a door or gate other than fire doors shall be as follows: 1. Interior hinged doors and gates: 5 pounds (22.2 N) maximum. 2. Sliding or folding doors: 5 pounds (22.2 N) maximum. These forces do not apply to the force required to retract latch bolts or disengage other devices that hold the door or gate in a closed position. Note: Fire doors shall have a minimum opening force allowable by the appropriate administrative authority.

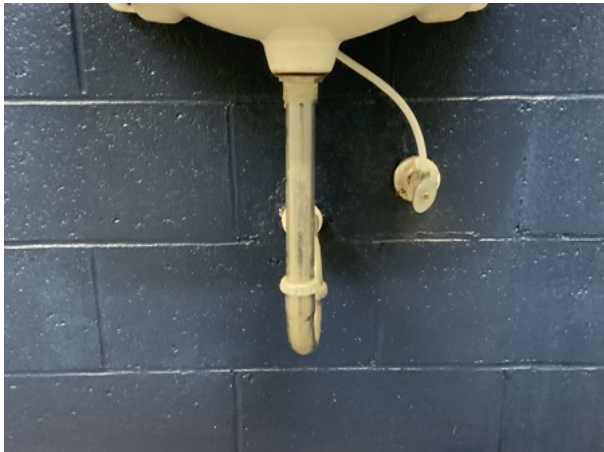
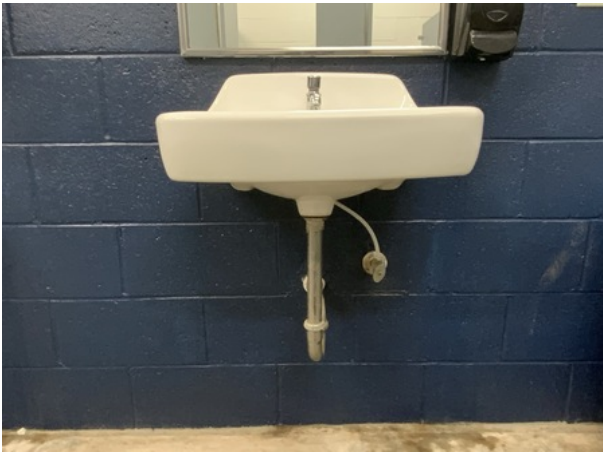
**Photos for Barrier ID: AX468755**

Assembly	Restroom
Type	Restroom/Bathroom - Lavatory
ADA Standard	213.3.4, 606.5
Barrier Detail	Pipes are not insulated.
Location Description	Women's Restroom
Observed	May 16, 2024 by javondrick.orange@bureauveritas.com
Site Conditions	The lavatory drainpipe and water supply lines are not insulated.

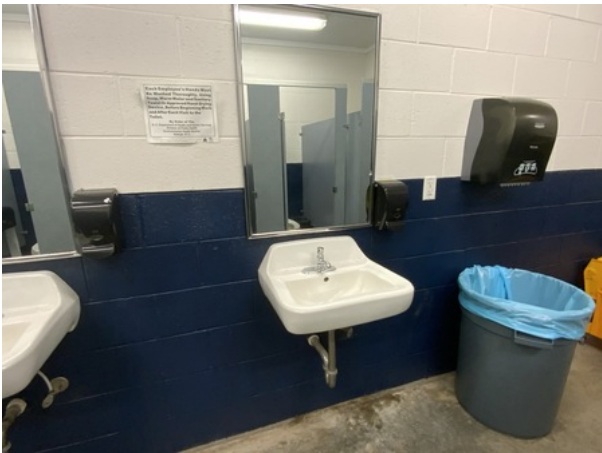
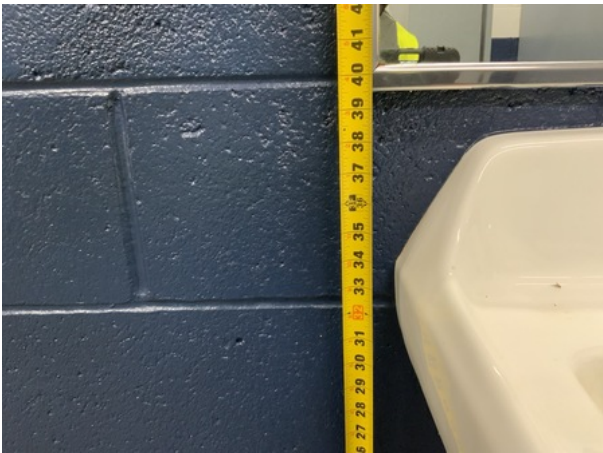
**Photos for Barrier ID: AX468756**

Assembly	Restroom
Type	Restroom/Bathroom - Mirror
ADA Standard	213.3.5; 603.3

Location Description	Women's Restroom
Observed	May 16, 2024 by javondrick.orange@bureauveritas.com
Site Conditions	The bottom of the reflective surface of the mirror is 40 1/4" above the floor.
